Crash Analysis Studio

Session 6: Amarillo, Texas

June 30, 2023

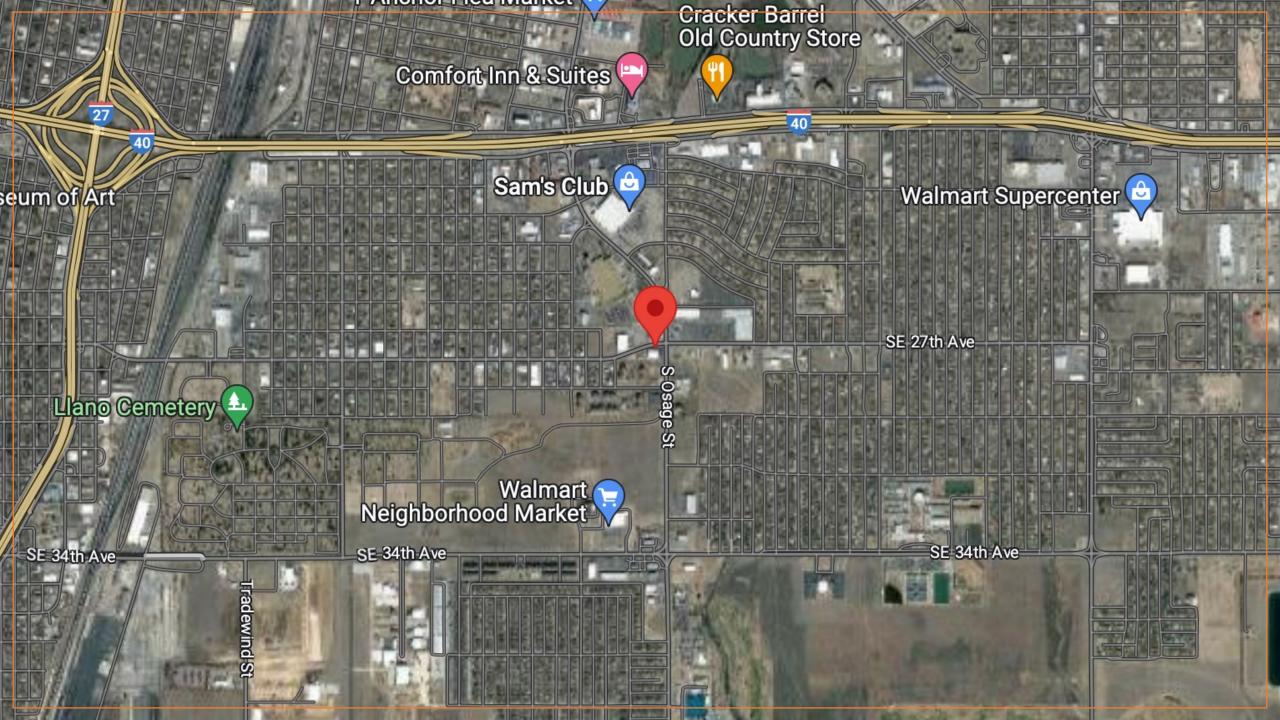
- S. Osage is an arterial street near two major highways (intersects with 40 & is nearby 27)
- SE 27th is an east/west collector street
- This segment of S. Osage Street has a 40MPH speed limit; SE 27th Avenue has a 35 MPH speed limit
- Osage Street, Northbound & Southbound consist of 5 lanes; 4 for through traffic and a continuous center turn lane
 - Sidewalks are disconnected and missing along Osage Street
 - Cobra Head style streetlights are sporadically located along Osage Street

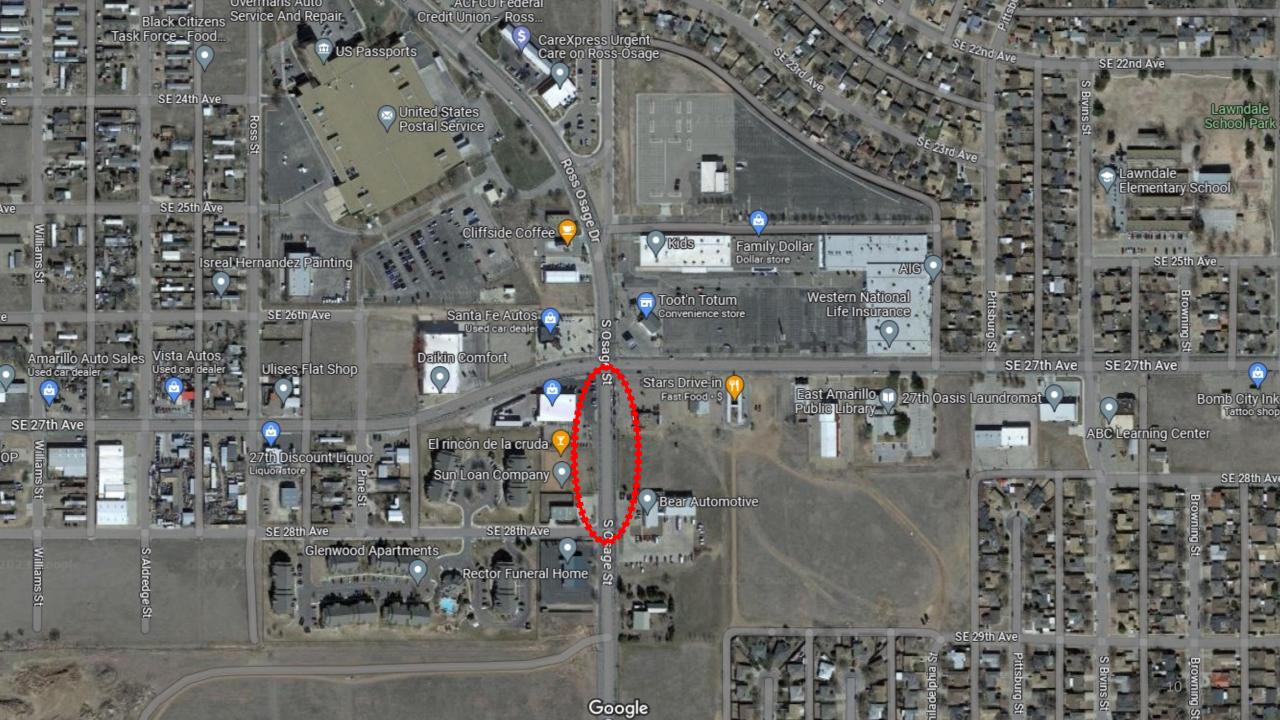
- Auto-oriented Sub-Urban development pattern
- S Osage St is fronted by large footprint auto-oriented commercial development and Industrial uses
 - Multiple curb cuts and parking fronting the street
- The regular street grid and rear alleys of the city are interrupted at SE 27th
 Ave and Osage St to accommodate large footprint development
- Suburban residential uses located behind commercial
 - Limited access and lack of connectivity
- Vast amount of undeveloped land

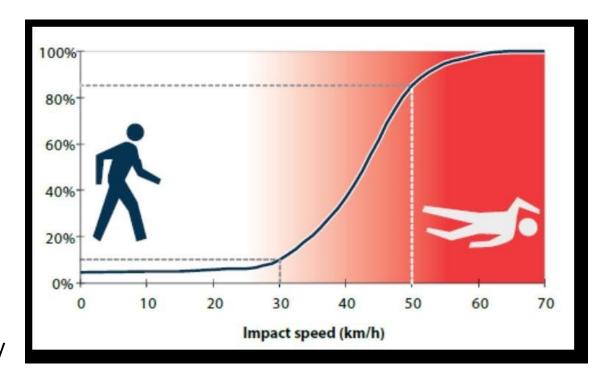
Preliminary Speed Study indicates significant number of automobiles traveling at fatal speeds

The effects of higher speed limits on traffic fatalities in the United States, 1993–2017.
