Crash Analysis Studio

Episode 1: Indianapolis, IN

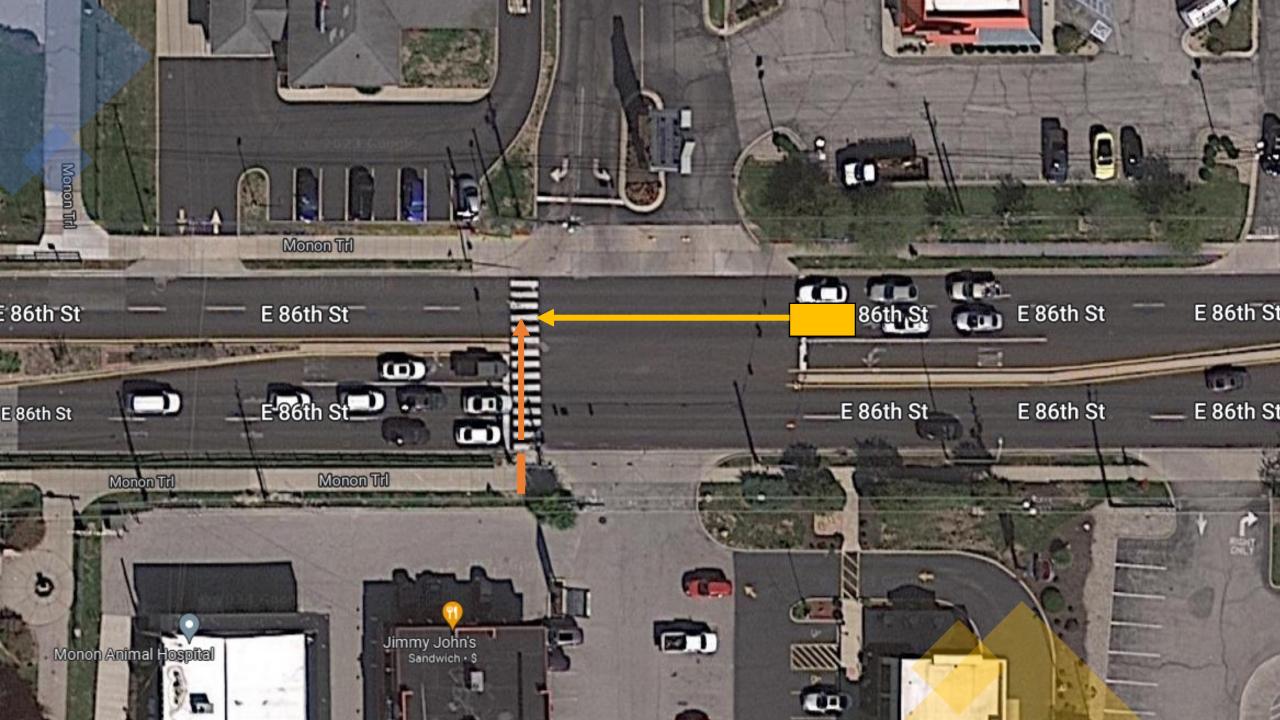
Police Crash Report

- Driver traveling west on East 86th Street in the left lane.
- Victim traveling north along Monon Trail by bike.
- Driver crossed through the intersection and struck the victim on the far west side.

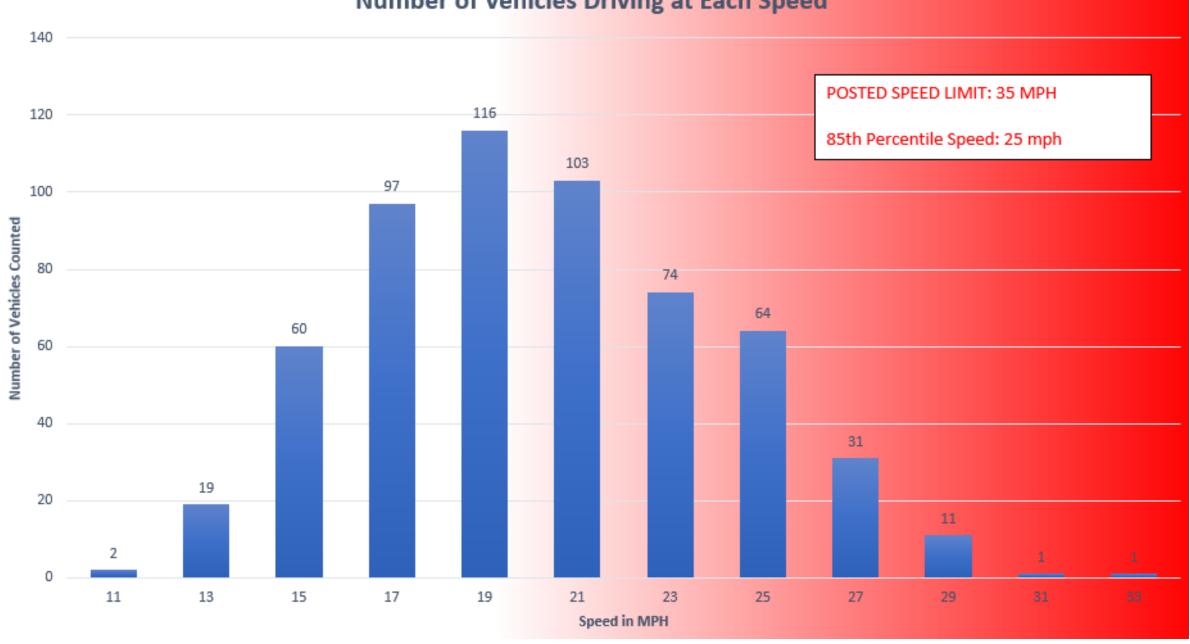
86th & Monon Trail Speed Study - Indianapolis Number of Vehicles Driving at Each Speed

Preliminary Speed Study indicates significant number of automobiles traveling at fatal speeds

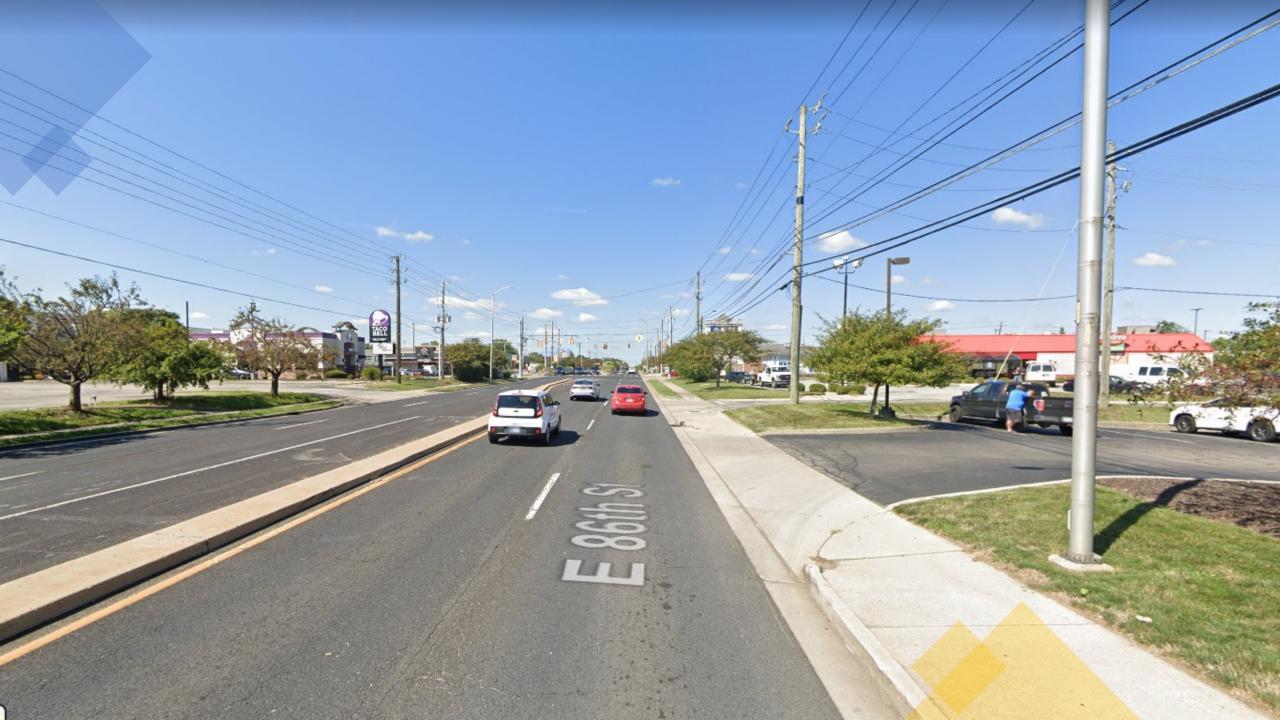
Intersection Approach Conditions (auto)

- Center concrete separation median (no refuge)
- Two lanes of traffic moving in the same direction
- Multiple access points with in-out turning movements (no crossovers)
- Sidewalks directly adjacent driving surface
- Electric poles adjacent to the sidewalks
- Turf and trees of medium height adjacent to the sidewalks

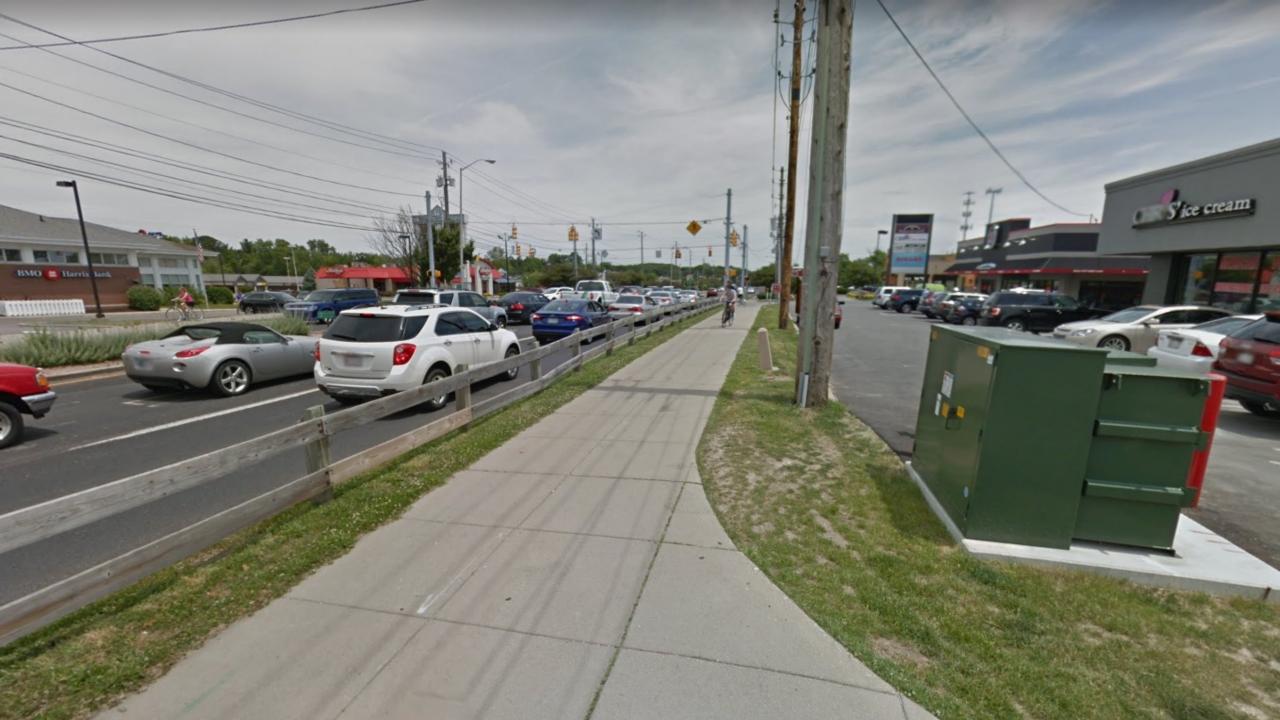
Intersection Approach Conditions (bike)

- Trail merges into sidewalk parallel to East 86th Street
- Wooden separation fence (non-collision resistant) between sidewalk and East 86th Street

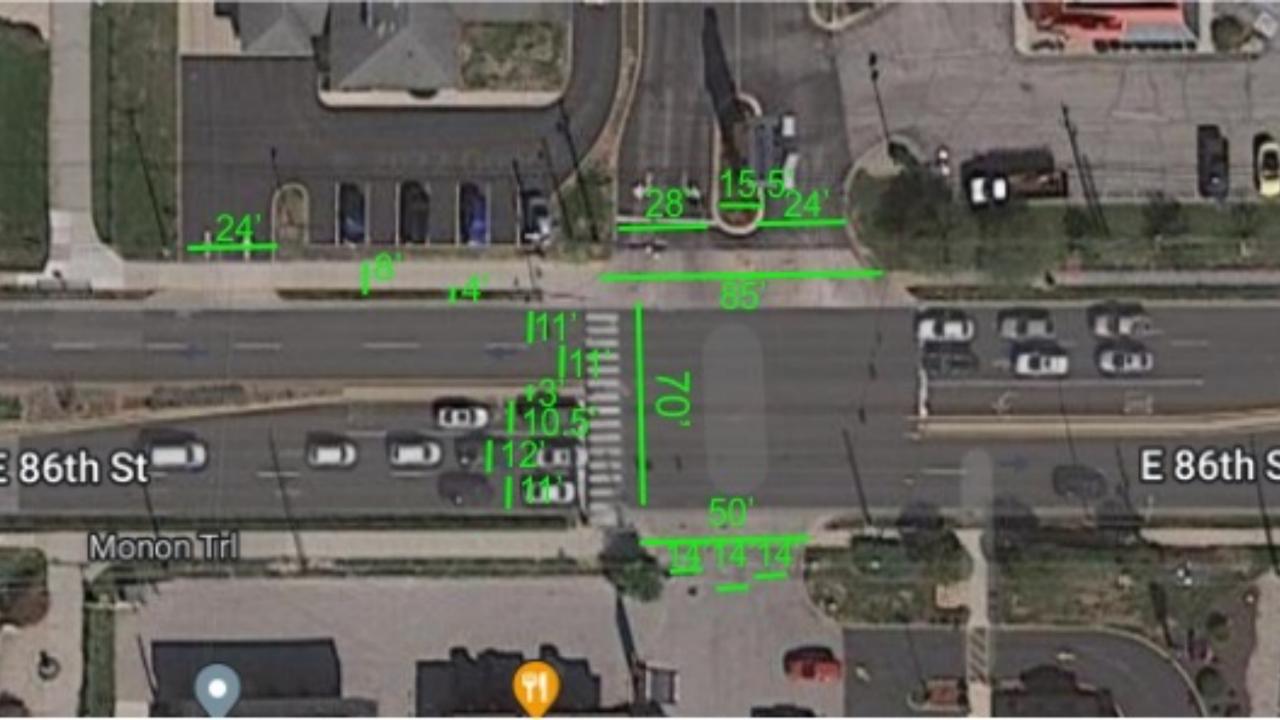
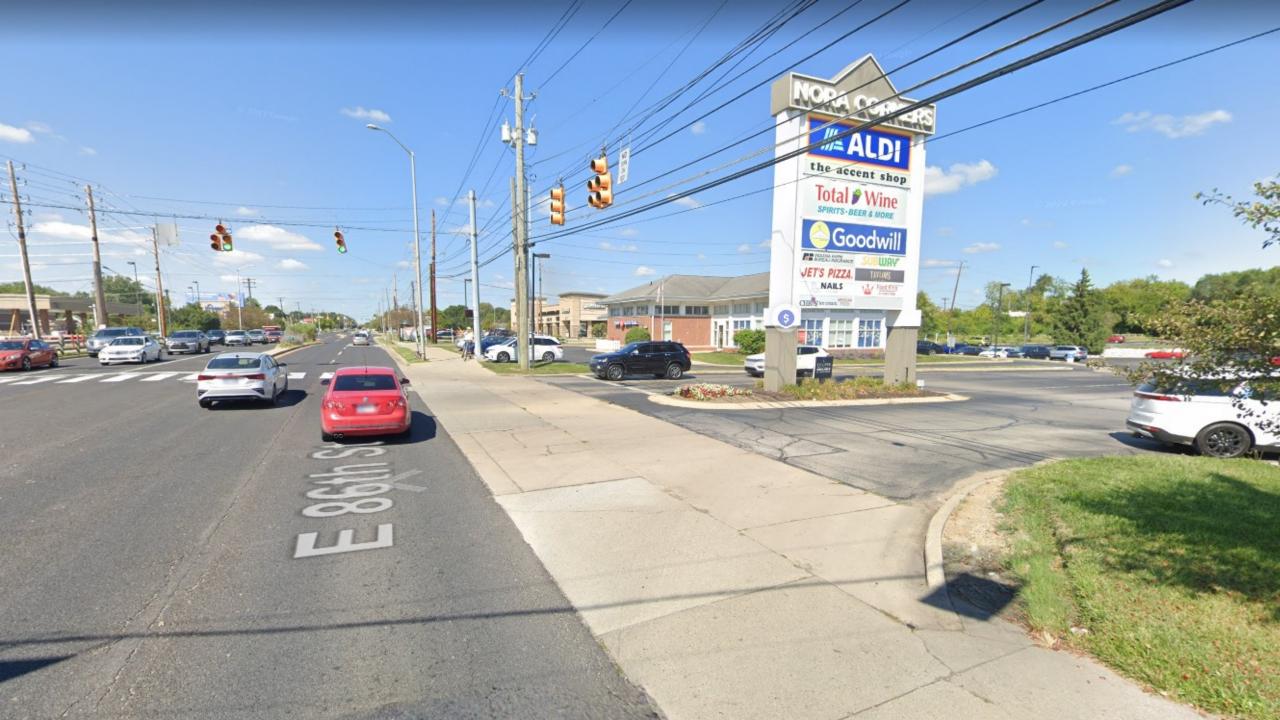
Intersection Conditions (auto)

- Left turn lanes in both east and west approaches
- Center concrete separation median diminishes (no refuge)
- Two lanes of traffic moving in the same direction
- Wide curb radius on north access point (Nora Corners)
- North access designed to accommodate two vehicles in each direction
- 85-foot total north access width

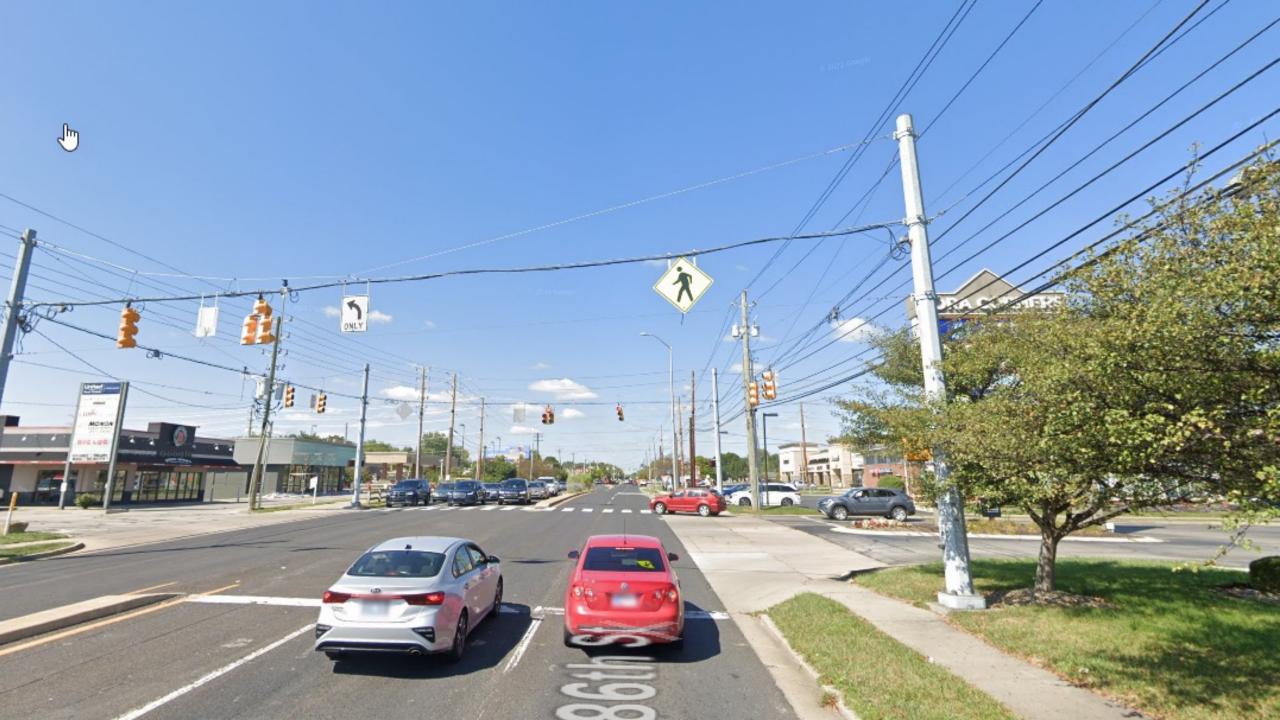
Intersection Conditions (auto)

- Sidewalks blend with driving surface
- No crosswalks on east (near) side of intersection
- Crosswalk present on west (far) side of intersection
- Pedestrian signage hung from wire
- Electric poles adjacent to the sidewalks
- Traffic signals hung from wires

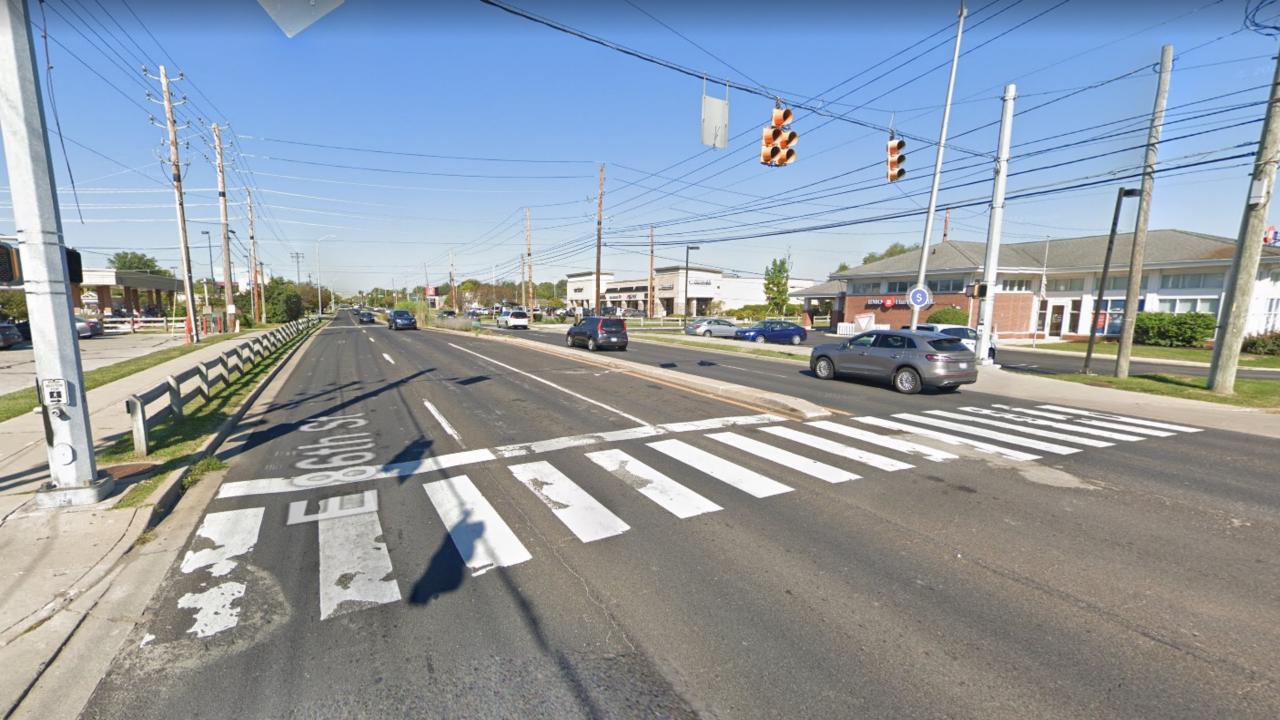
Intersection Conditions (trail)

- 70 feet of total crossing, no refuge
 - Two lanes of through traffic traveling east
 - One lane of left-turning traffic traveling north into Nora Corners
 - Two lanes of through traffic traveling west
- Crosswalk present on west side of intersection
- Permission button on pole coordinated with signal
- Long signal interval, excessive wait time
