# Crash Analysis Studio

Session 2: Hyattsville, MD

March 3, 2023

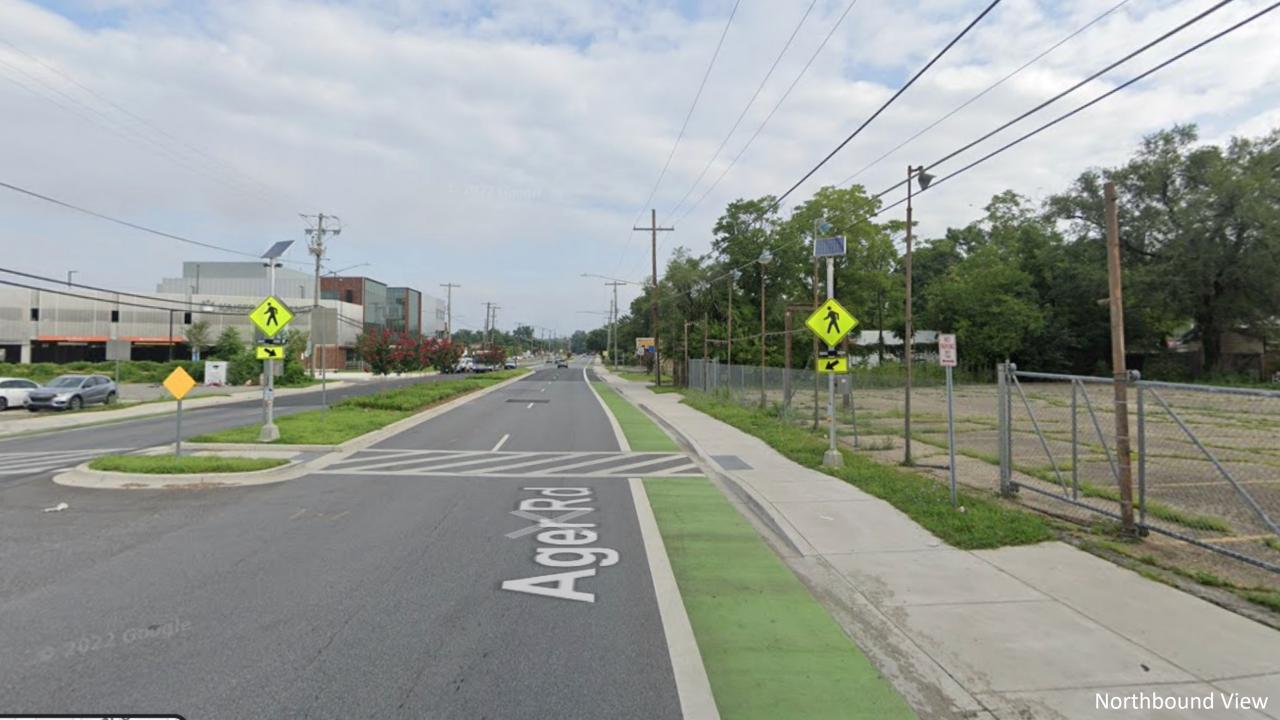
Southbound Approach

Southbound View

LEFT LANE MUST

TURN LEFT AT HAMILTON ST

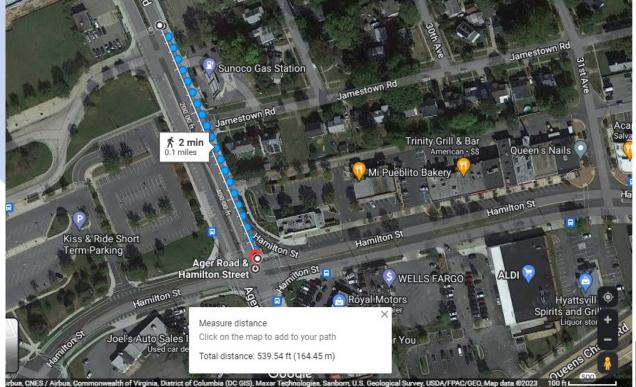
#### <---- GPS Coordinates listed in County crash report

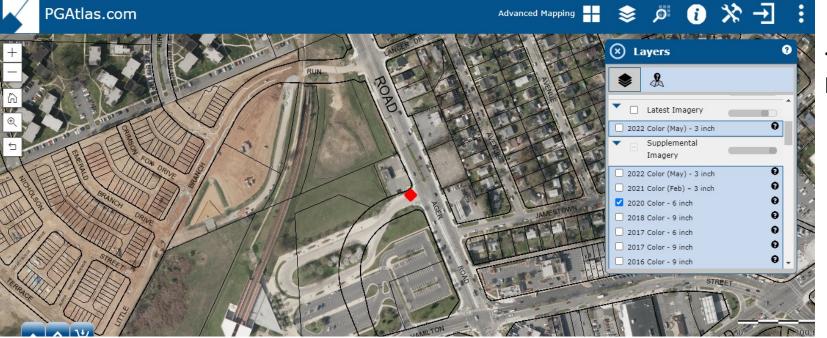
<----- Crash location & surrounding area prior to redesign (pre-crosswalk)

Crash location & surrounding area after redesign (crosswalk installed) ----->
