Crash Analysis Studio

Session 5: Bradenton, Florida

May 26, 2023

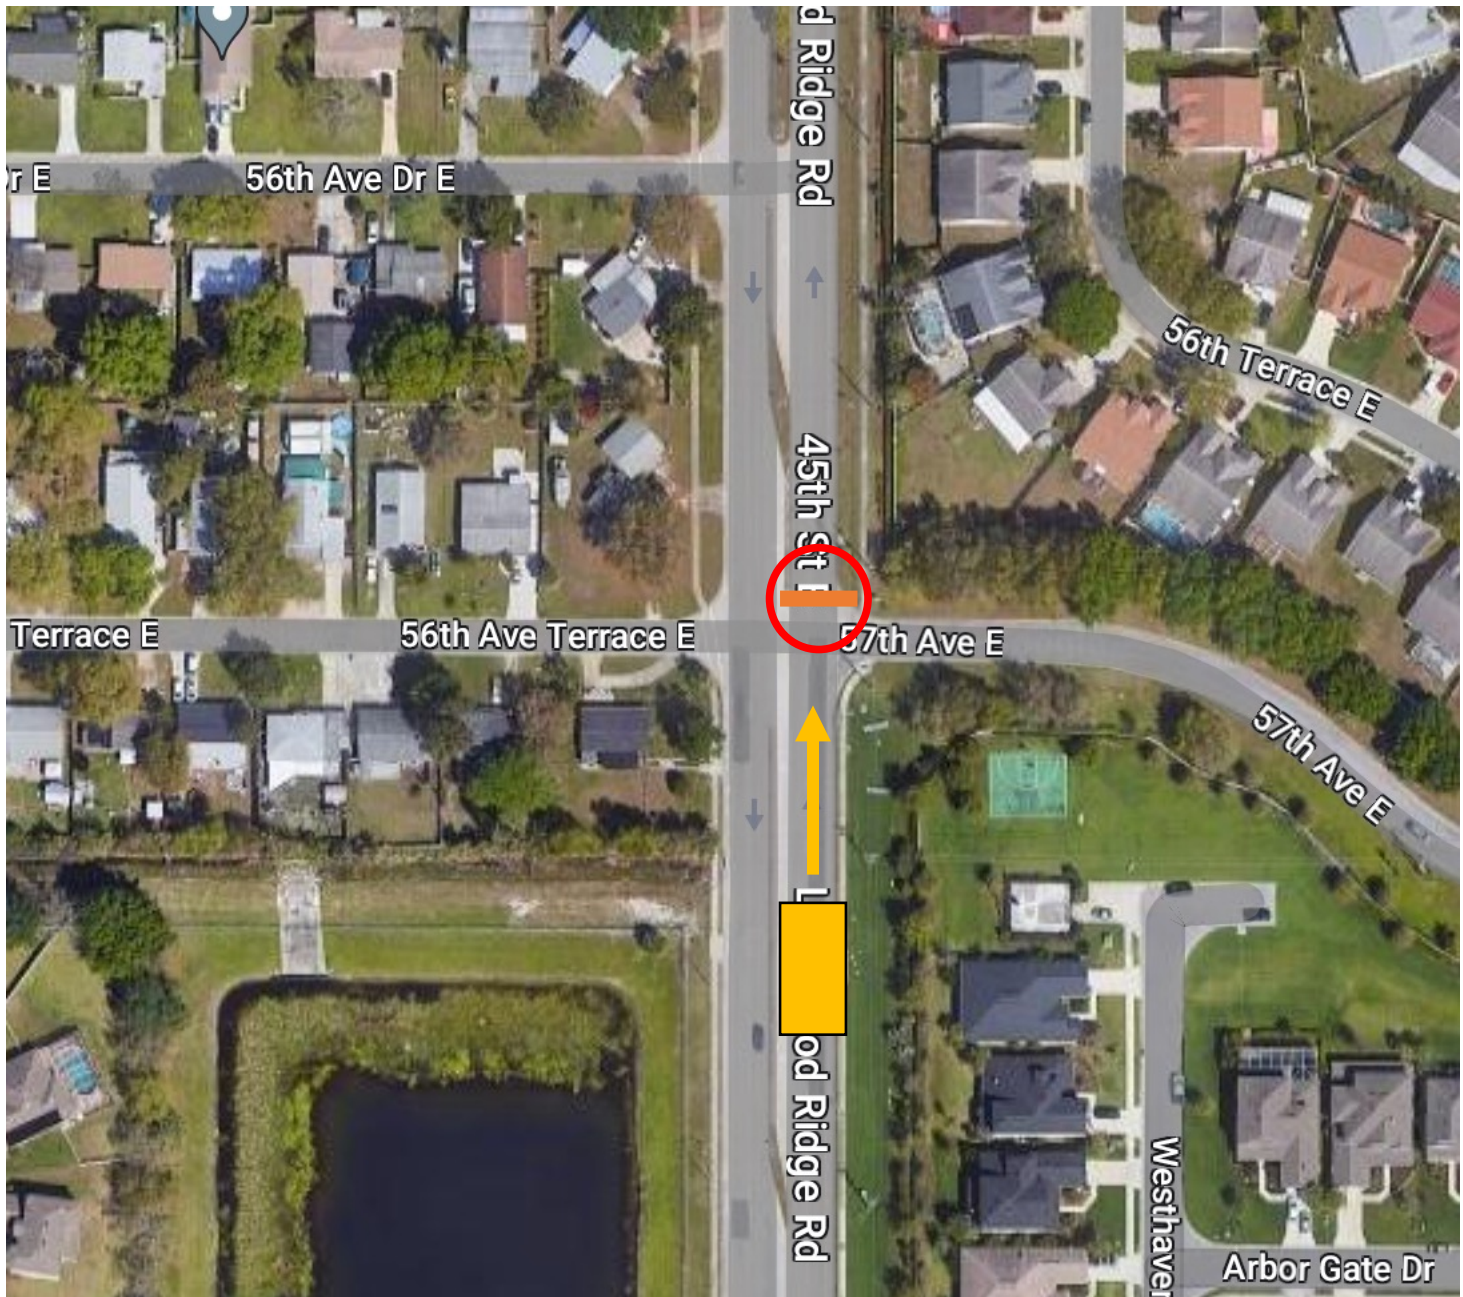
- The posted speed limit documented by both the crash report and our nominator is 40MPH
- Pedestrian was crossing west – without a marked crosswalk – from 57th Avenue East to 56th Avenue Terrace East
- Collision occurred in the left (inner) northbound lane of Lockwood Ridge Road
- Pedestrian pronounced deceased at the scene at 9:19am
- Pedestrian's body came to final rest in the right (outer) northbound lane of Lockwood Ridge Road
- Motorist (80 y/o) suffered minor injuries

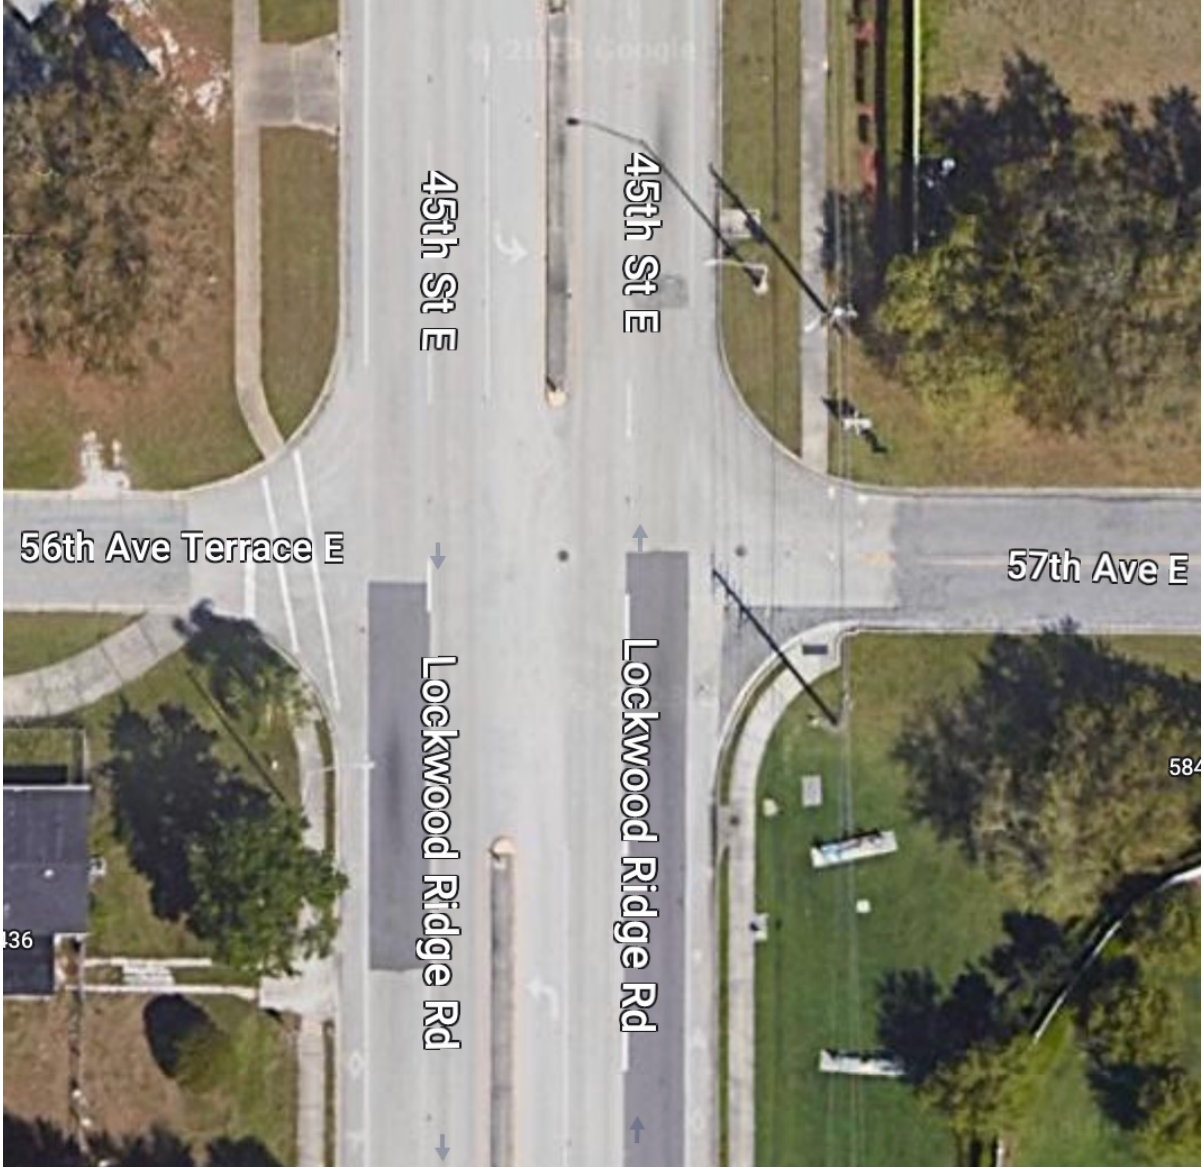
Overall Site Conditions

- **Northbound & Southbound Lockwood Ridge Road**

- Each direction has 2 thru traffic lanes with one left turn lane at 57th Avenue intersection
- No marked crosswalks; 40mph speed limit
- Some areas have no sidewalks along the streets
- A stop sign is present on the north side of 57th Avenue East and the south side of 56th Avenue Terrace East (2-way traffic on both avenues)
- 3 weeks after this crash, another serious collision happened on Lockwood Ridge Road approximately 2 blocks north near 55th Avenue

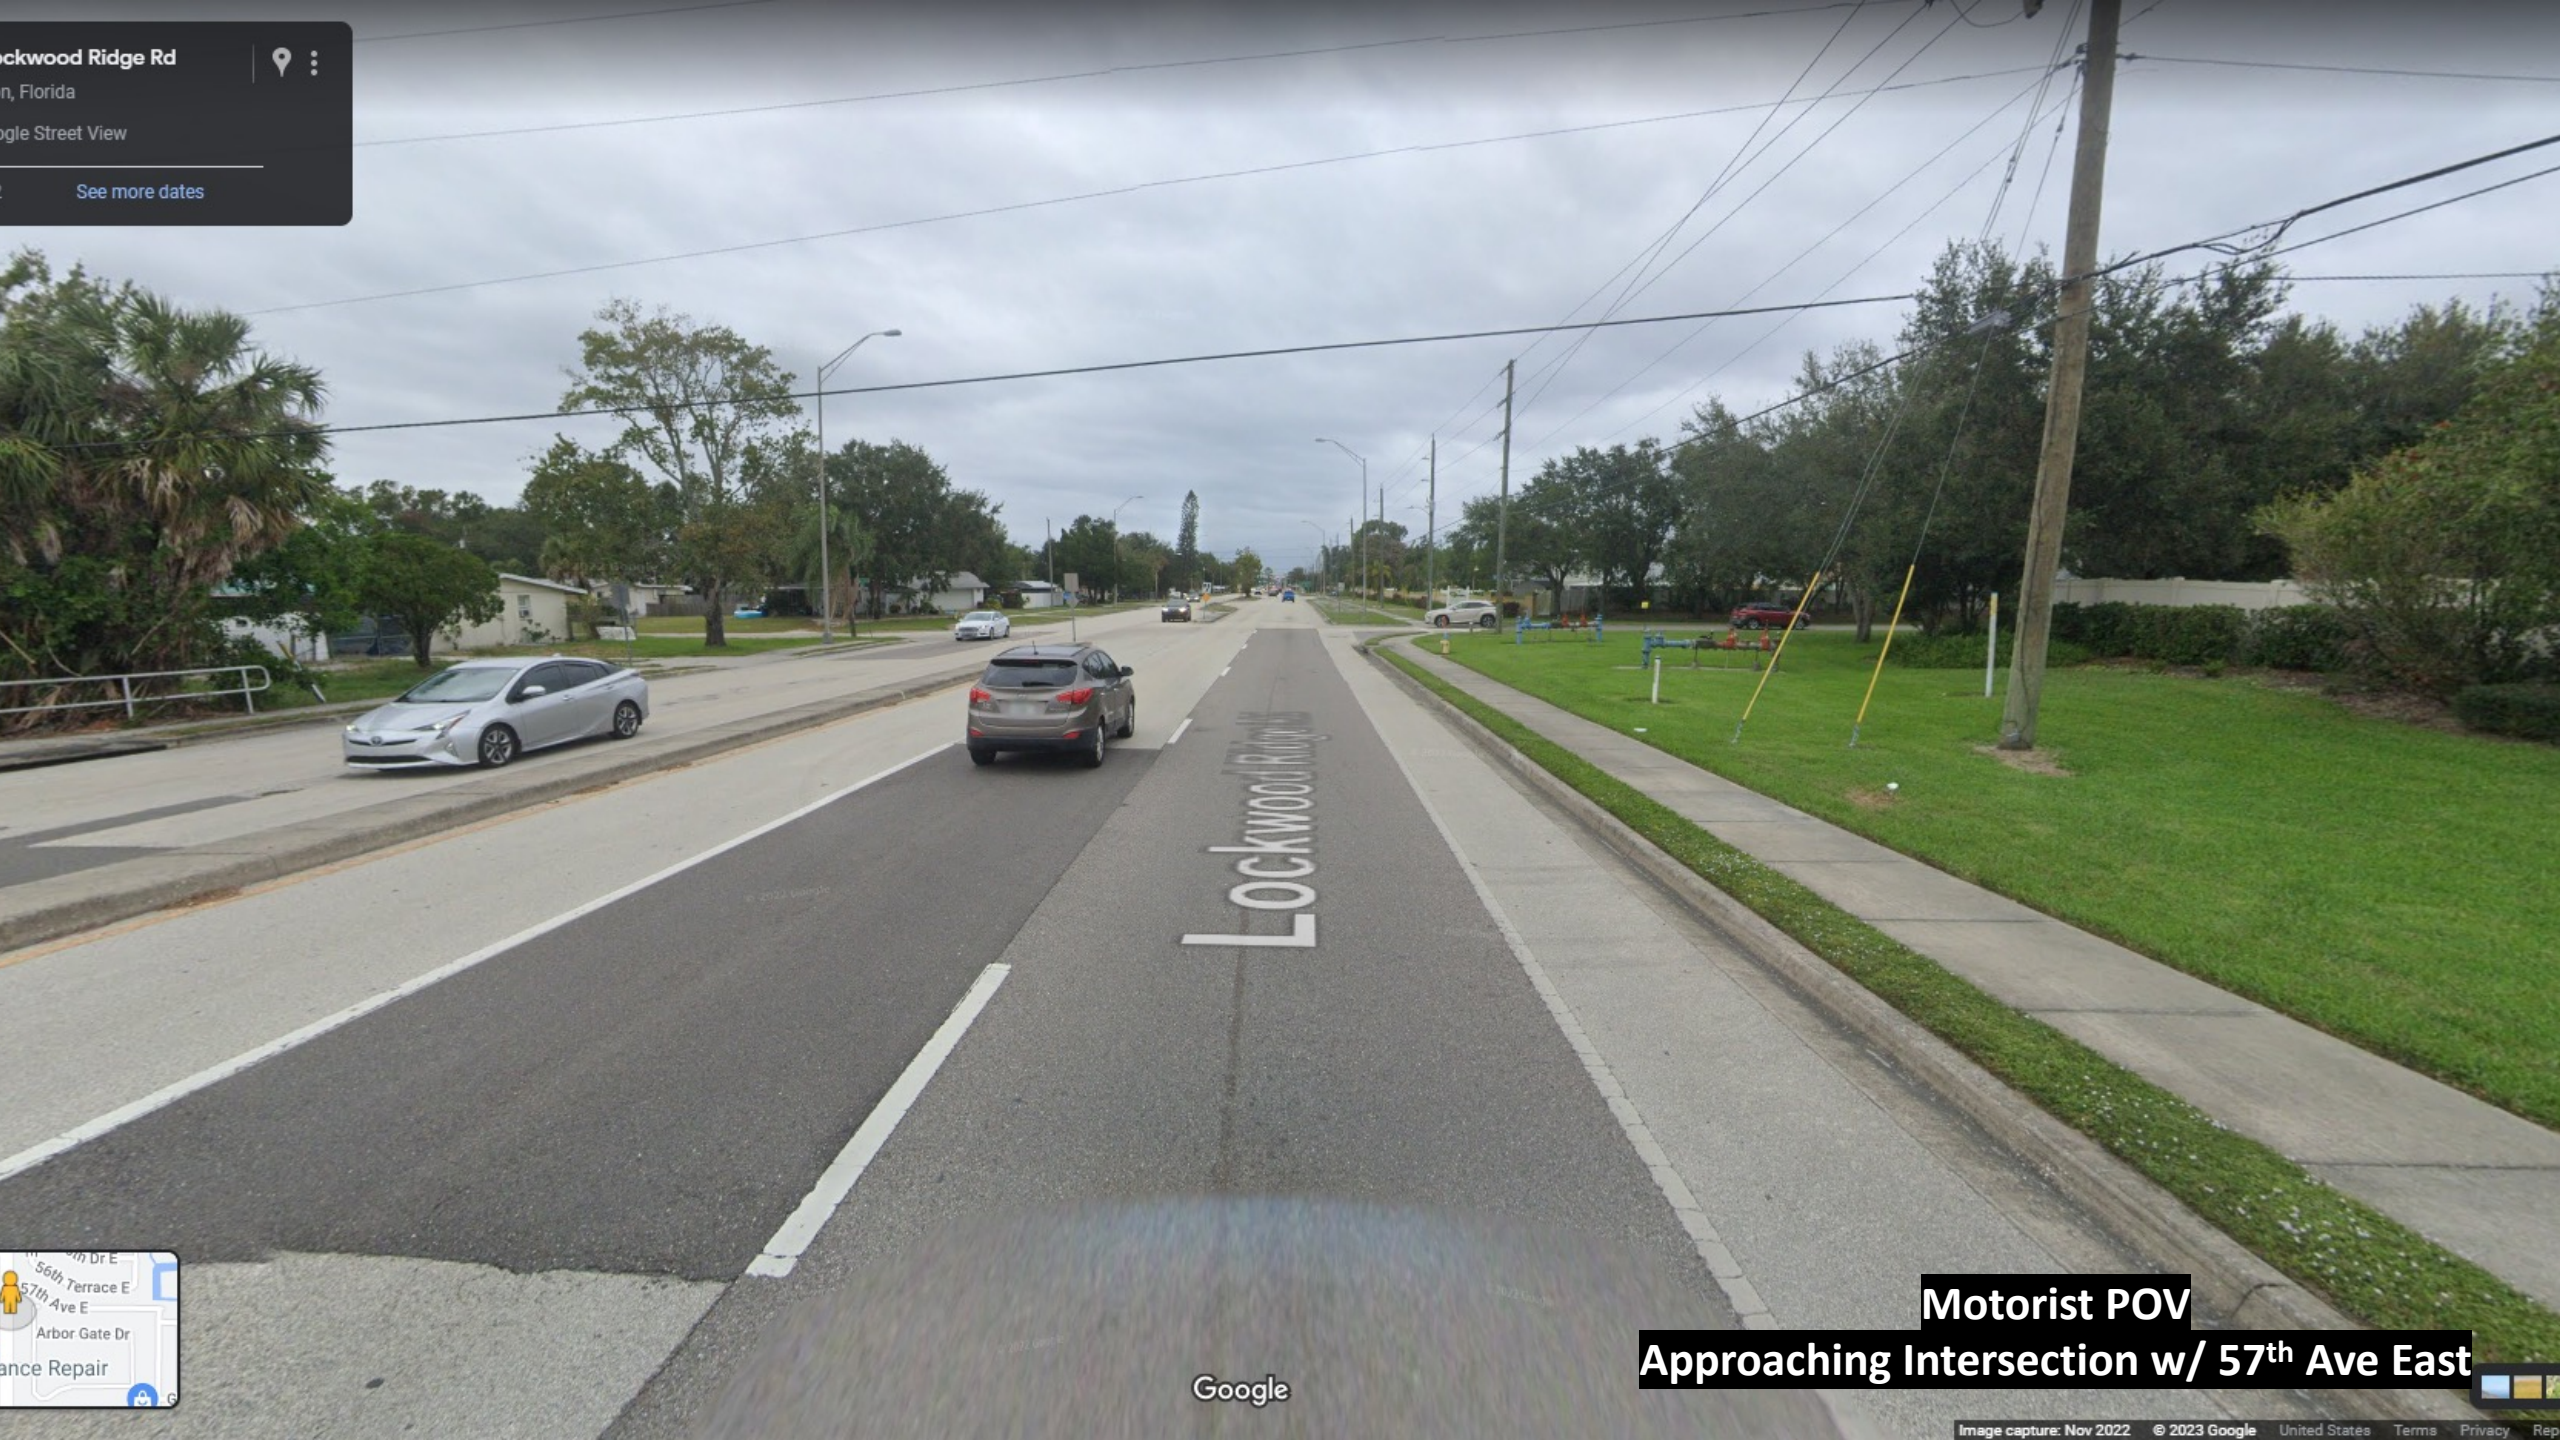
**Northbound Left Lane
Lockwood Ridge Road
750 feet south of Intersection**

Motorist POV
Approaching Intersection w/ 57th Ave East

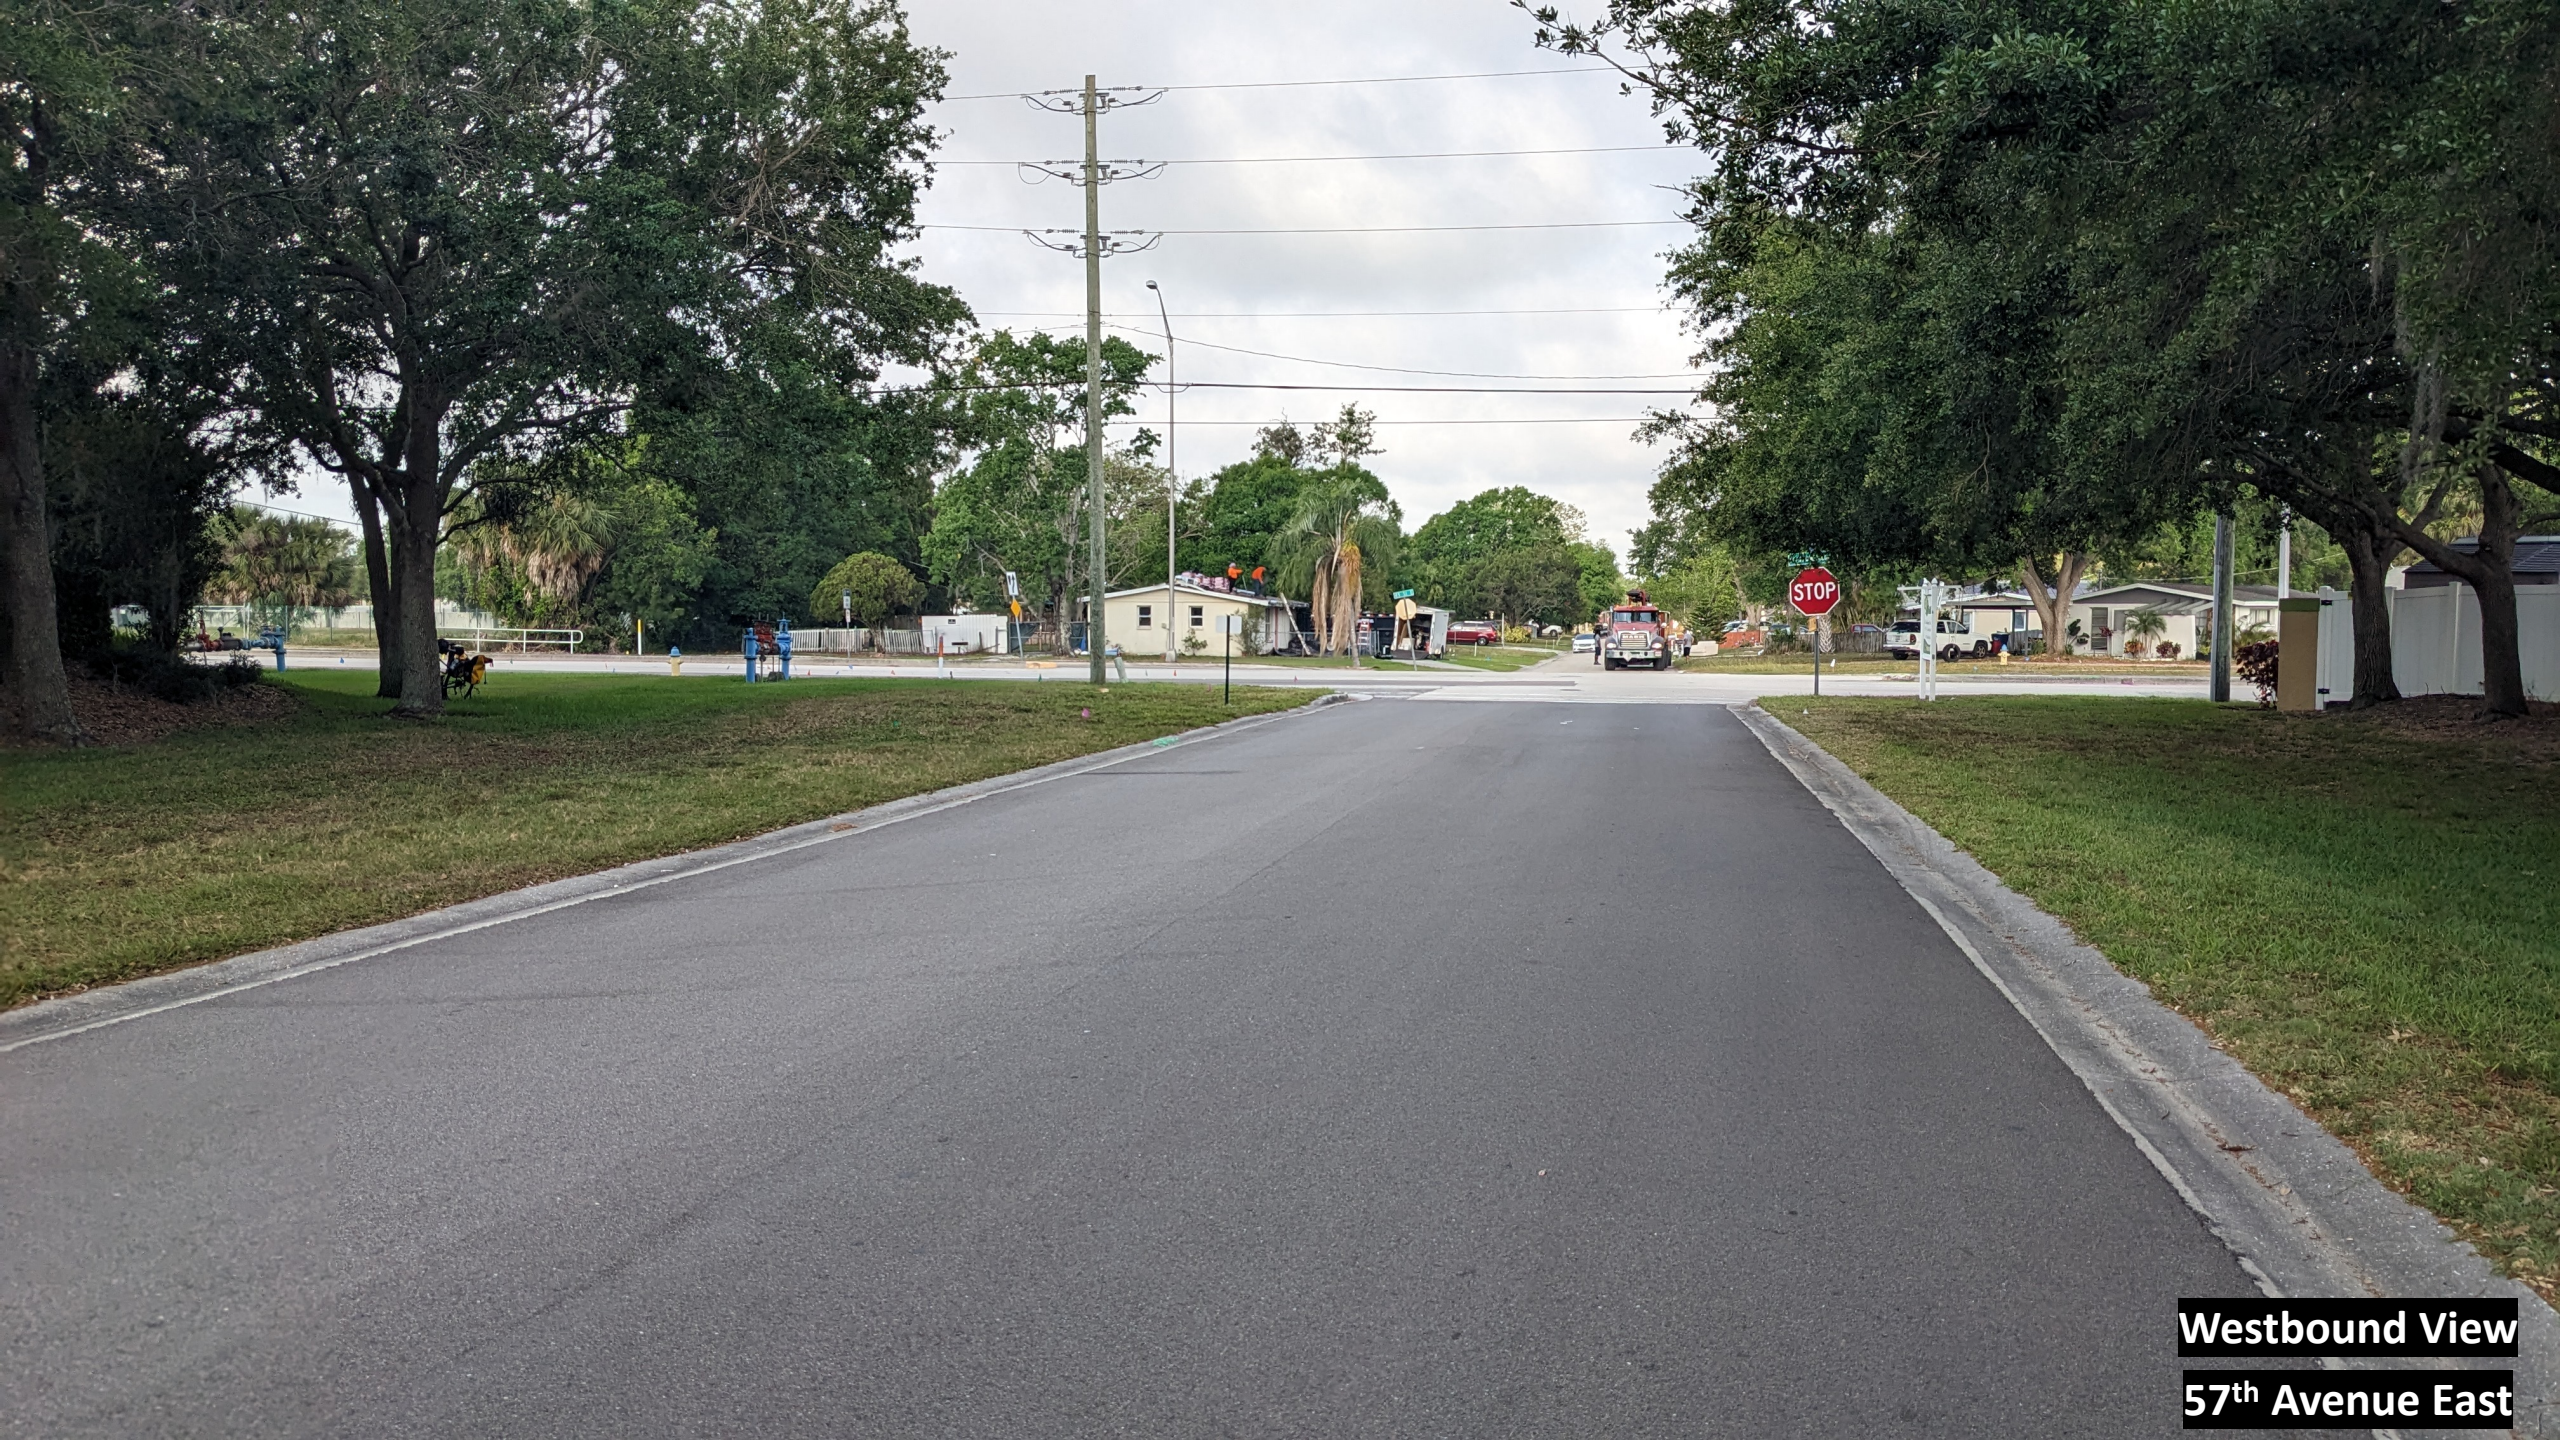
Westbound View

57th Avenue East

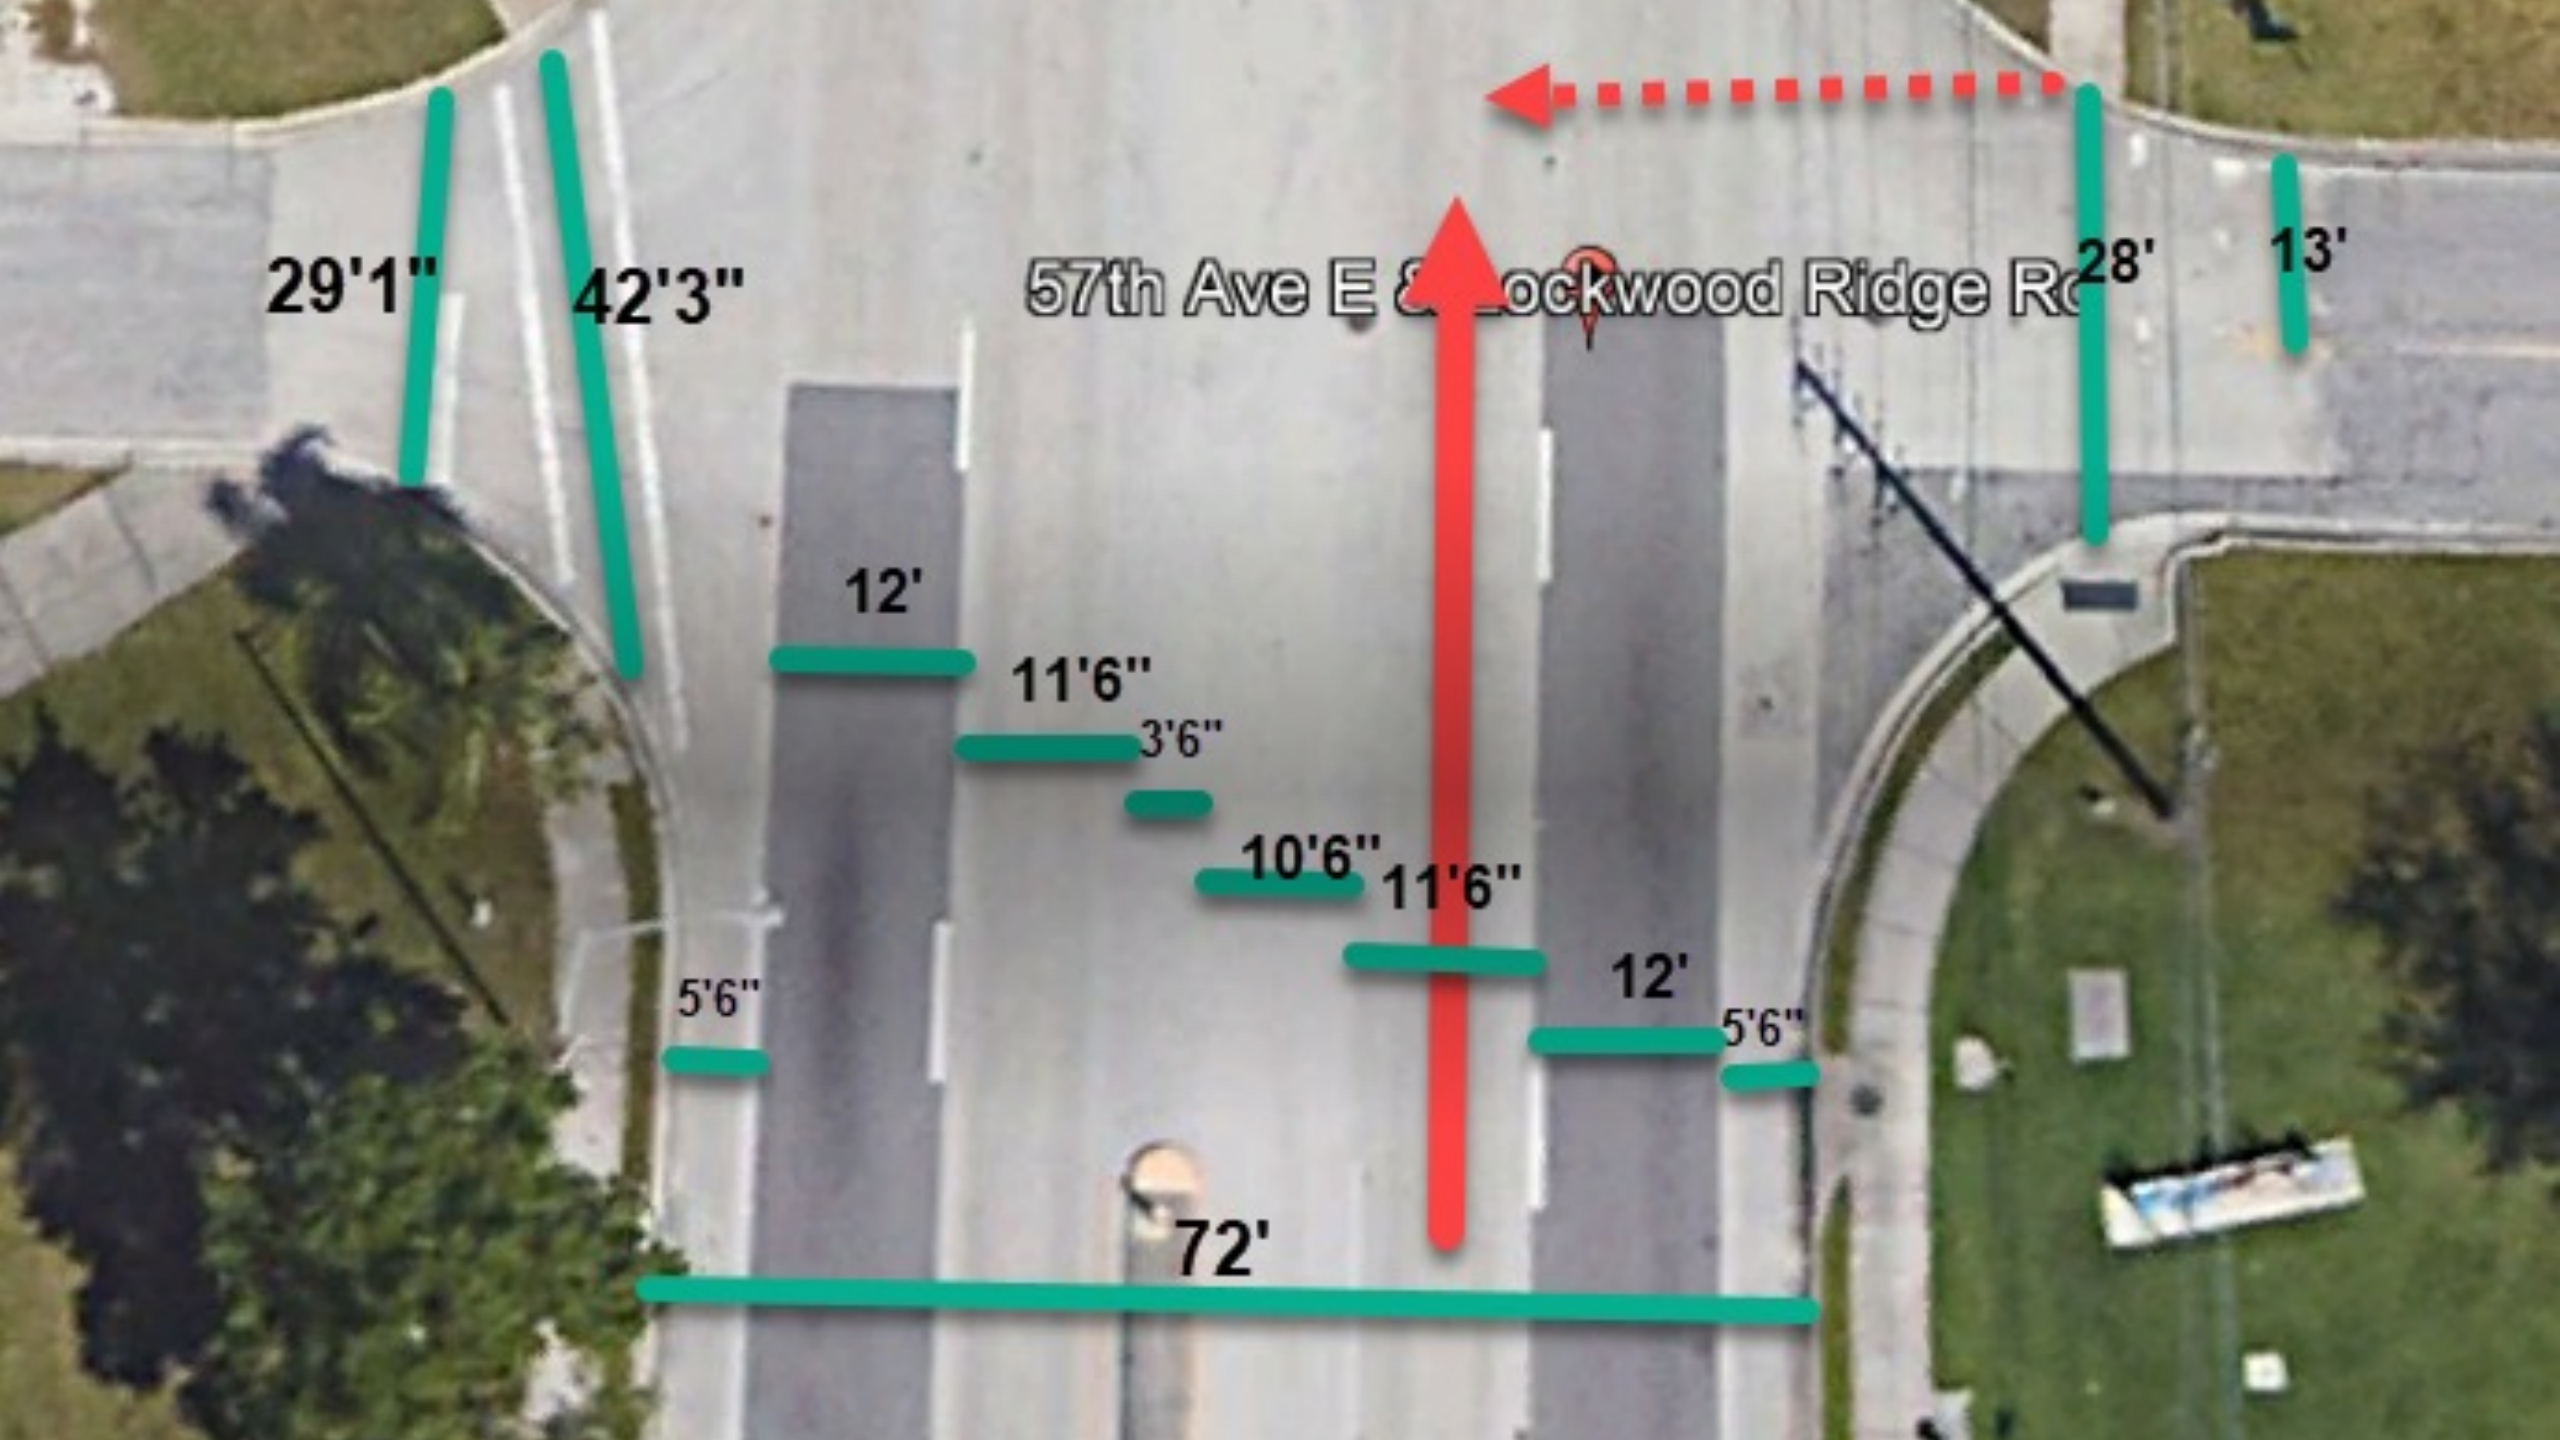
57th Ave E & Lockwood Ridge Rd

29'1"

42'3"

28'

13'

12'

11'6"

3'6"

10'6"

5'6"

72'

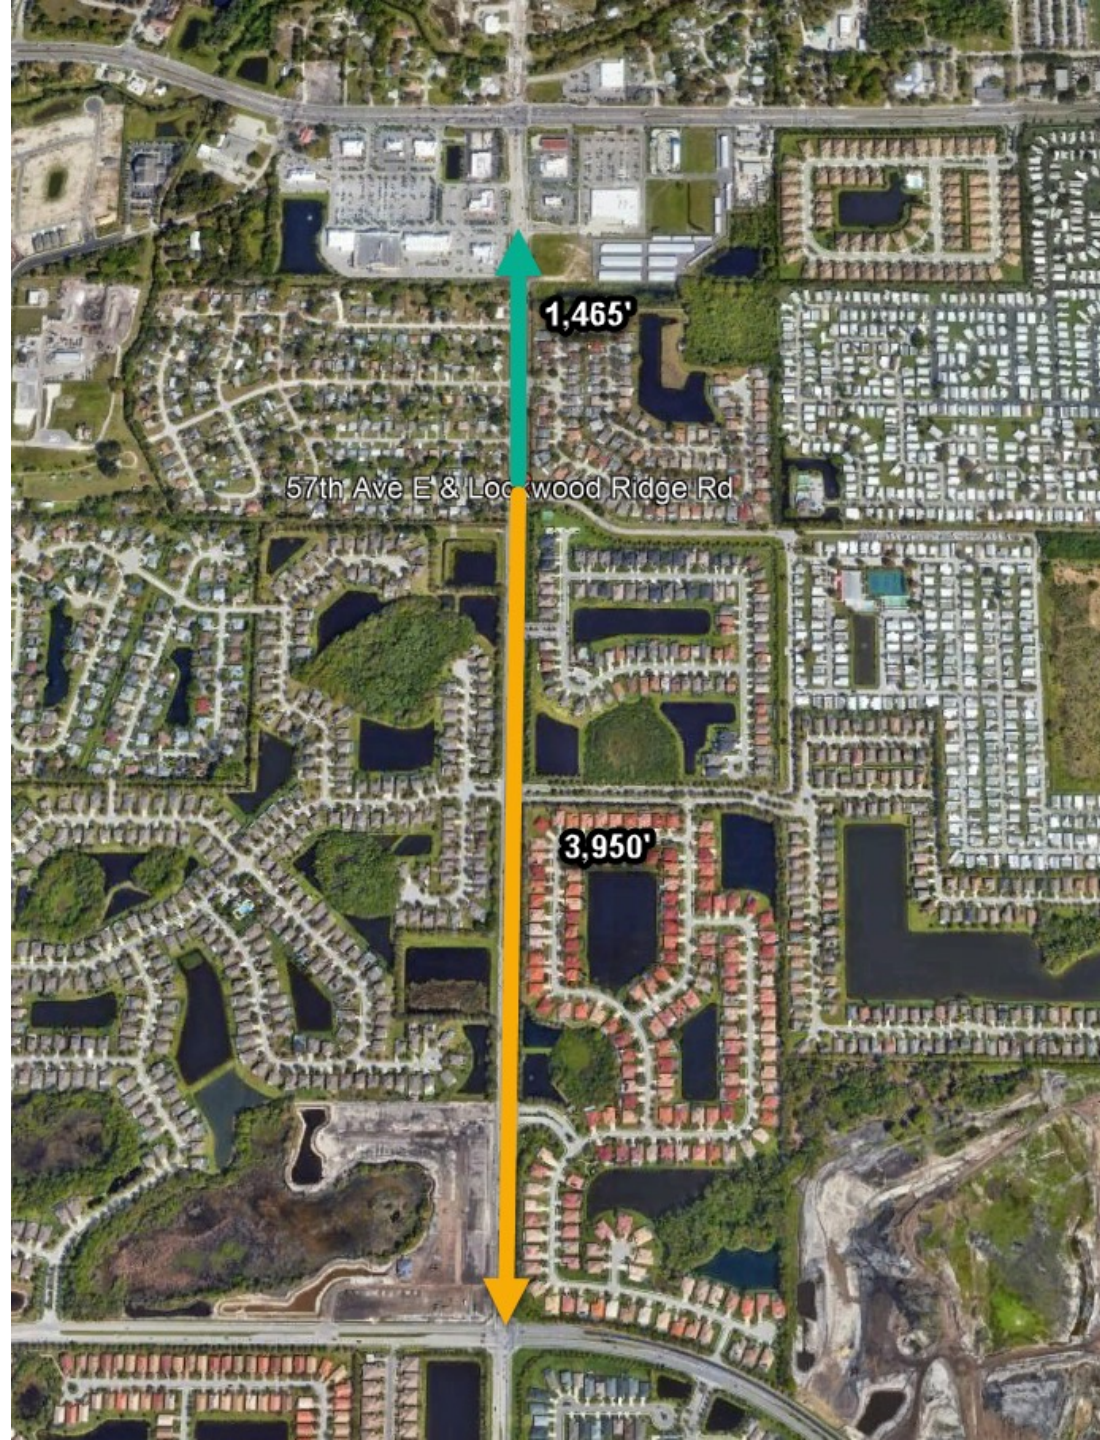
57th Ave E & Lockwood Ridge Rd

Nearest East-West Crosswalks

1,465 feet to the North

3,950 feet to the South

Nearest Signalized Intersections

Appx. 4224 feet to the South

- Suburban development pattern; primarily residential with some retail use
 - Proximity to Publix, Walmart, Aldi, Wawa
 - Crash location adjacent to Gold Tree, a resident-owned community
- Street Blocks surrounded by major roadways on three sides
 - I-75 to the East
 - State Road 70 (53rd Ave E) to the North
 - State Road 301 to the West
- Significant distances between marked (E ->W) crosswalks across Lockwood Ridge Road

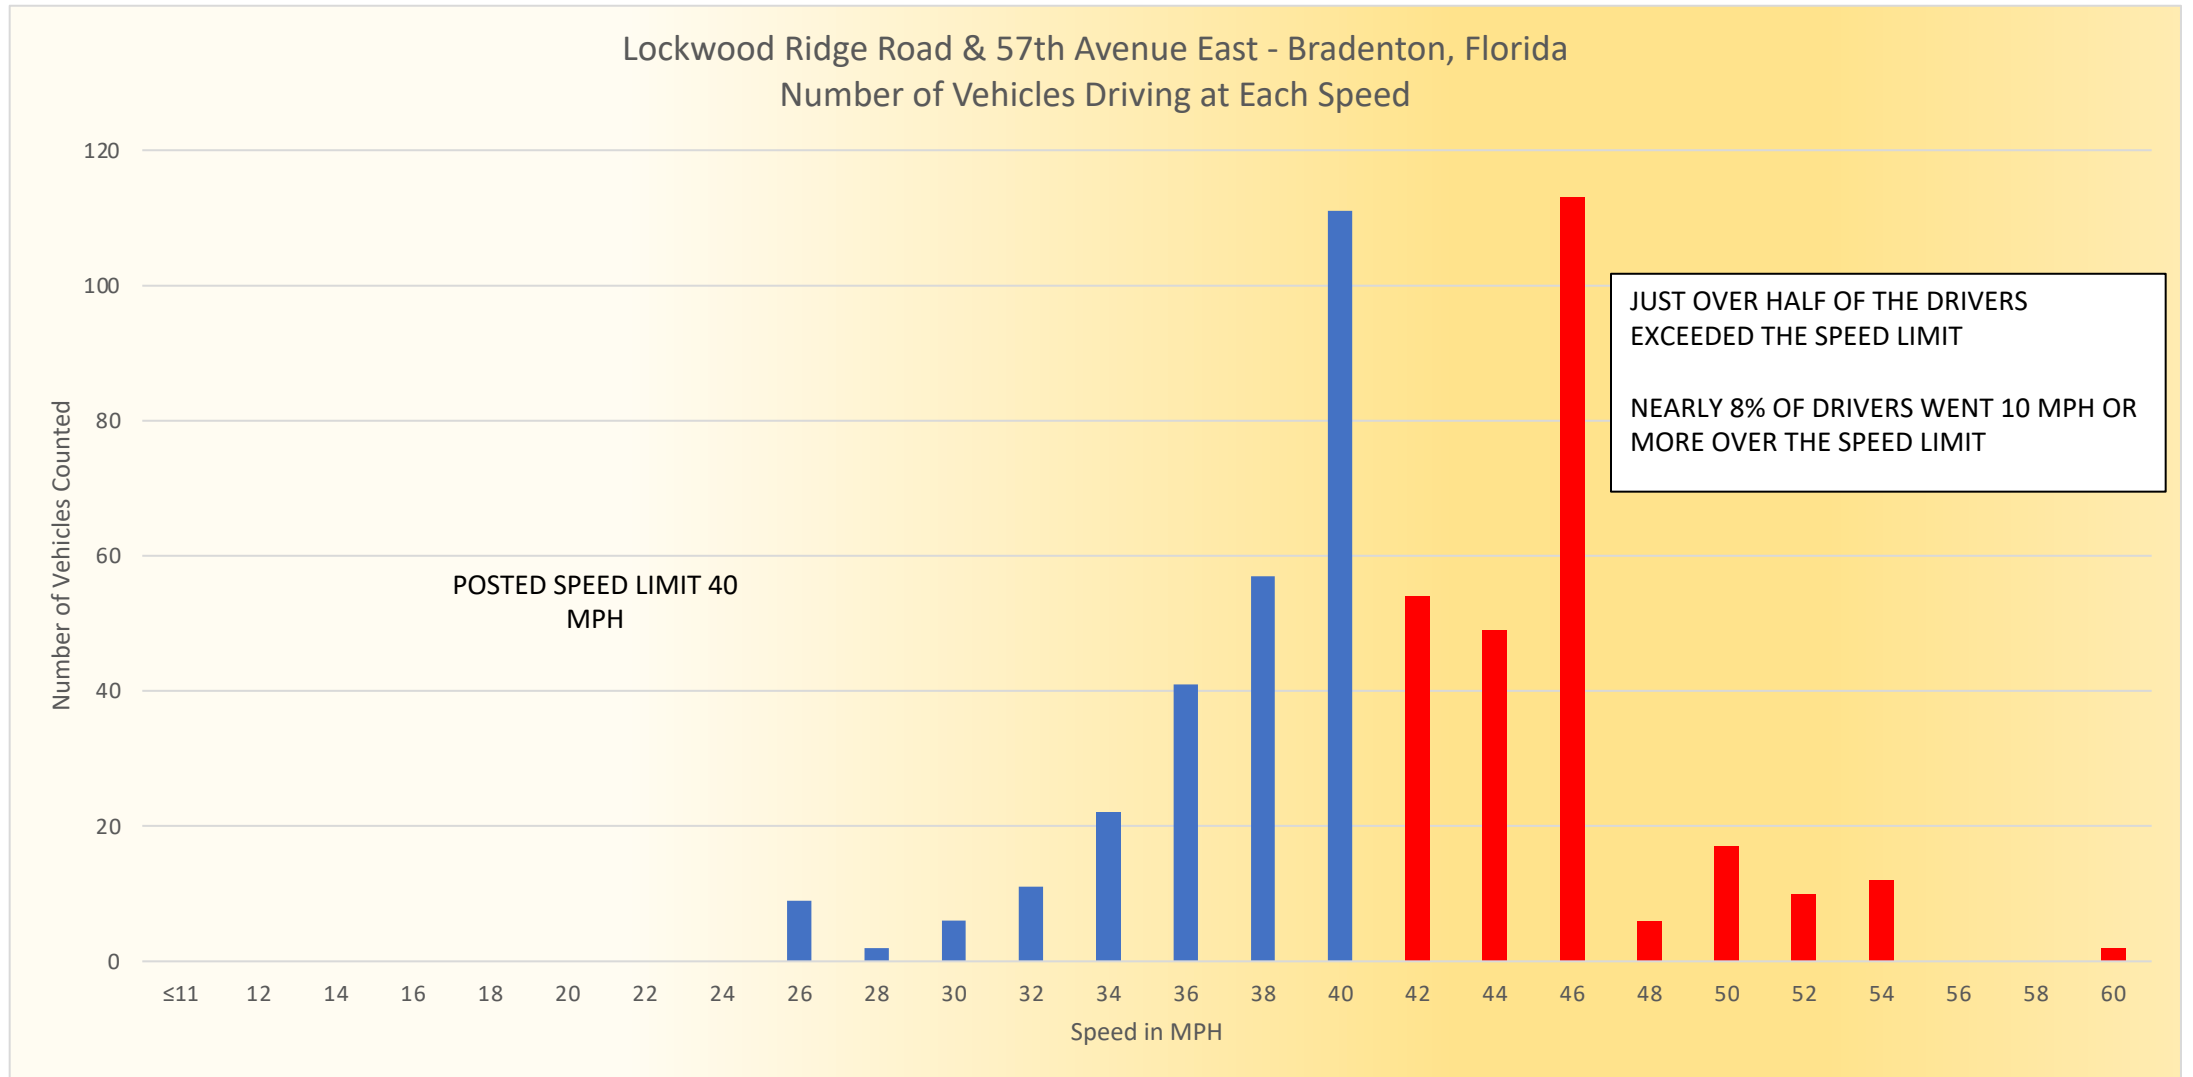
Speed Data

*85th percentile speed = 46 MPH

- Preliminary Speed Study indicates significant number of automobiles traveling at fatal speeds
