Crash Analysis Studio

Session 7: Brandon, Manitoba

July 21, 2023

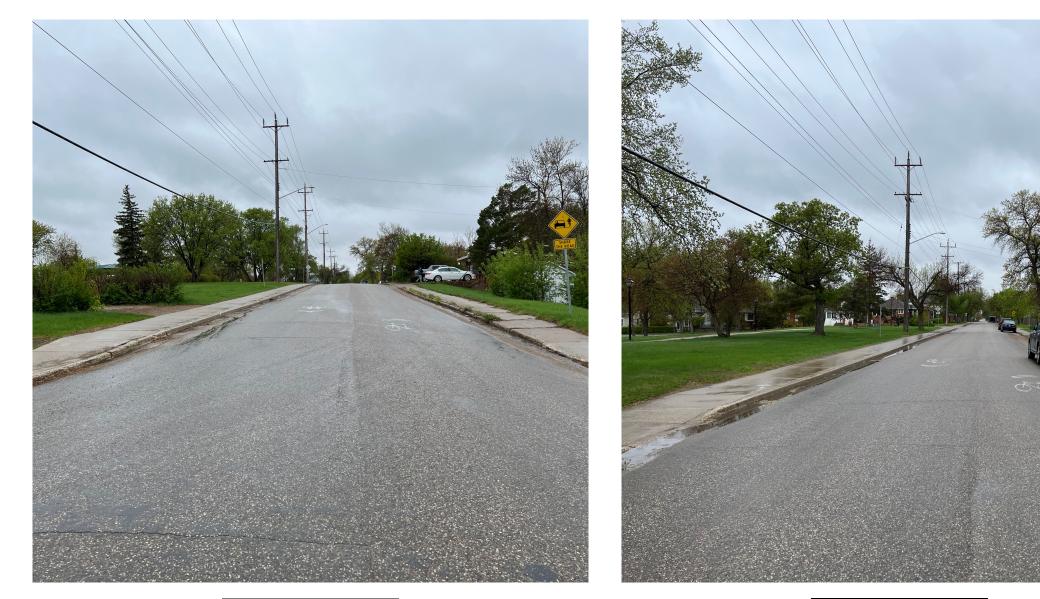
Westbound Lorne Franklin Street Intersection

Westbound Lorne Rideau Street Intersection

Westbound Motorist on Lorne Approaching Intersection

Westbound Lorne Avenue Entering Park Street Intersection

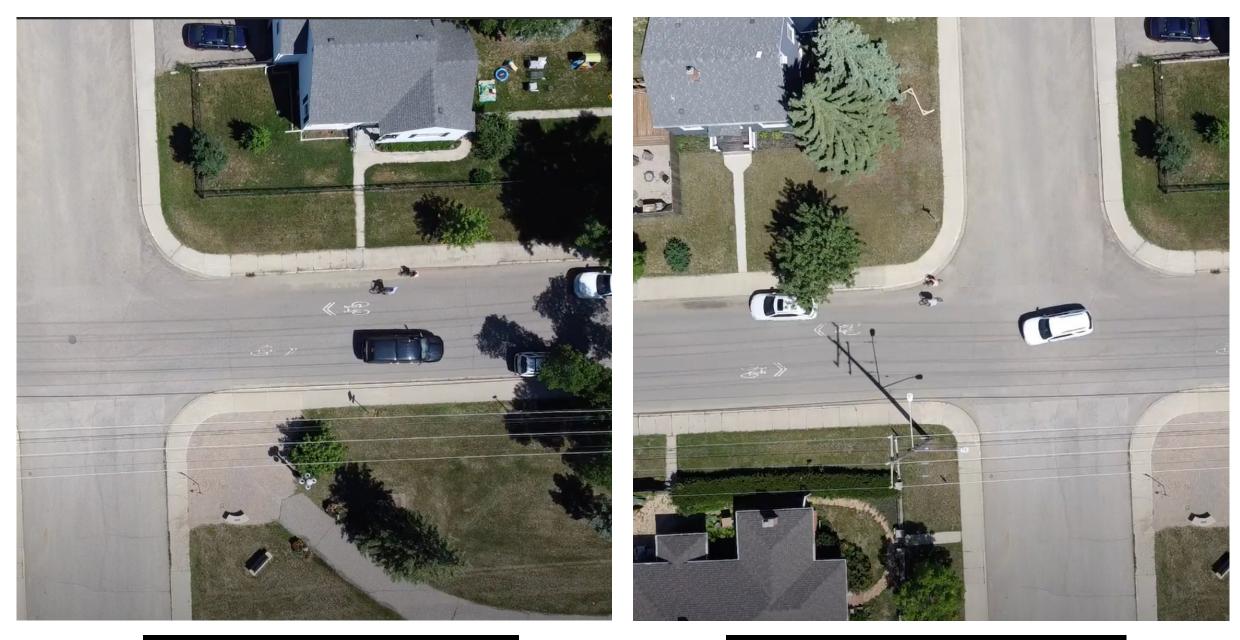
Cyclists & Motorists (Pre-Intersection)

Cyclists & Motorists (Inside Intersection)

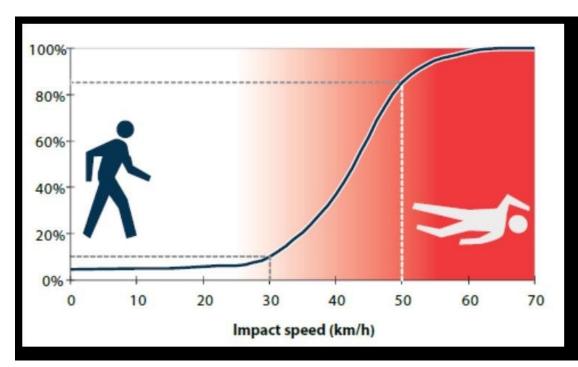
Preliminary Speed Study indicates significant number of automobiles traveling at fatal speeds

The effects of higher speed limits on traffic fatalities in the United States, 1993–2017.

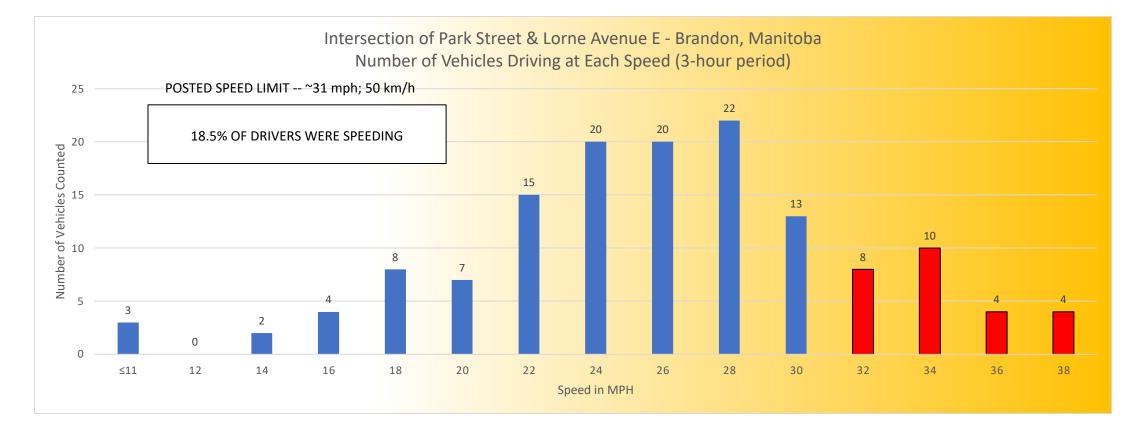
Speed Data

Data gathered during construction – 140 cars tracked 12 pedestrians & 14 cyclists tallied 85th percentile speed: 32 mph

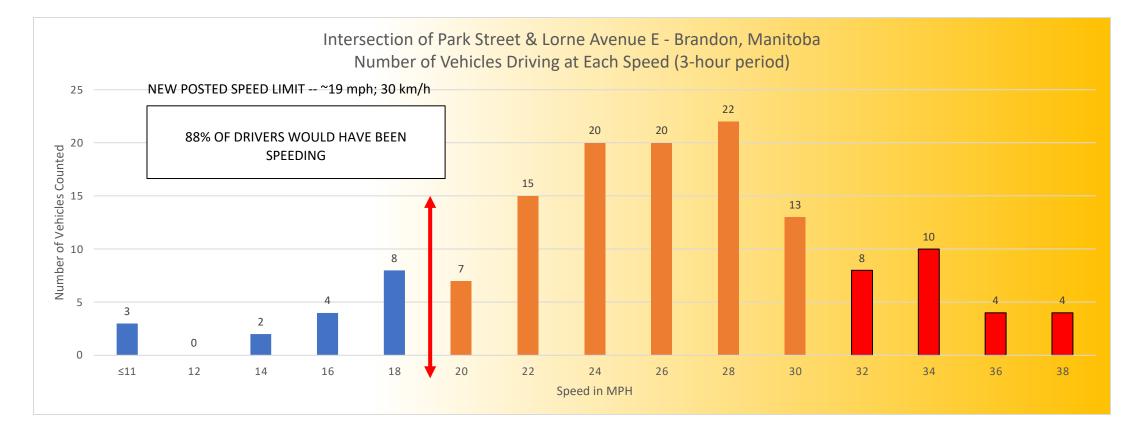
Speed Data

Data gathered during construction – 140 cars tracked 12 pedestrians & 14 cyclists tallied 85th percentile speed: 32 mph
