Crash Analysis Studio

Session 8: Charlotte, North Carolina

August 25, 2023

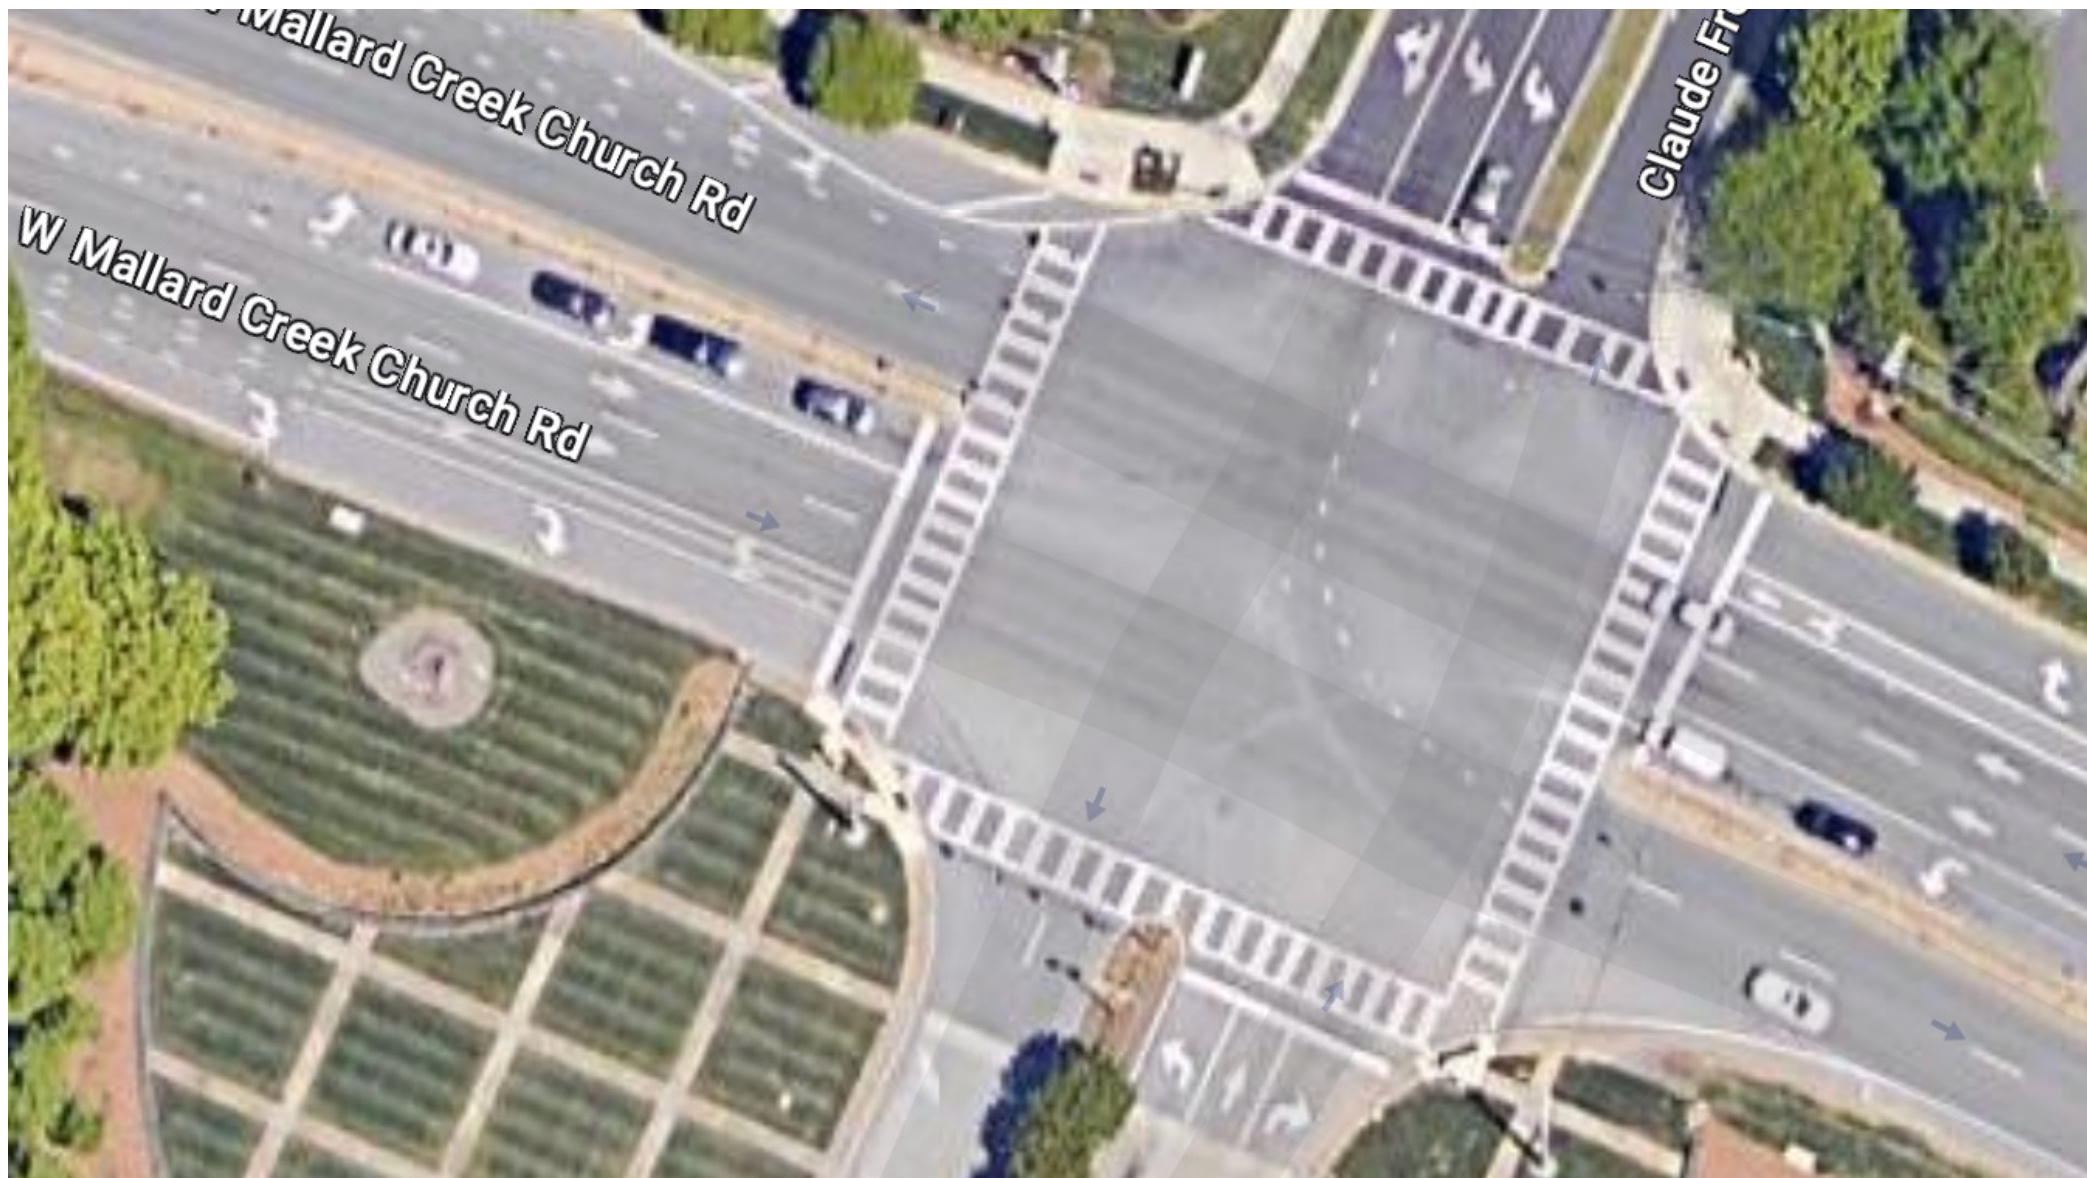
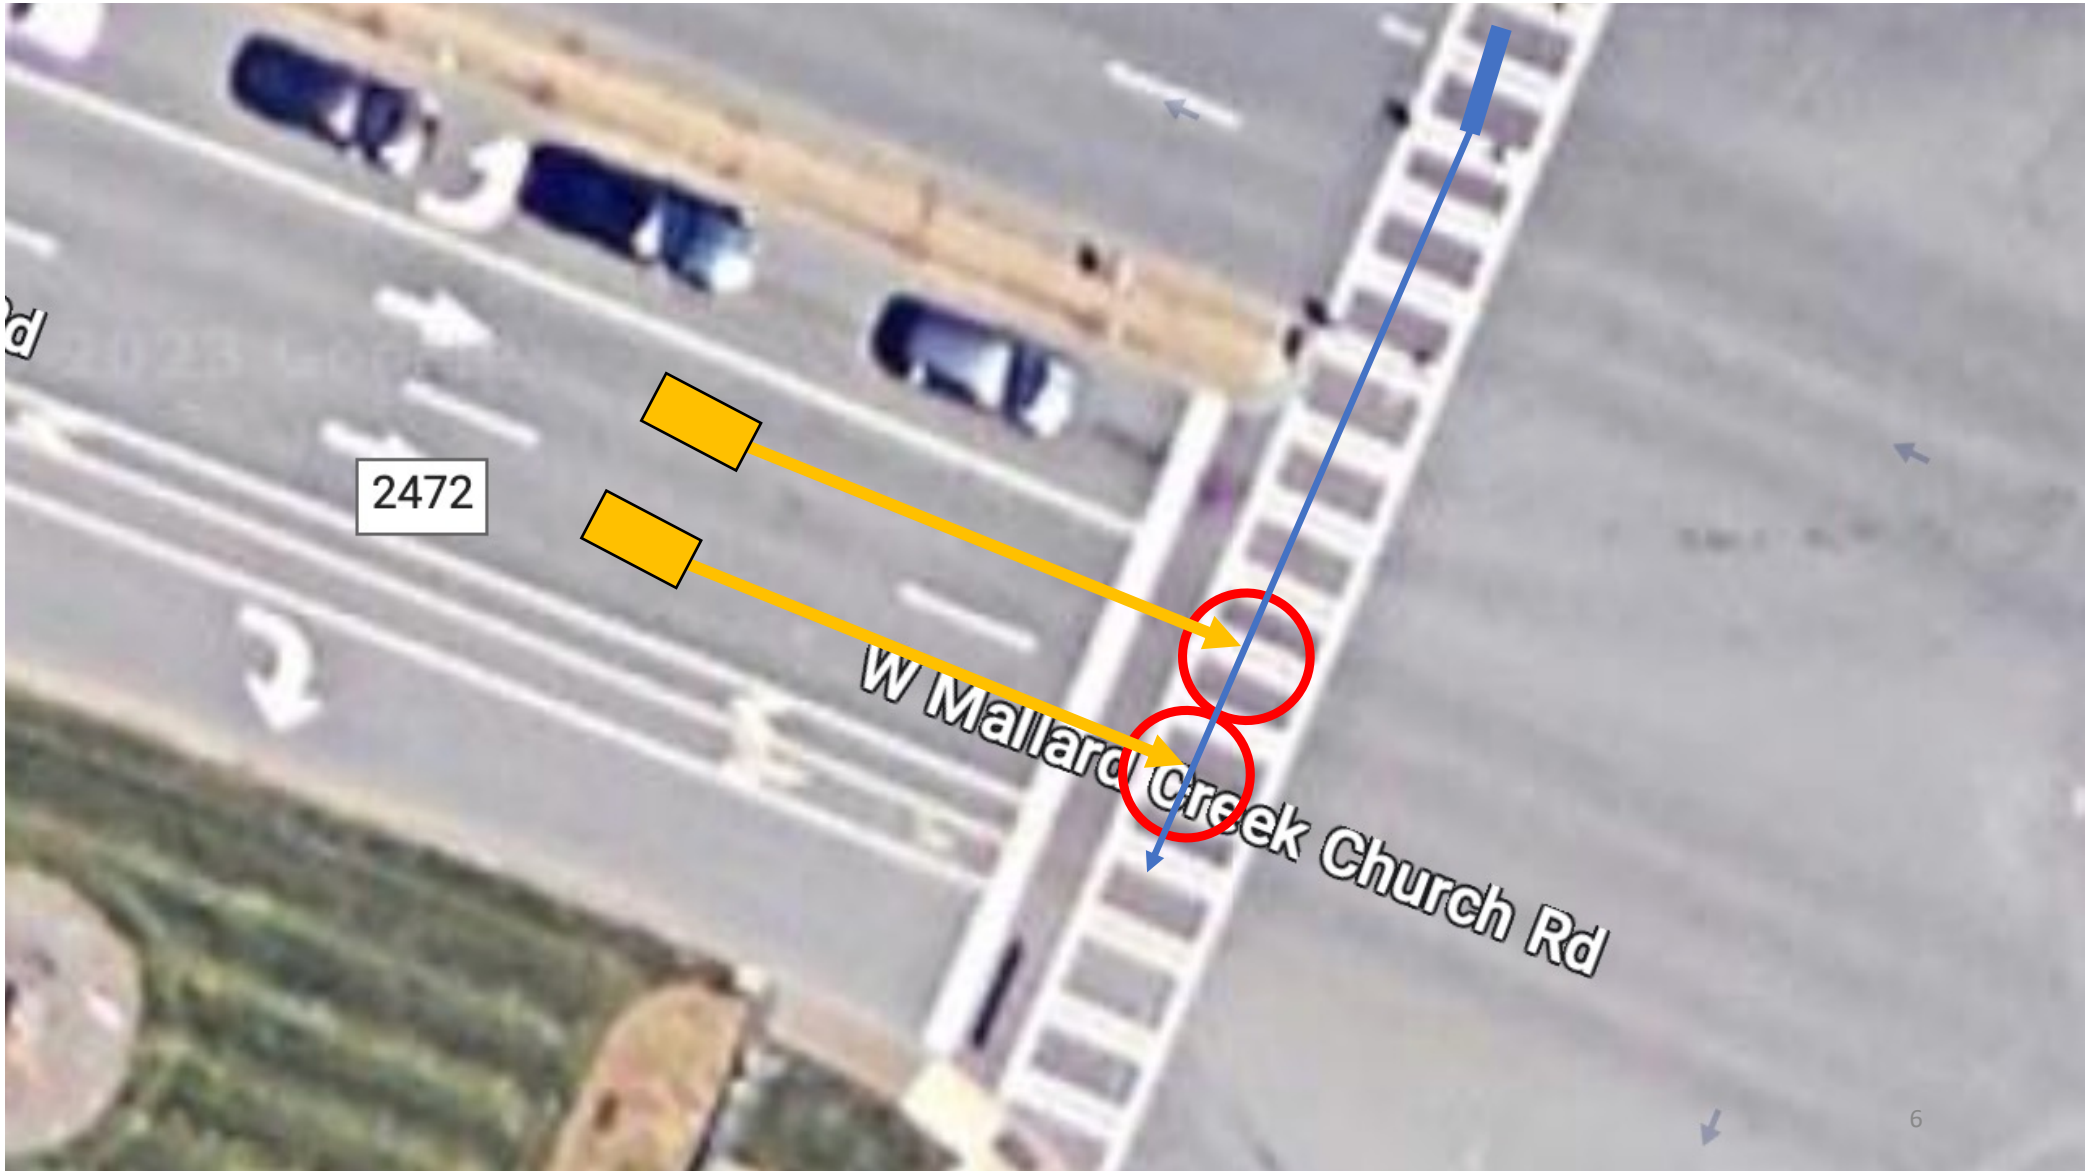
- Jaden Blank documented the West Mallard Creek Church Road speed limit to be 45 mph
- At the time of the collision, the motorist was traveling east, and Michael-Luther was running south
- Weather report indicates that day was sunny and dry; sunrise happened at 7:11am

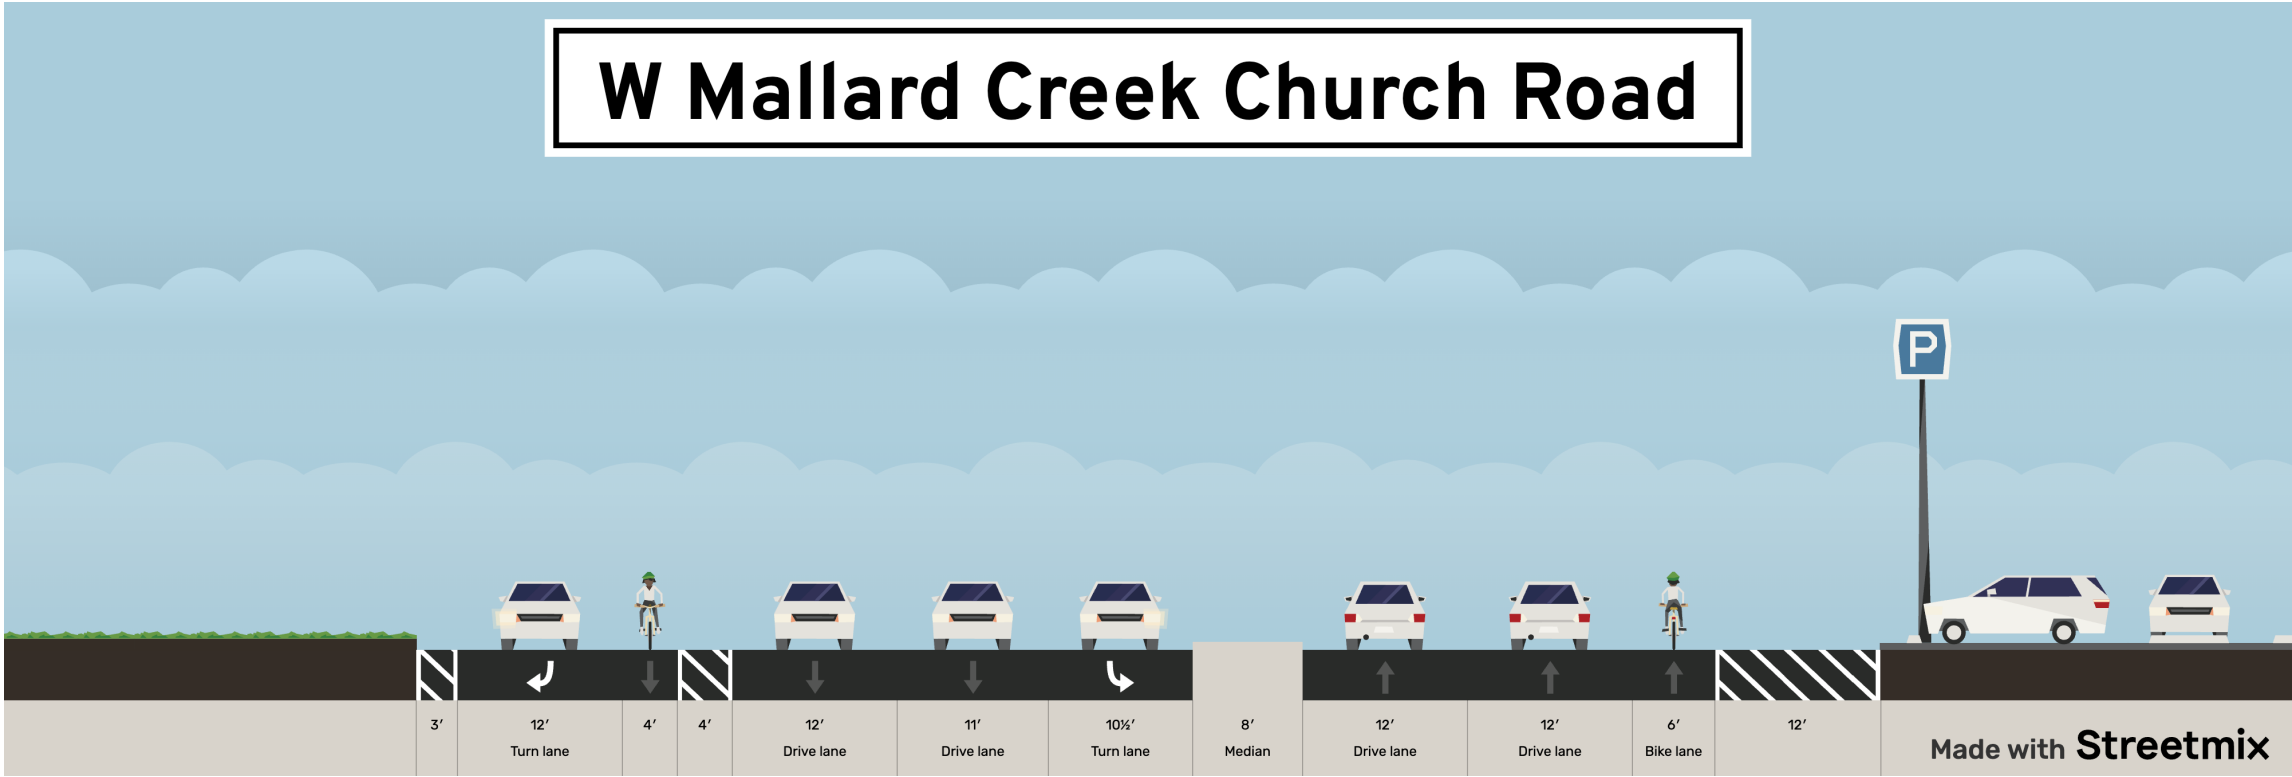
W Mallard Creek Church Road

Total Width of 106.5 Feet

- This segment of West Mallard Creek Church Road has a 45 MPH speed limit and facilitates sizable traffic flow
- **Mallard Creek Church Road, Eastbound** consists of 4 traffic lanes; 2 for through traffic and dedicated turn lanes going both north and south on Claude Freeman. There is a bike lane with a four-foot separation from through traffic.
- **Mallard Creek Church Road, Westbound** consists of 2 through traffic lanes and a bicycle lane that is not buffered from through traffic, but is separated from the curb
- There are marked crosswalks at the crash location/intersection
 - Pedestrian pushbuttons are present and clear
- Chris Miller recorded the west leg pedestrian crossing time as 31.75 seconds & the east side as 36 seconds

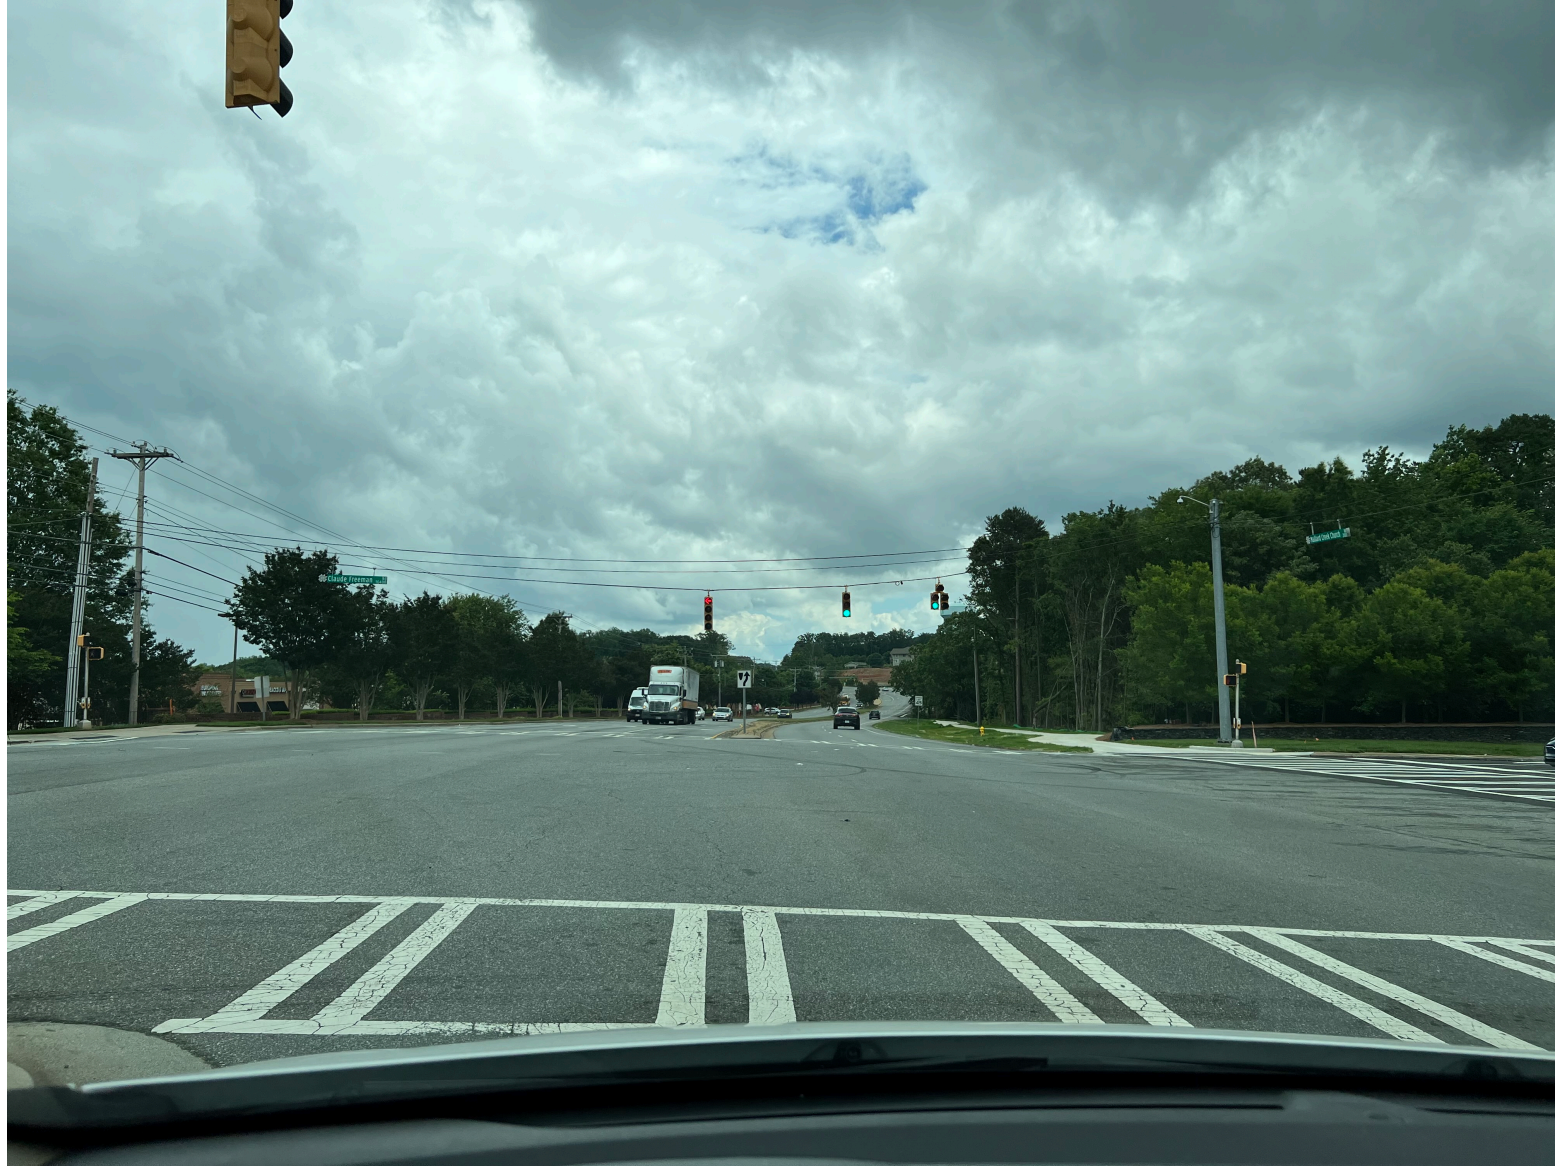
Driver View at Collision Site

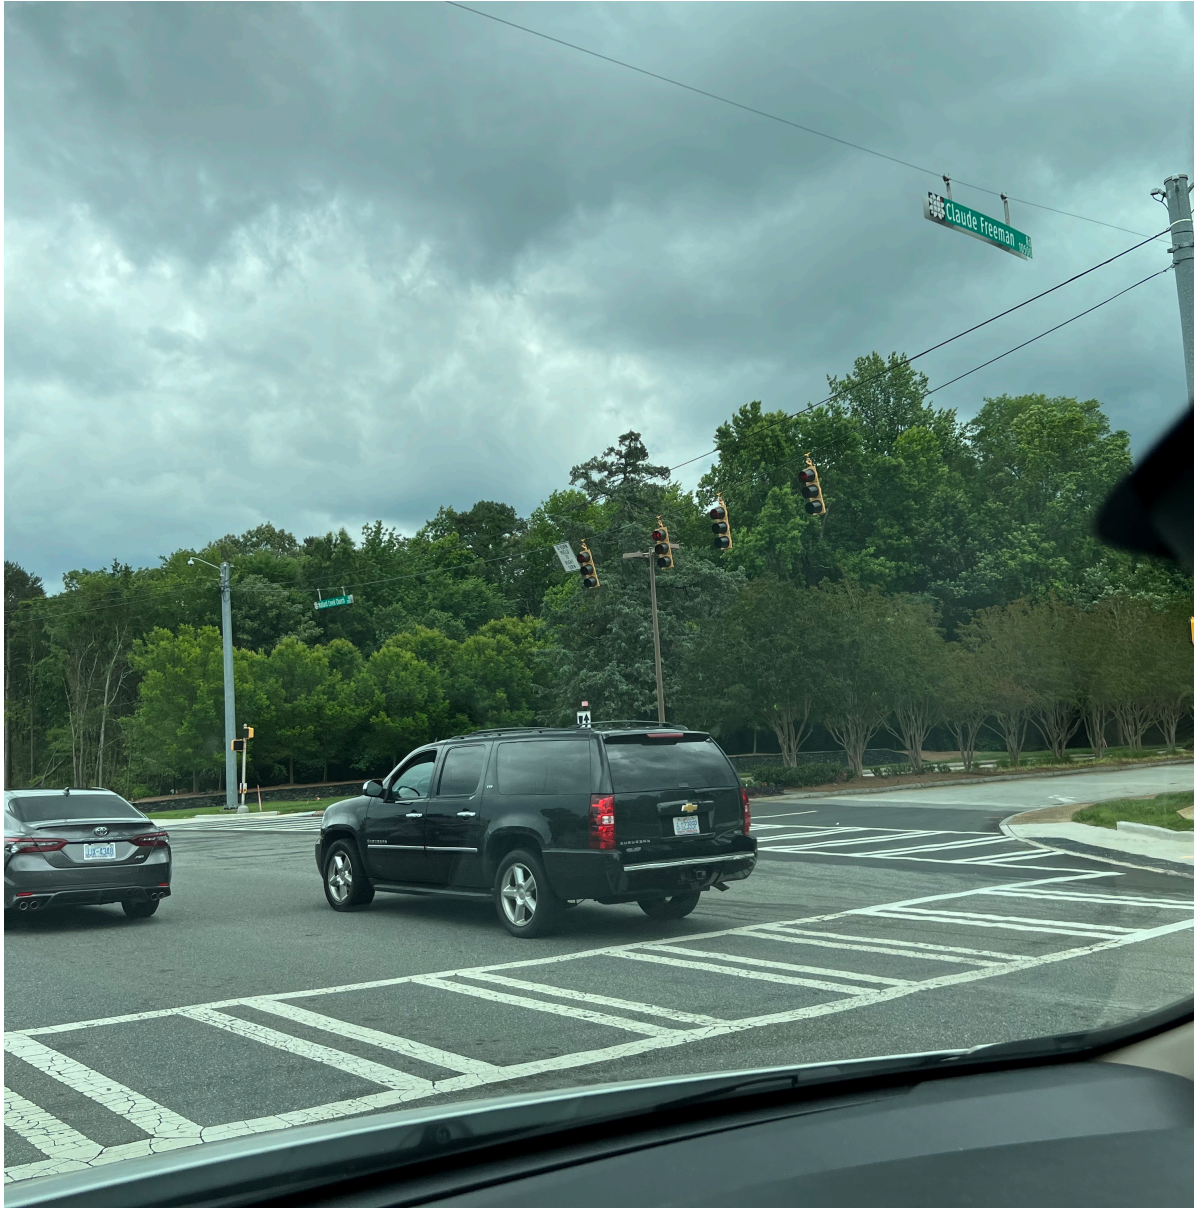
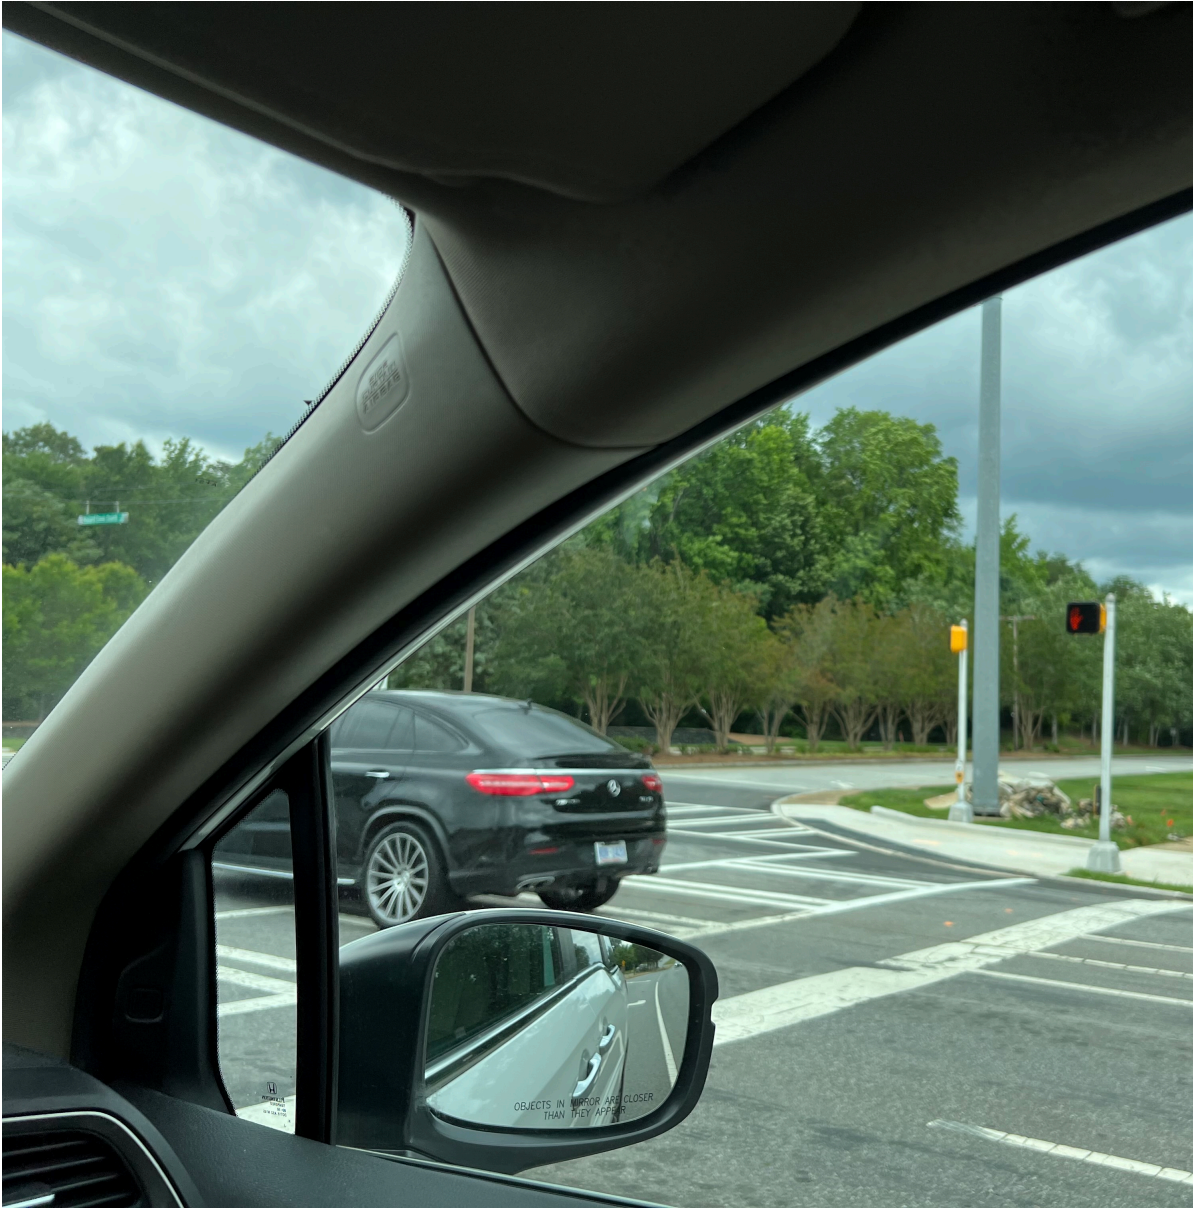
Side View(s) at Collision Site

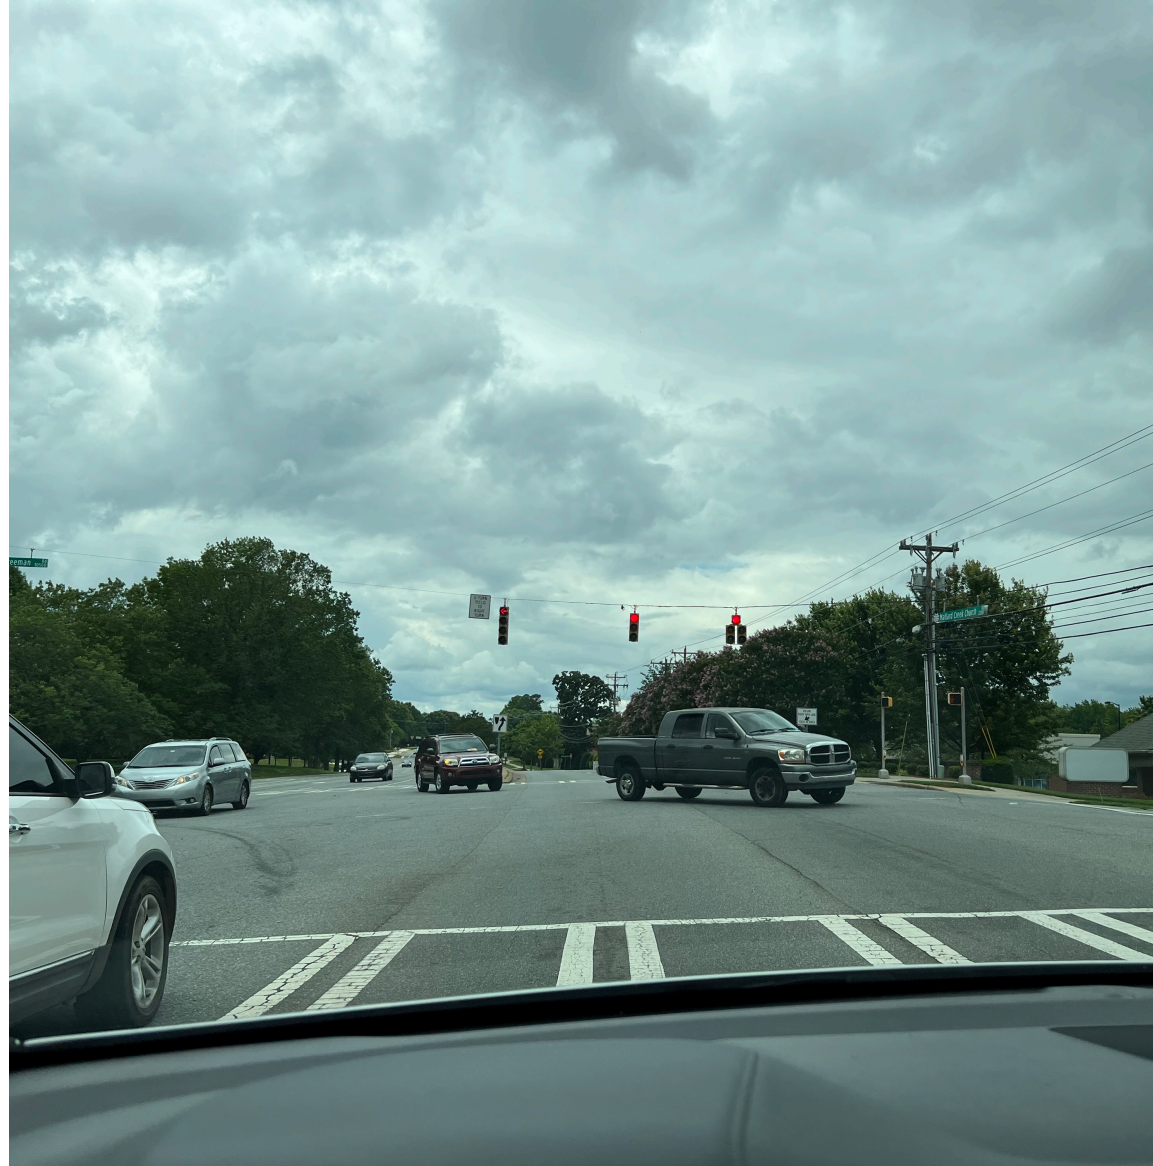
Driver View Across from Collision Site
