Crash Analysis Studio

Session 12: Rochester, New York

December 15, 2023

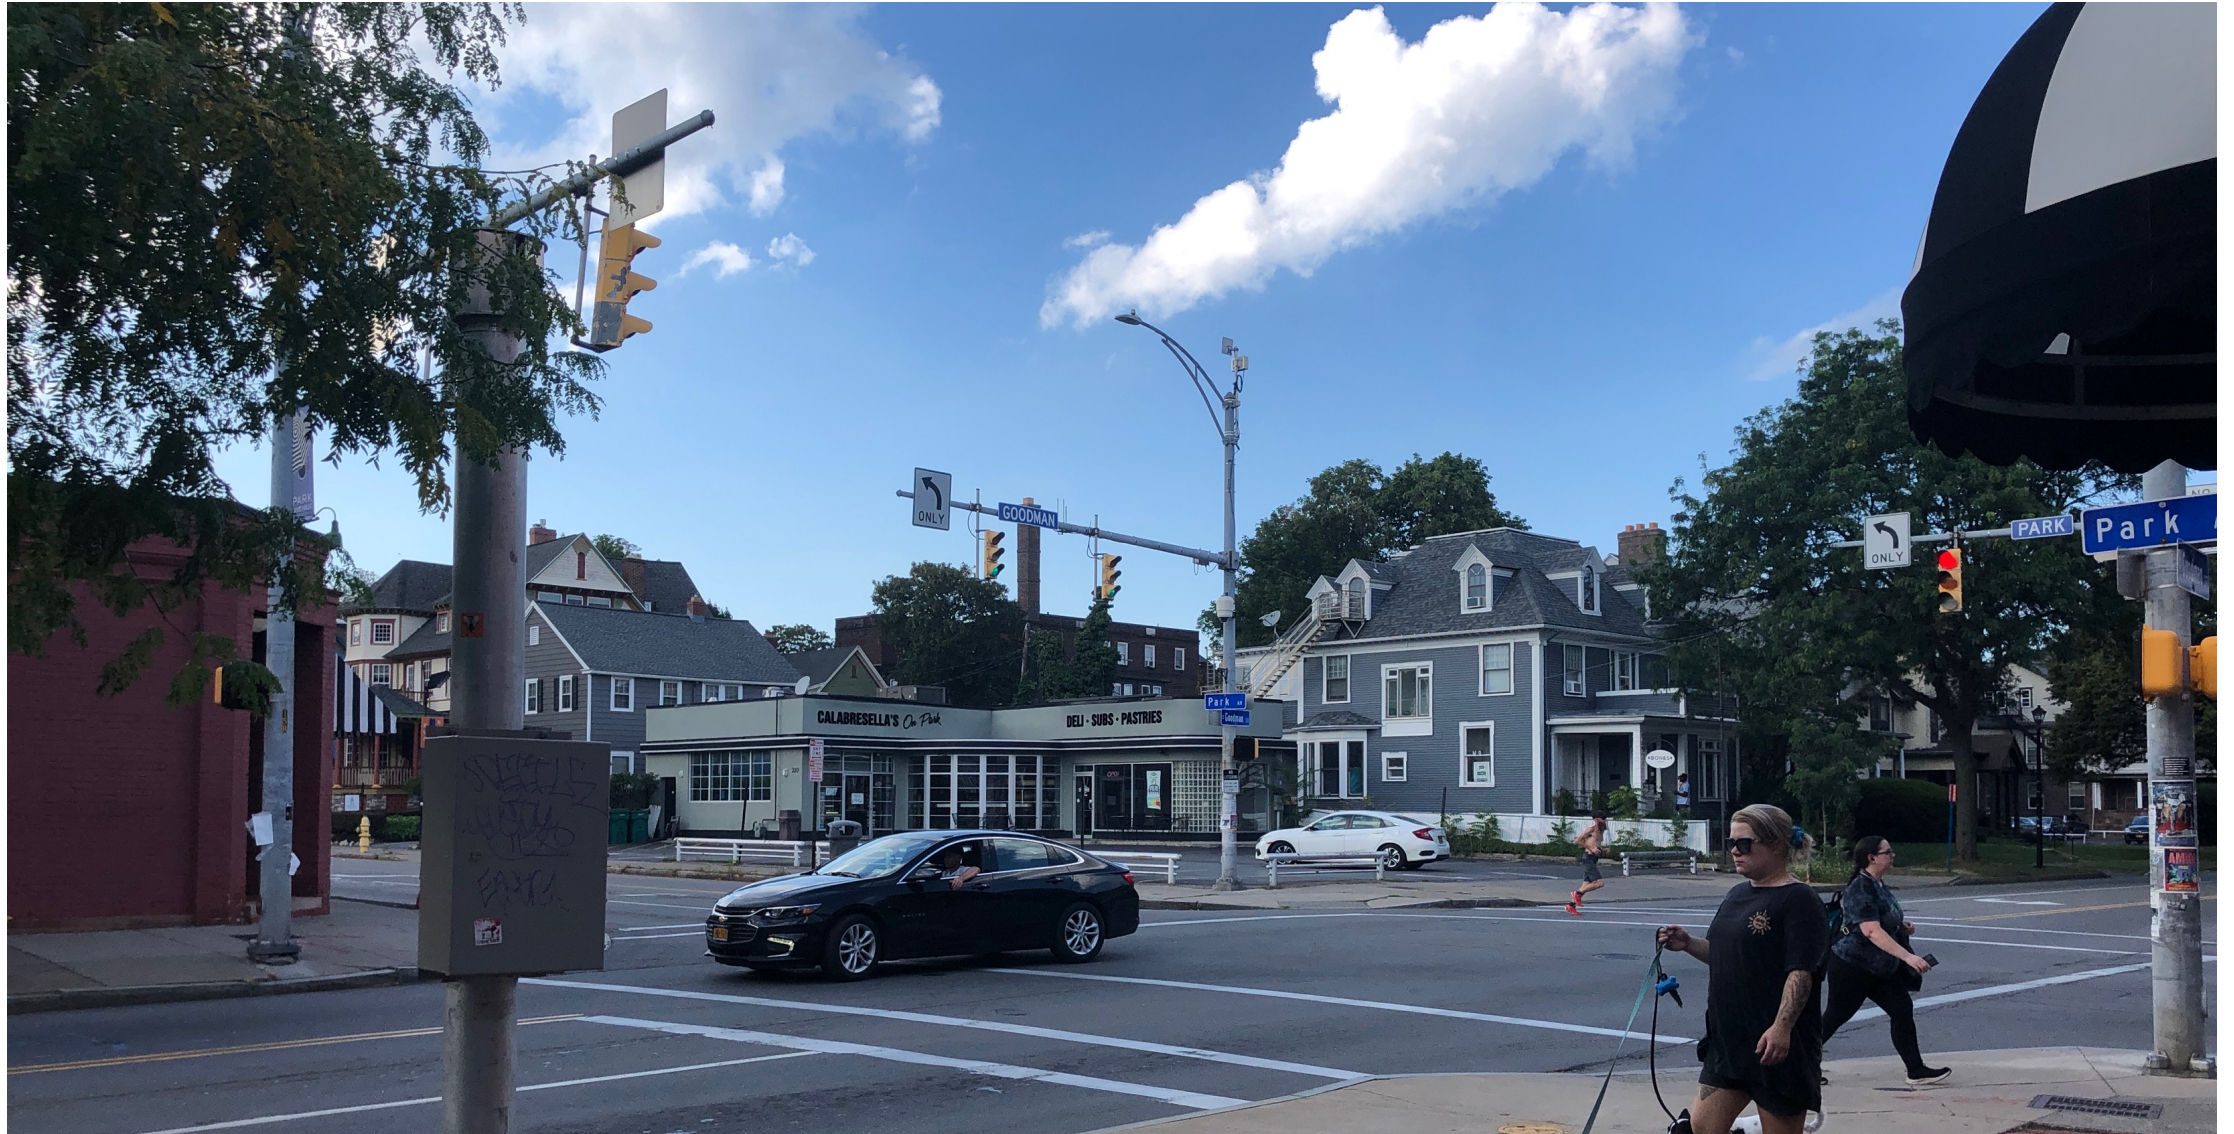
Intersection & Collision Location

- Evan Lowenstein documented the South Goodman Street speed limit is posted at 30 mph
- Crash report diagram indicates that Santa Cruz was struck on the east crossing segment on the south side of the intersection
- Bevel was indicted in March on charges of manslaughter
- An article released on November 29th indicates Bevel pleaded guilty and will serve somewhere between two and six years in prison

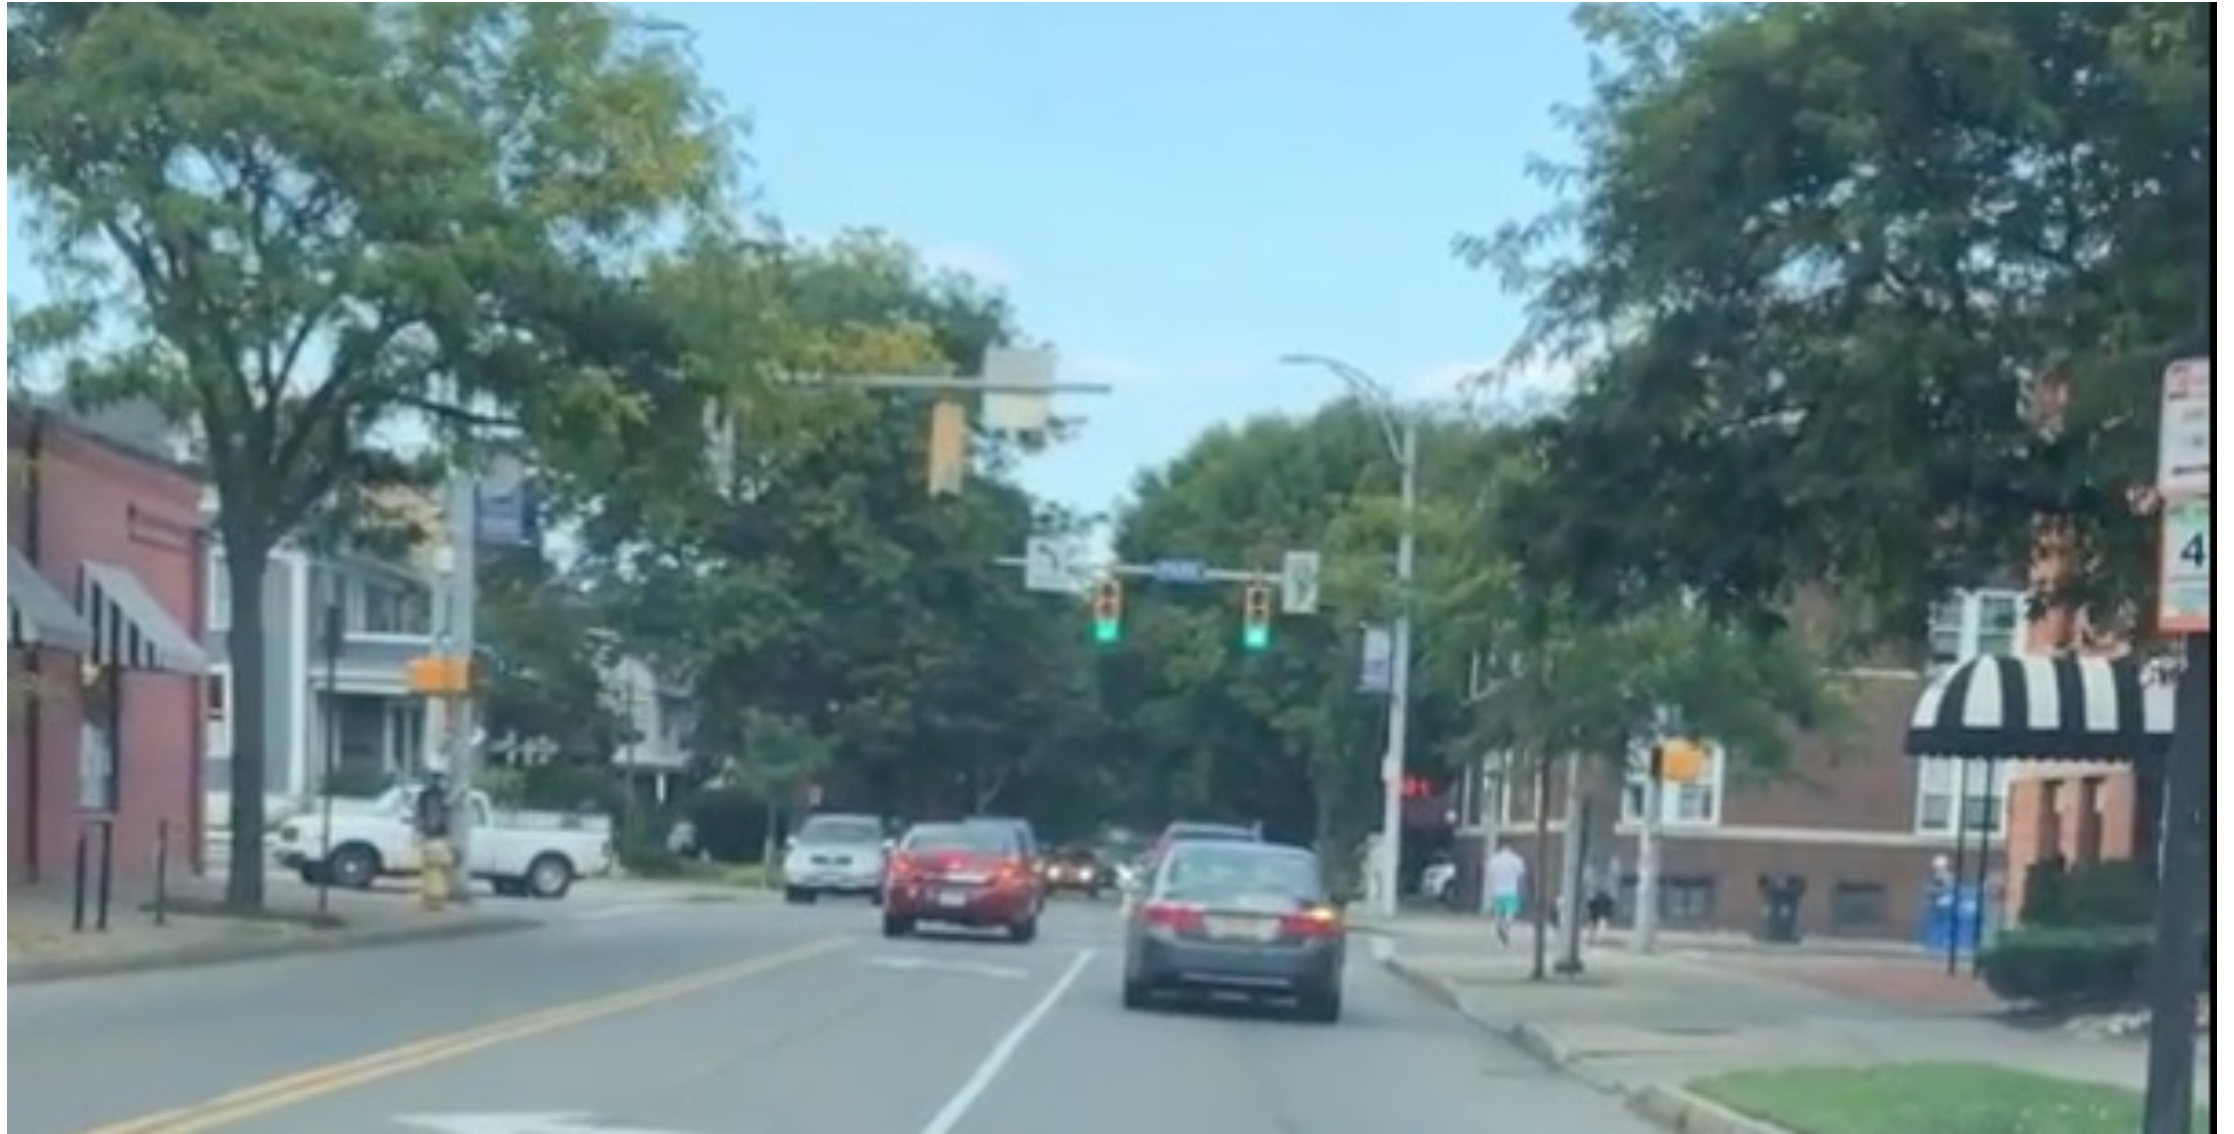
**Northbound Motorist
Approaching Intersection**

- The crash location segment of **South Goodman Street** consists of sidewalks on either side, a through traffic lane in each direction (north & south), and a center lane for left-hand turns
- Streetlights are placed over the traffic signals on all four legs of the intersection with Park Avenue
 - Traffic signals do not appear to be back plated
- Crosswalks are painted; pedestrian push buttons and signals are present and easily identified
 - Stop bars are striped at the intersection

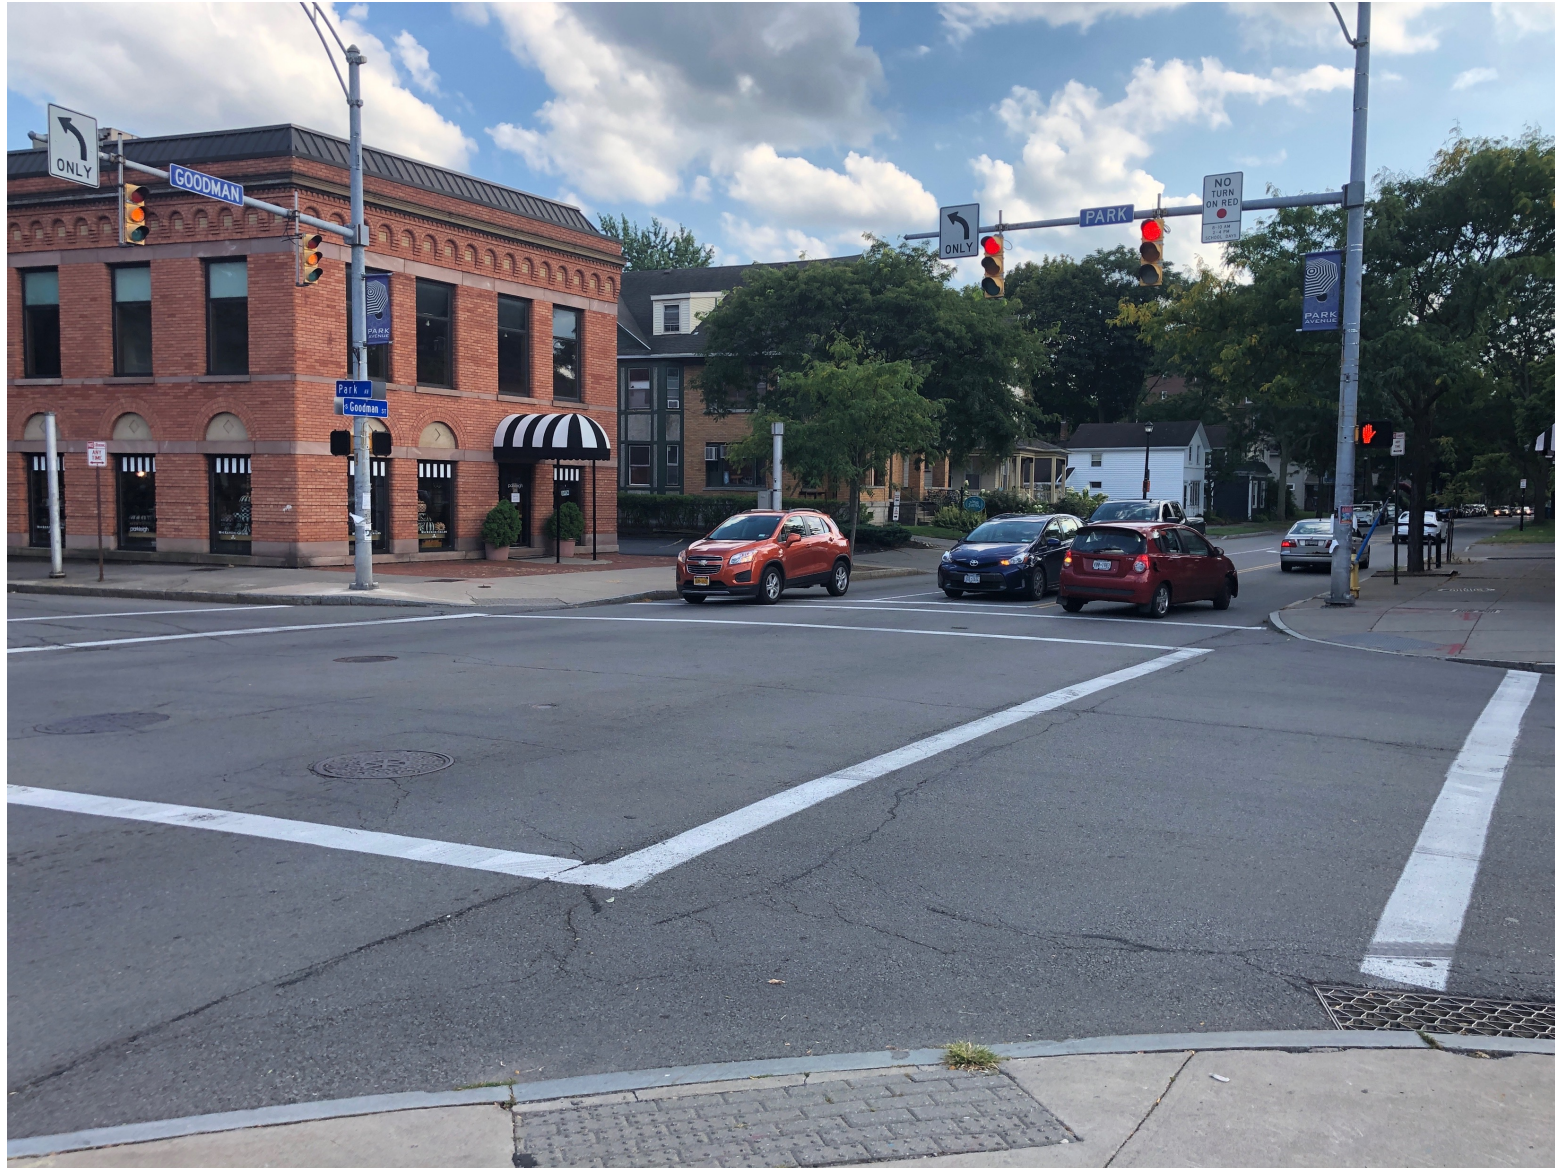
Intersection View – Looking Southeast

South Goodman Street (NB)
