Crash Analysis Studio

Session 15: Grand Junction, CO

March 22, 2024

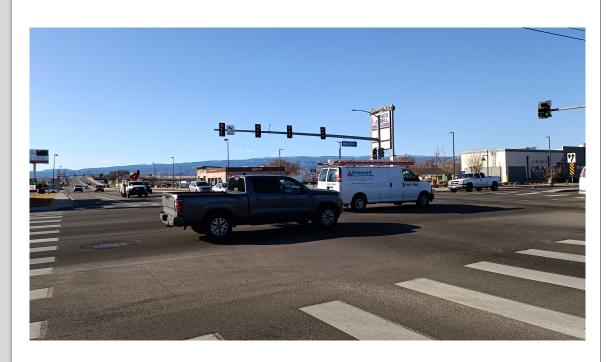
View of Intersection from NE Corner

- North Avenue is a 6 lane roadway at this intersection
 - There are 4 through traffic lanes two westbound and two eastbound
 - At this location, westbound traffic also has a dedicated left-turn and a dedicated right-turn lane
- There are no bike lanes on North Avenue at this intersection, though there is a small median in the center of the roadway
 - 29 Road **does** have bike lanes **south of North Avenue**; the bike lane north of North Avenue disappears and then picks back up after you pass the Walgreens
- This intersection is signalized and has white crosswalks striped on all four of its legs.
 - The crossing on 29 Road is on recall; the crossing on North Avenue is actuated.

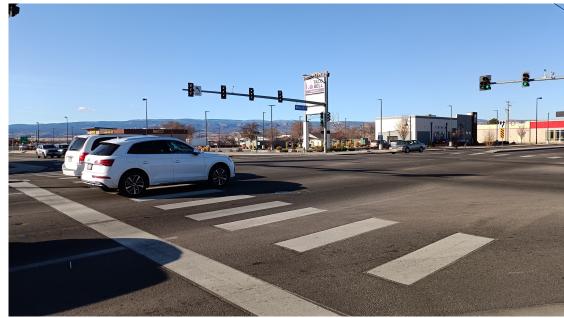
Crash Location from NE Corner

- A cyclist—Joseph E.—was traveling north a few feet outside of the east crosswalk that runs along North Avenue at its intersection with 29 Road.
- A motorist—Trisha L.—was driving her Tahoe in the inner westbound lane, approaching 29 Road, prior to hitting Joseph.
 - The motorist entered the intersection with a green signal light when the crash happened.
- The crash took place at 8:53pm on October 8, 2023
- The crash report indicated the crash location was dark-lighted and dry; there was clear weather that night in Grand Junction.
