Crash Analysis Studio

Ottawa, Ontario

Crash Information

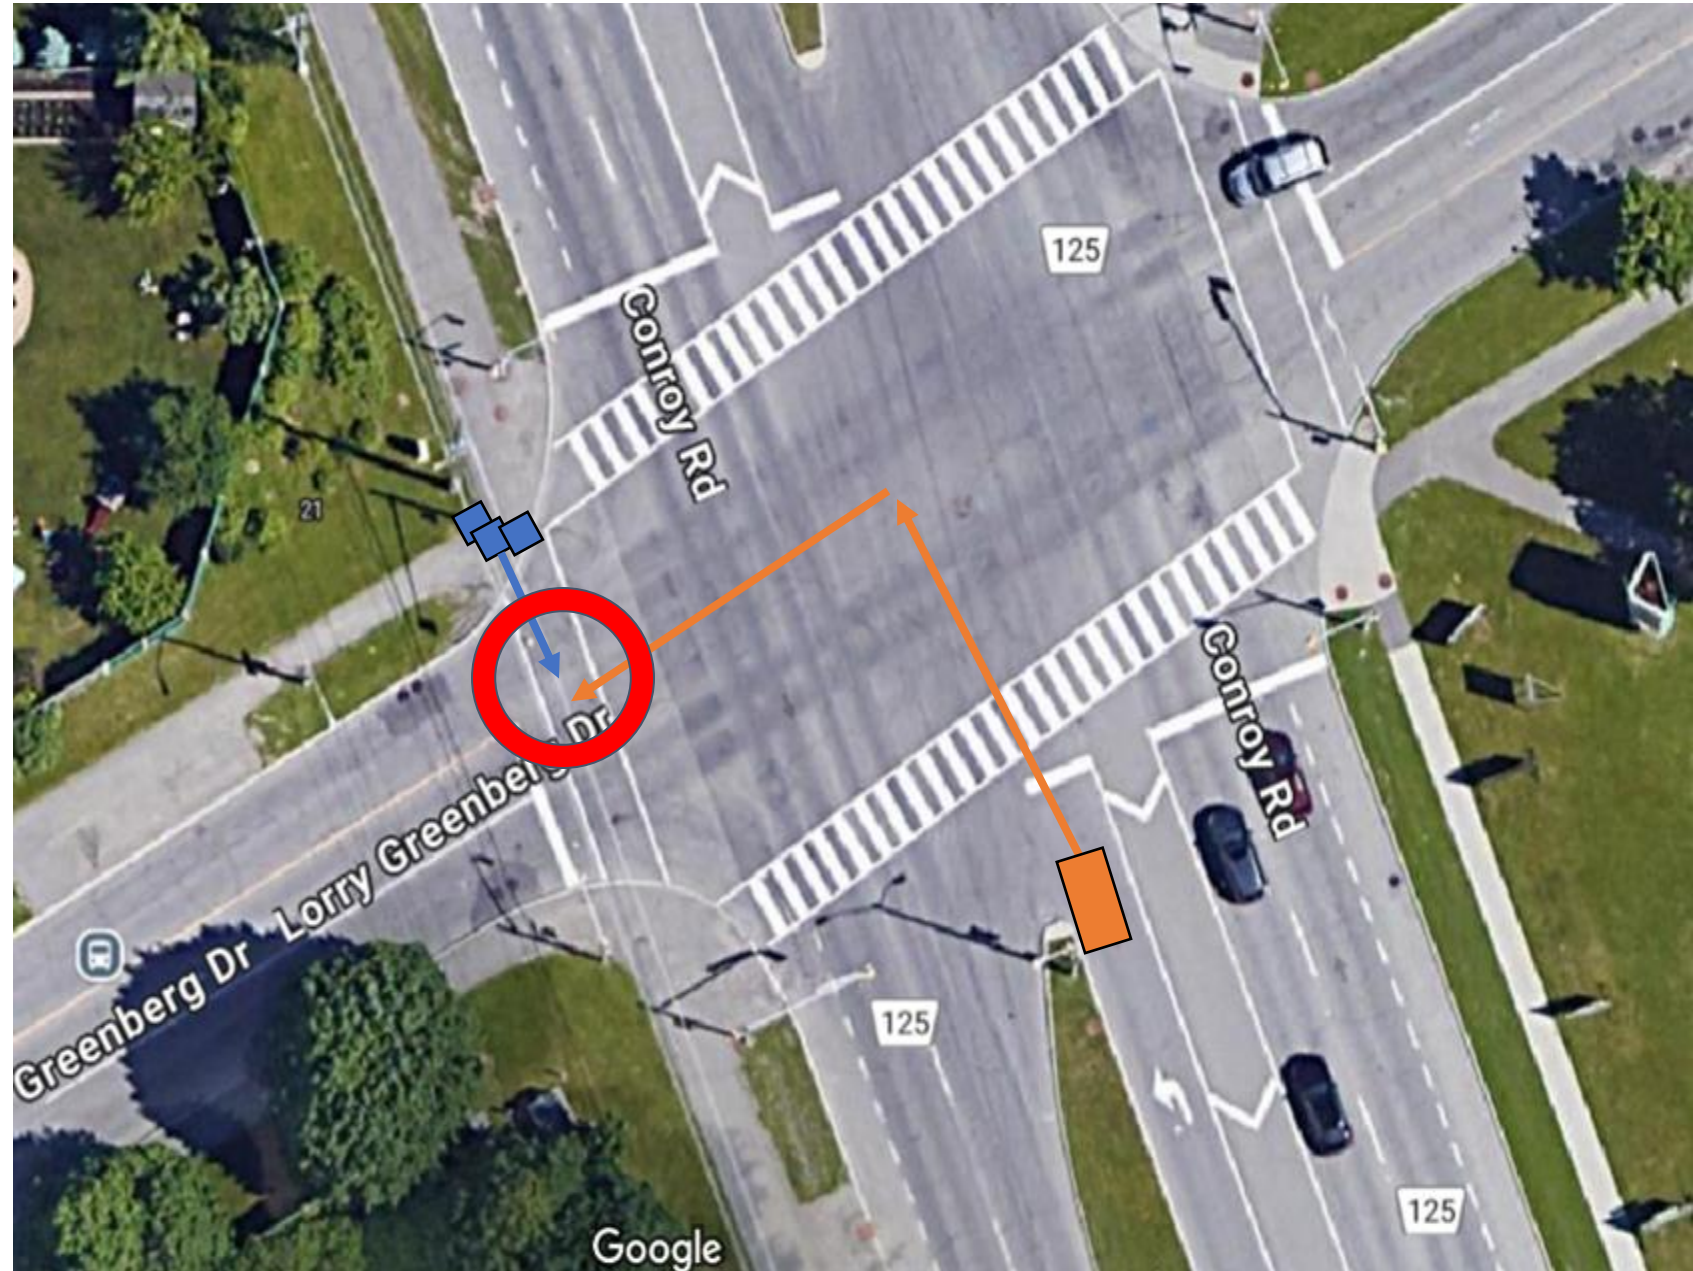
Pre-Collision

- Male and two females waiting on sidewalk for green light to cross crosswalk
- Car either waiting for green light or approaching intersection

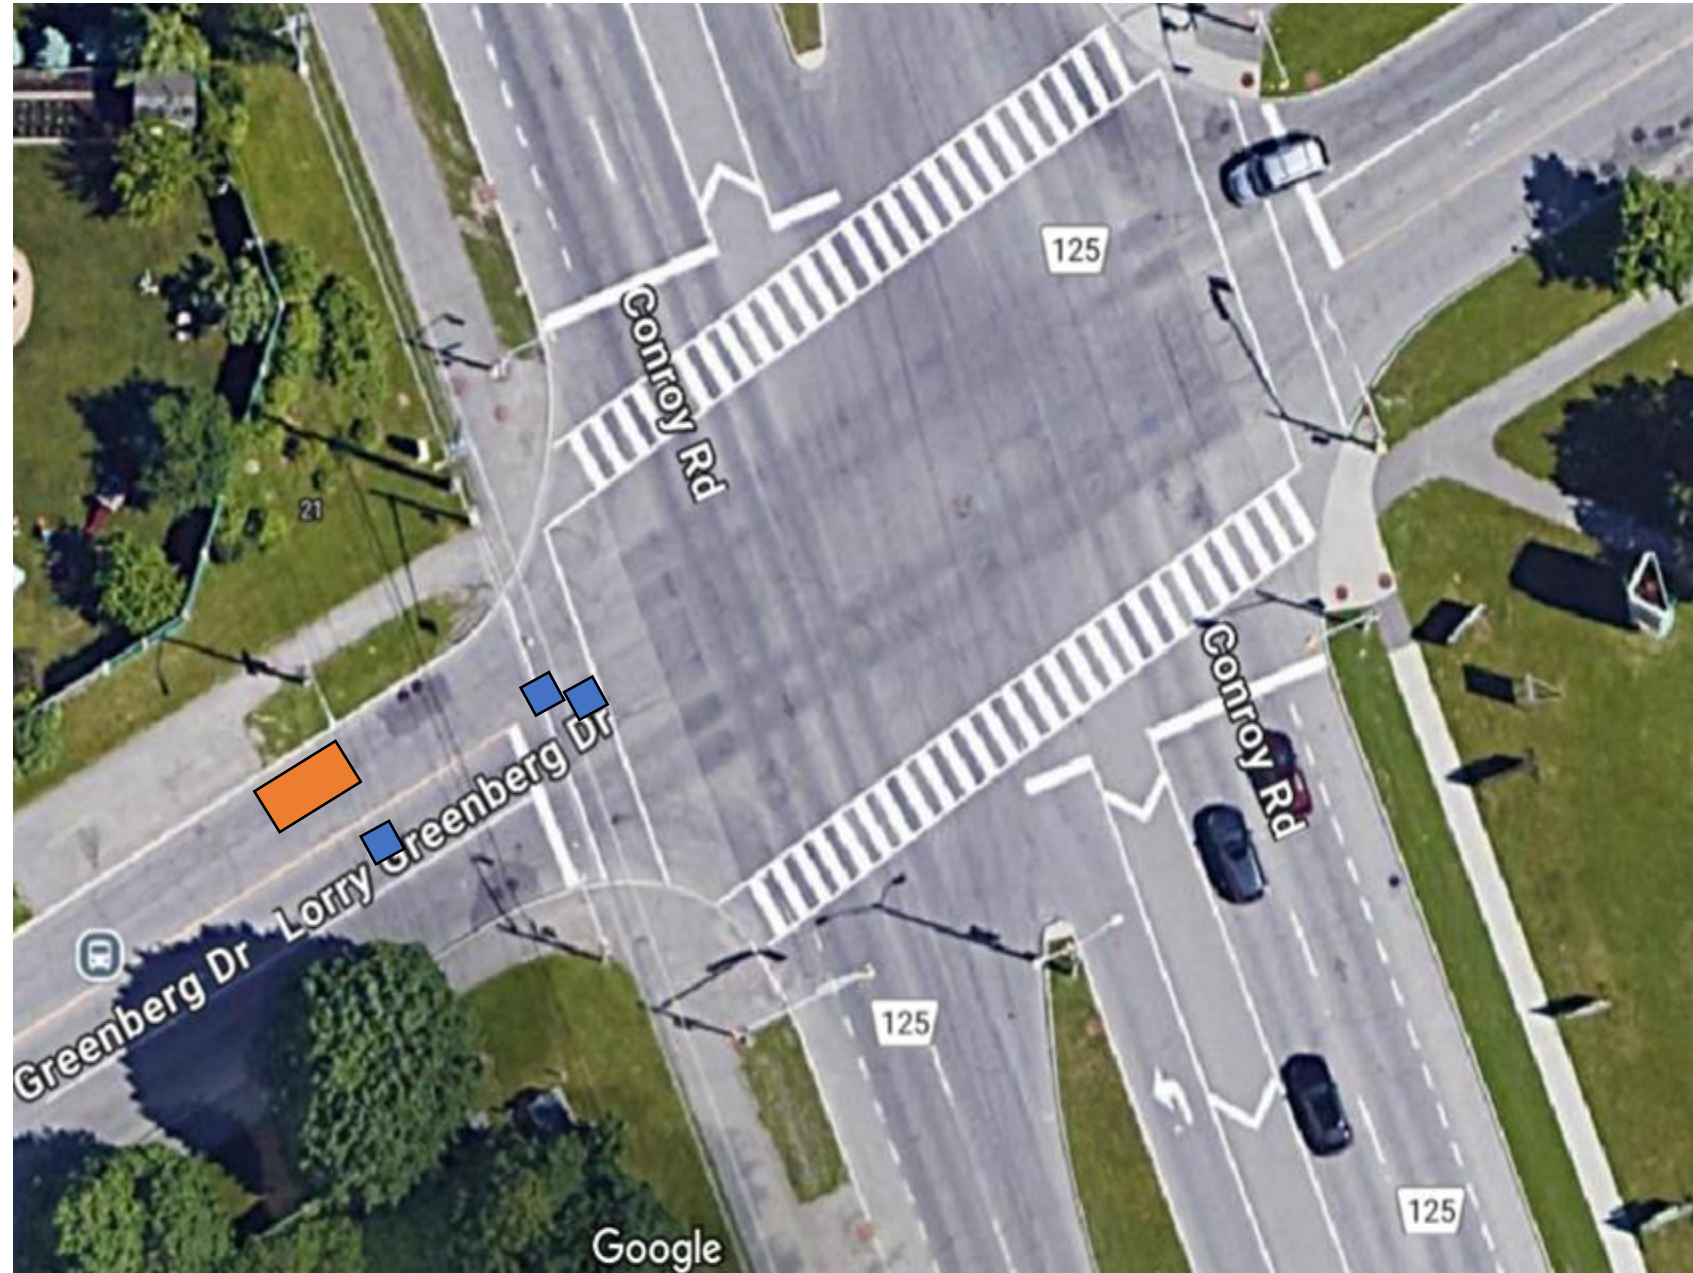
Post-Collision

- Male was hit and fell 5-10 meters away from crosswalk

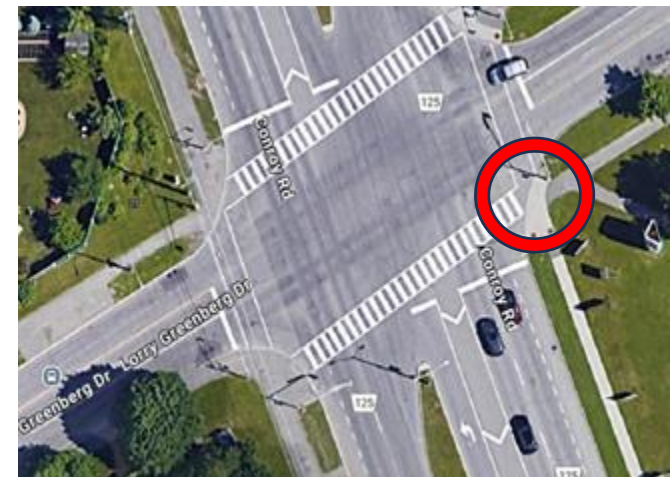
Full Intersection 2

Travelling Northbound on Conroy -
no advanced green light.

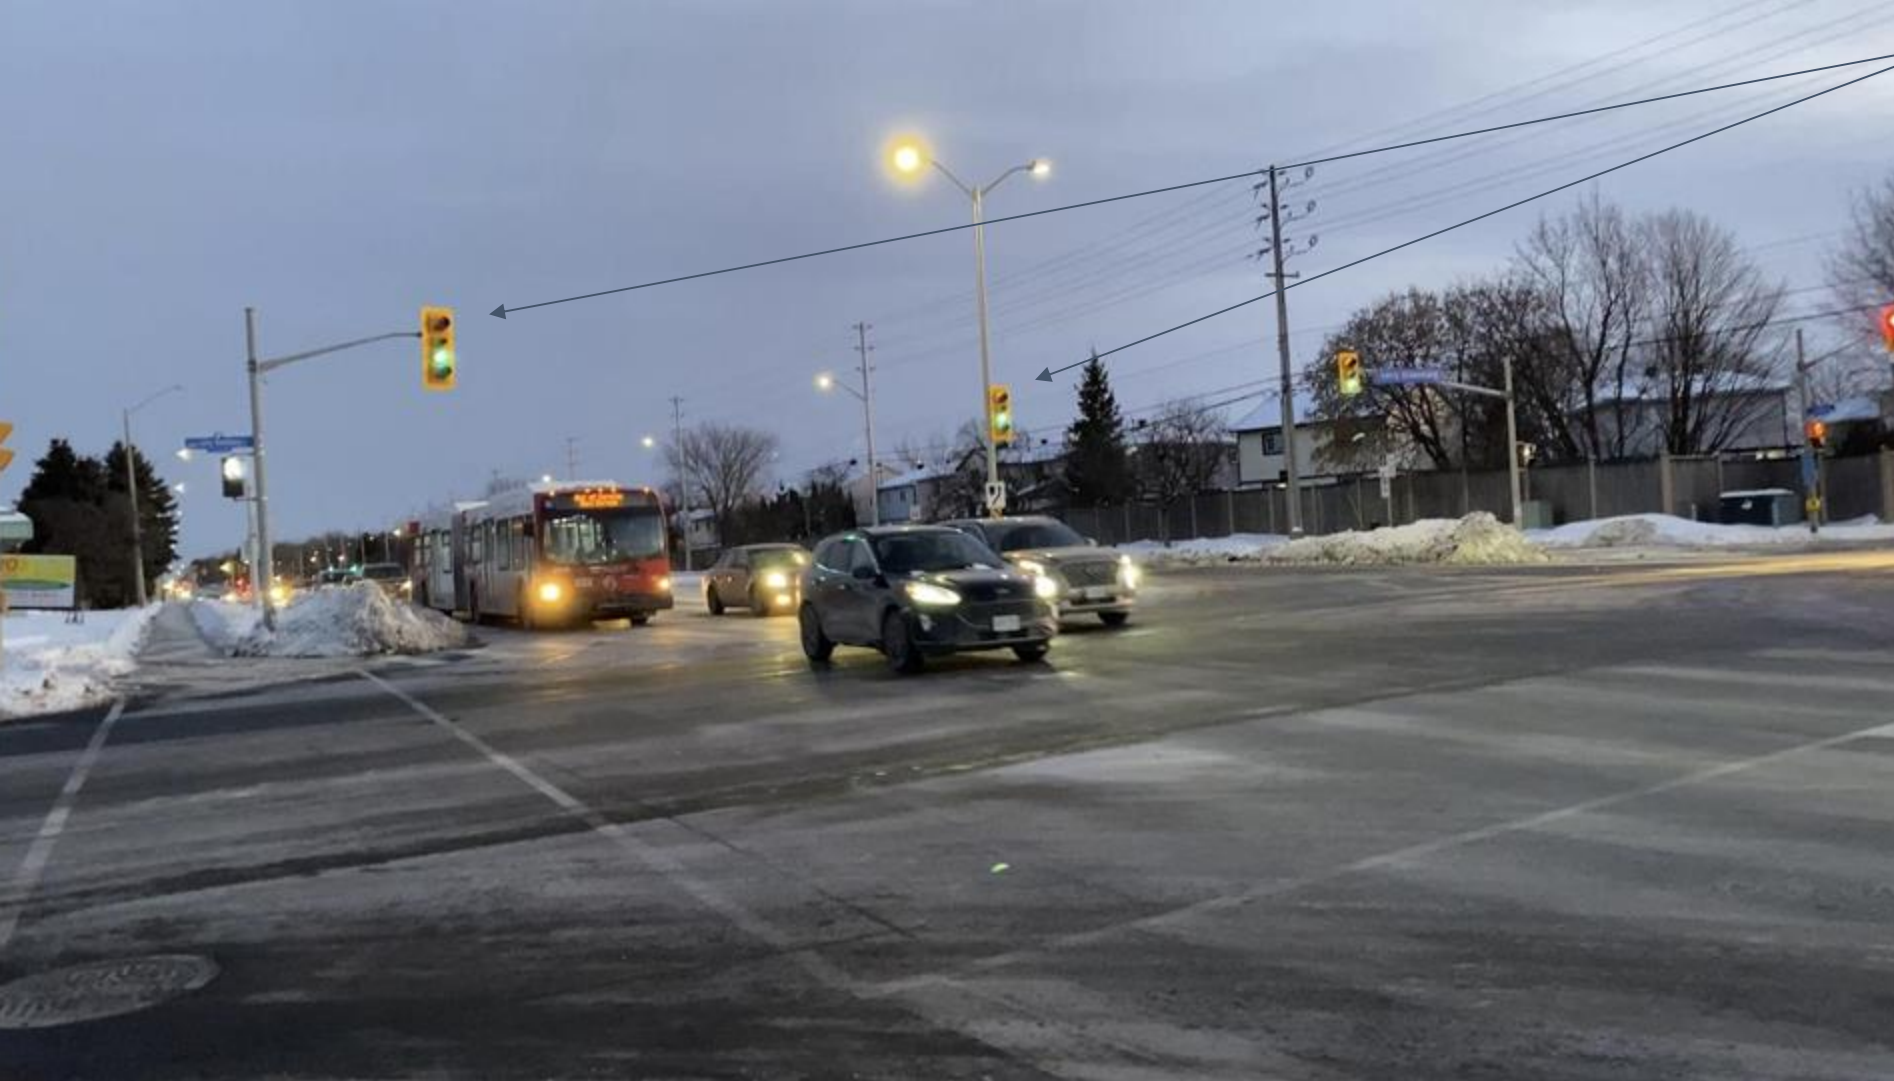
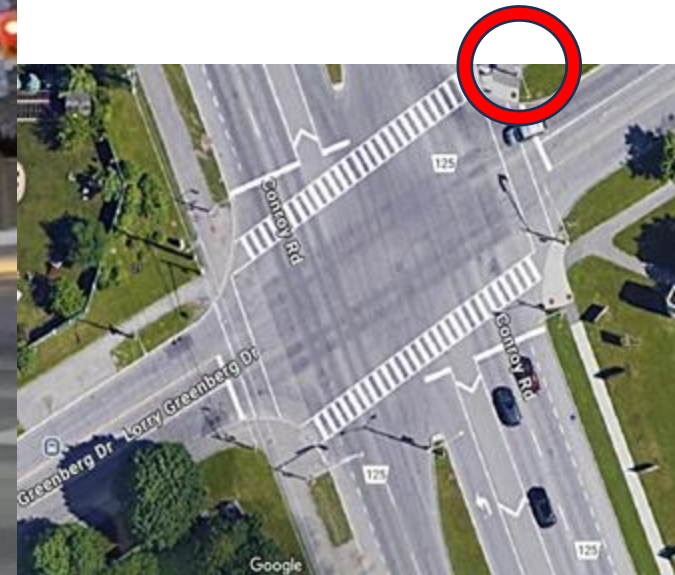
Travelling Southbound on Conroy has an advanced green light

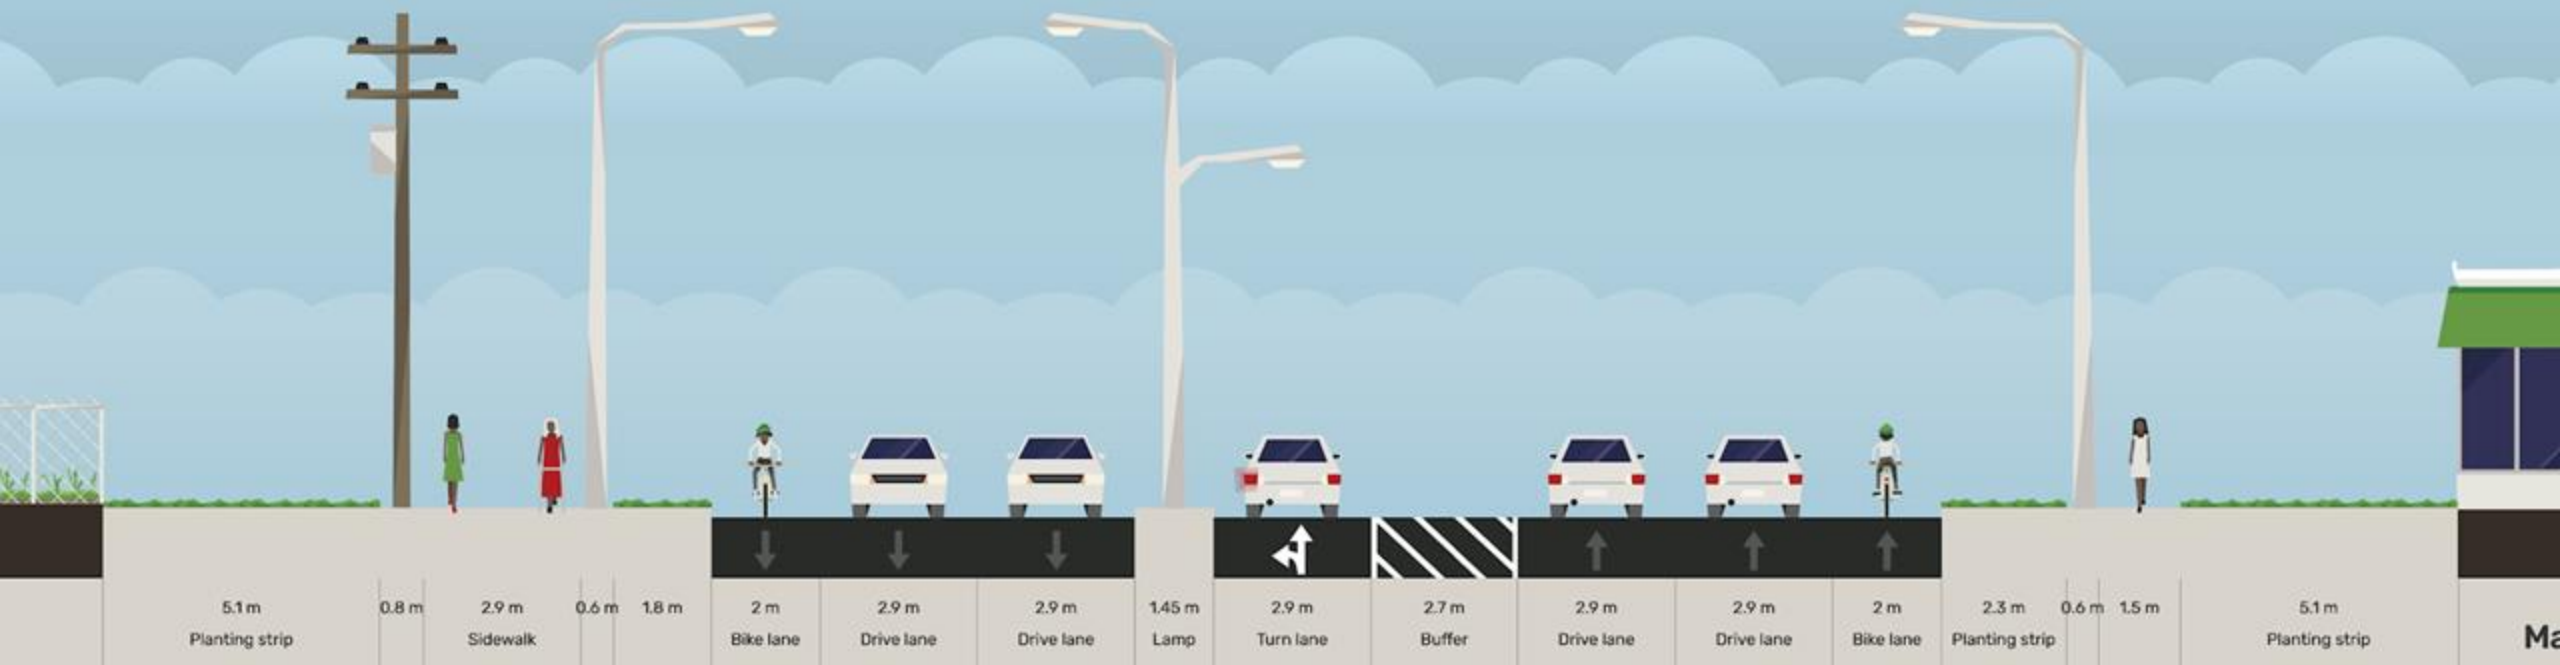
Conroy Road

60km/h (37mph)
Total width: ~ 43m

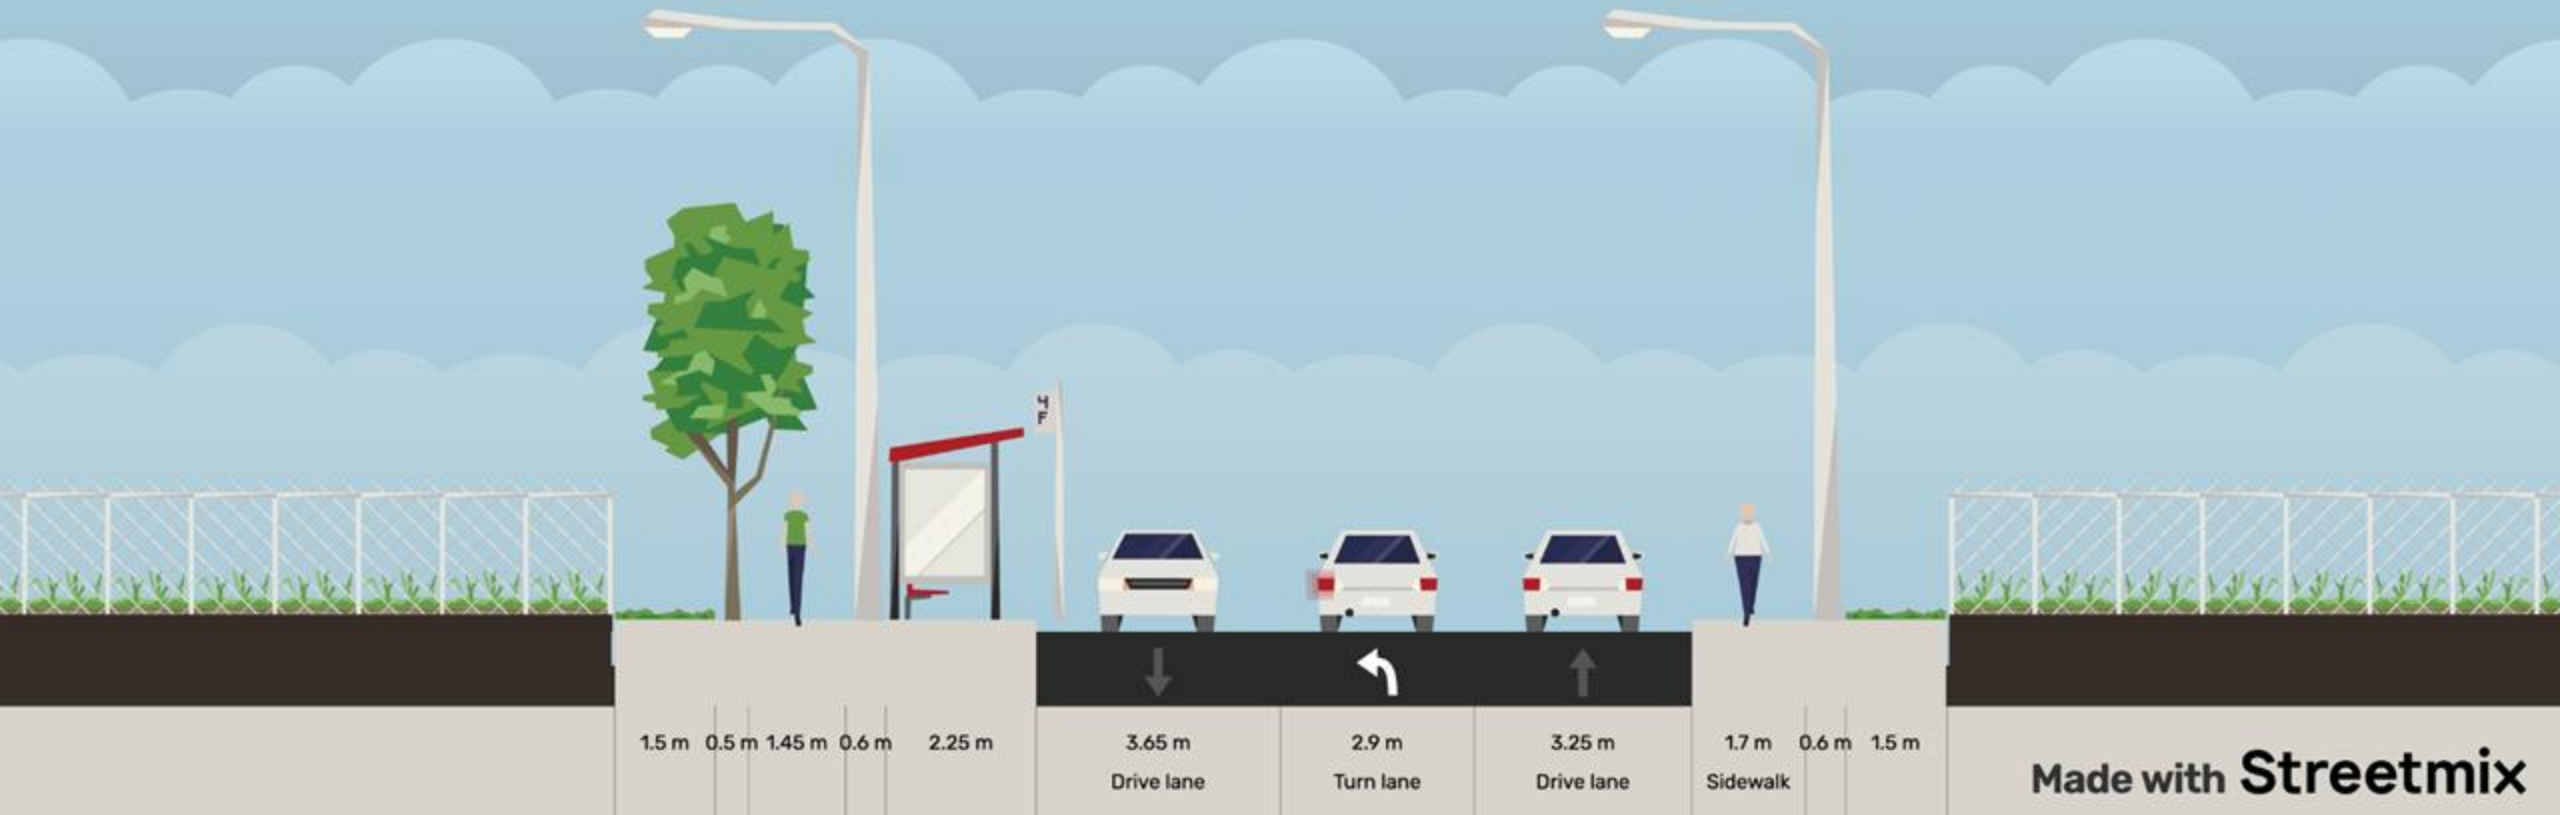
Lorry Greenberg Drive

50km/h (31mph)
Total width: ~ 20m

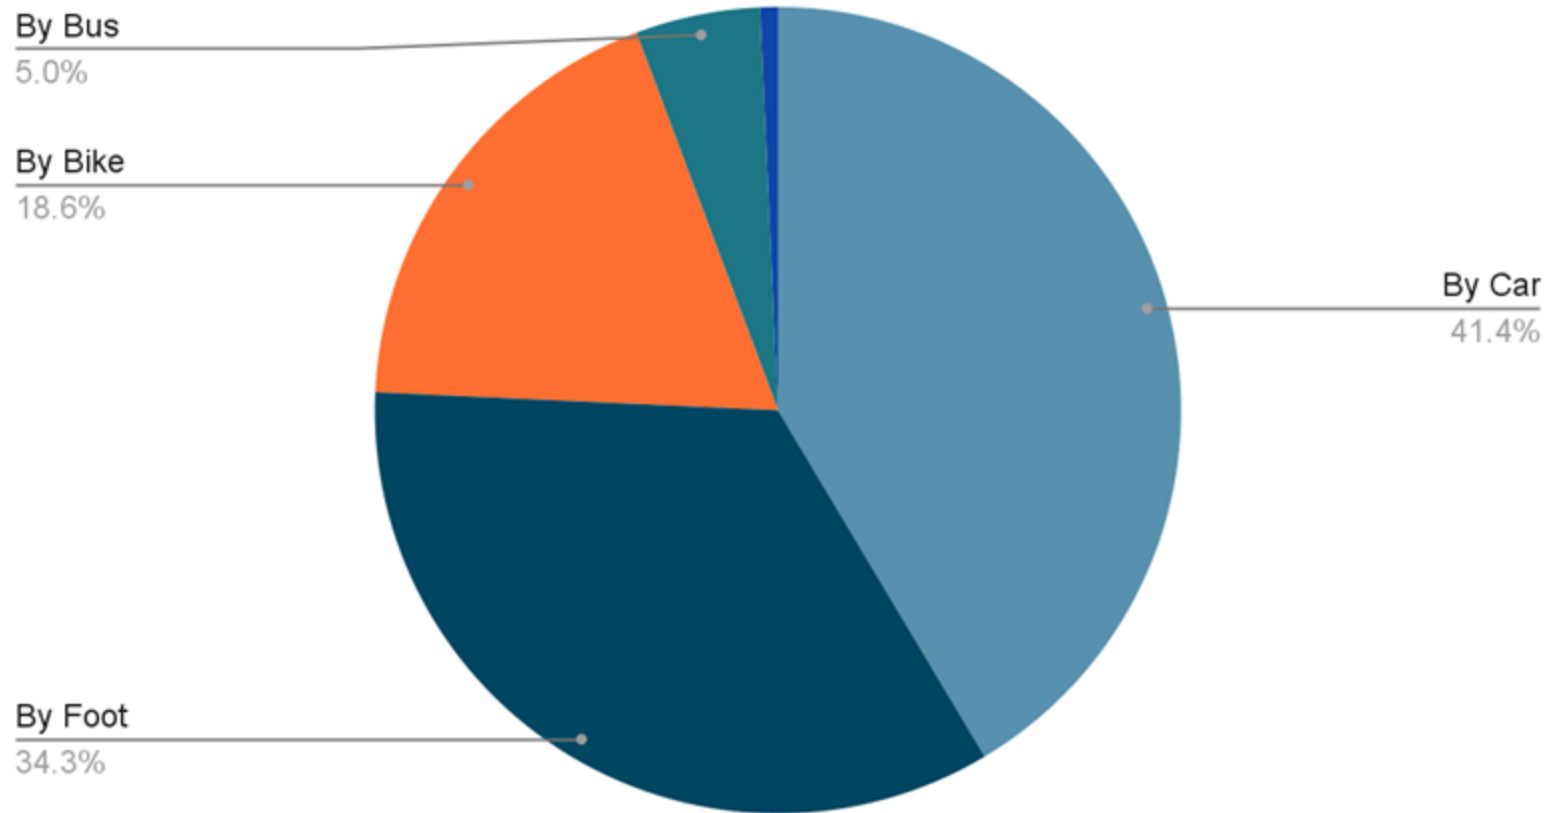
Modes of Travel through Intersection

- 63 survey responses
- Time period: March 9 - May 2, 2025

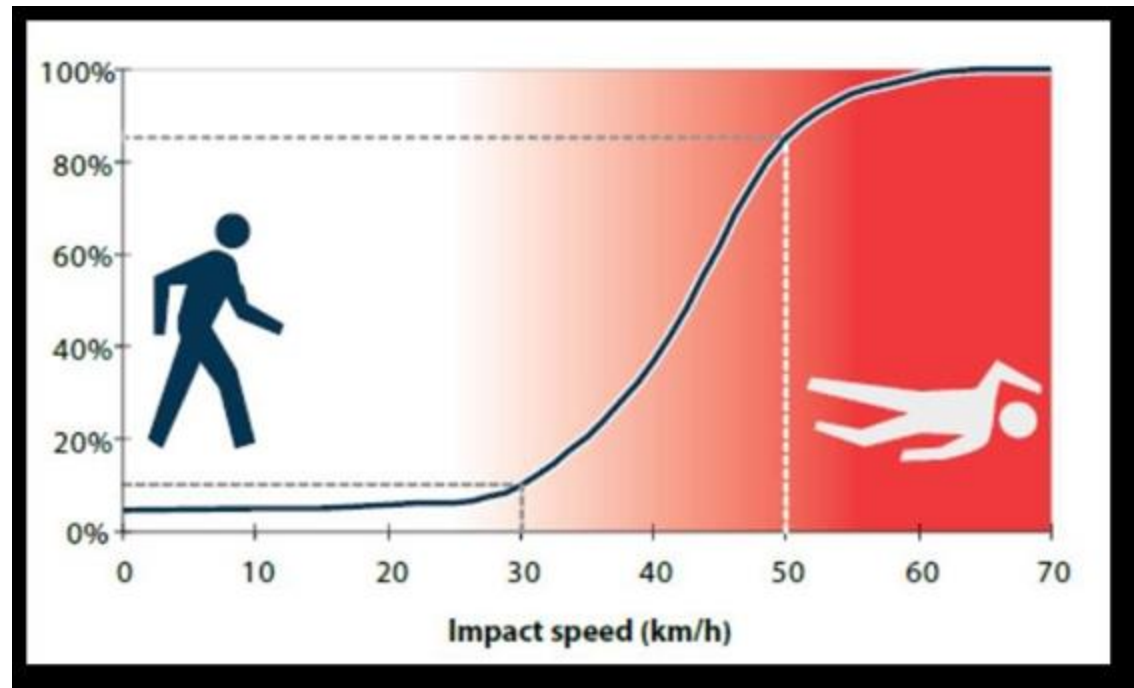
The effects of higher speed limits on traffic fatalities in the United States, 1993–2017.

- Preliminary Speed Study indicates significant number of automobiles traveling at fatal speeds

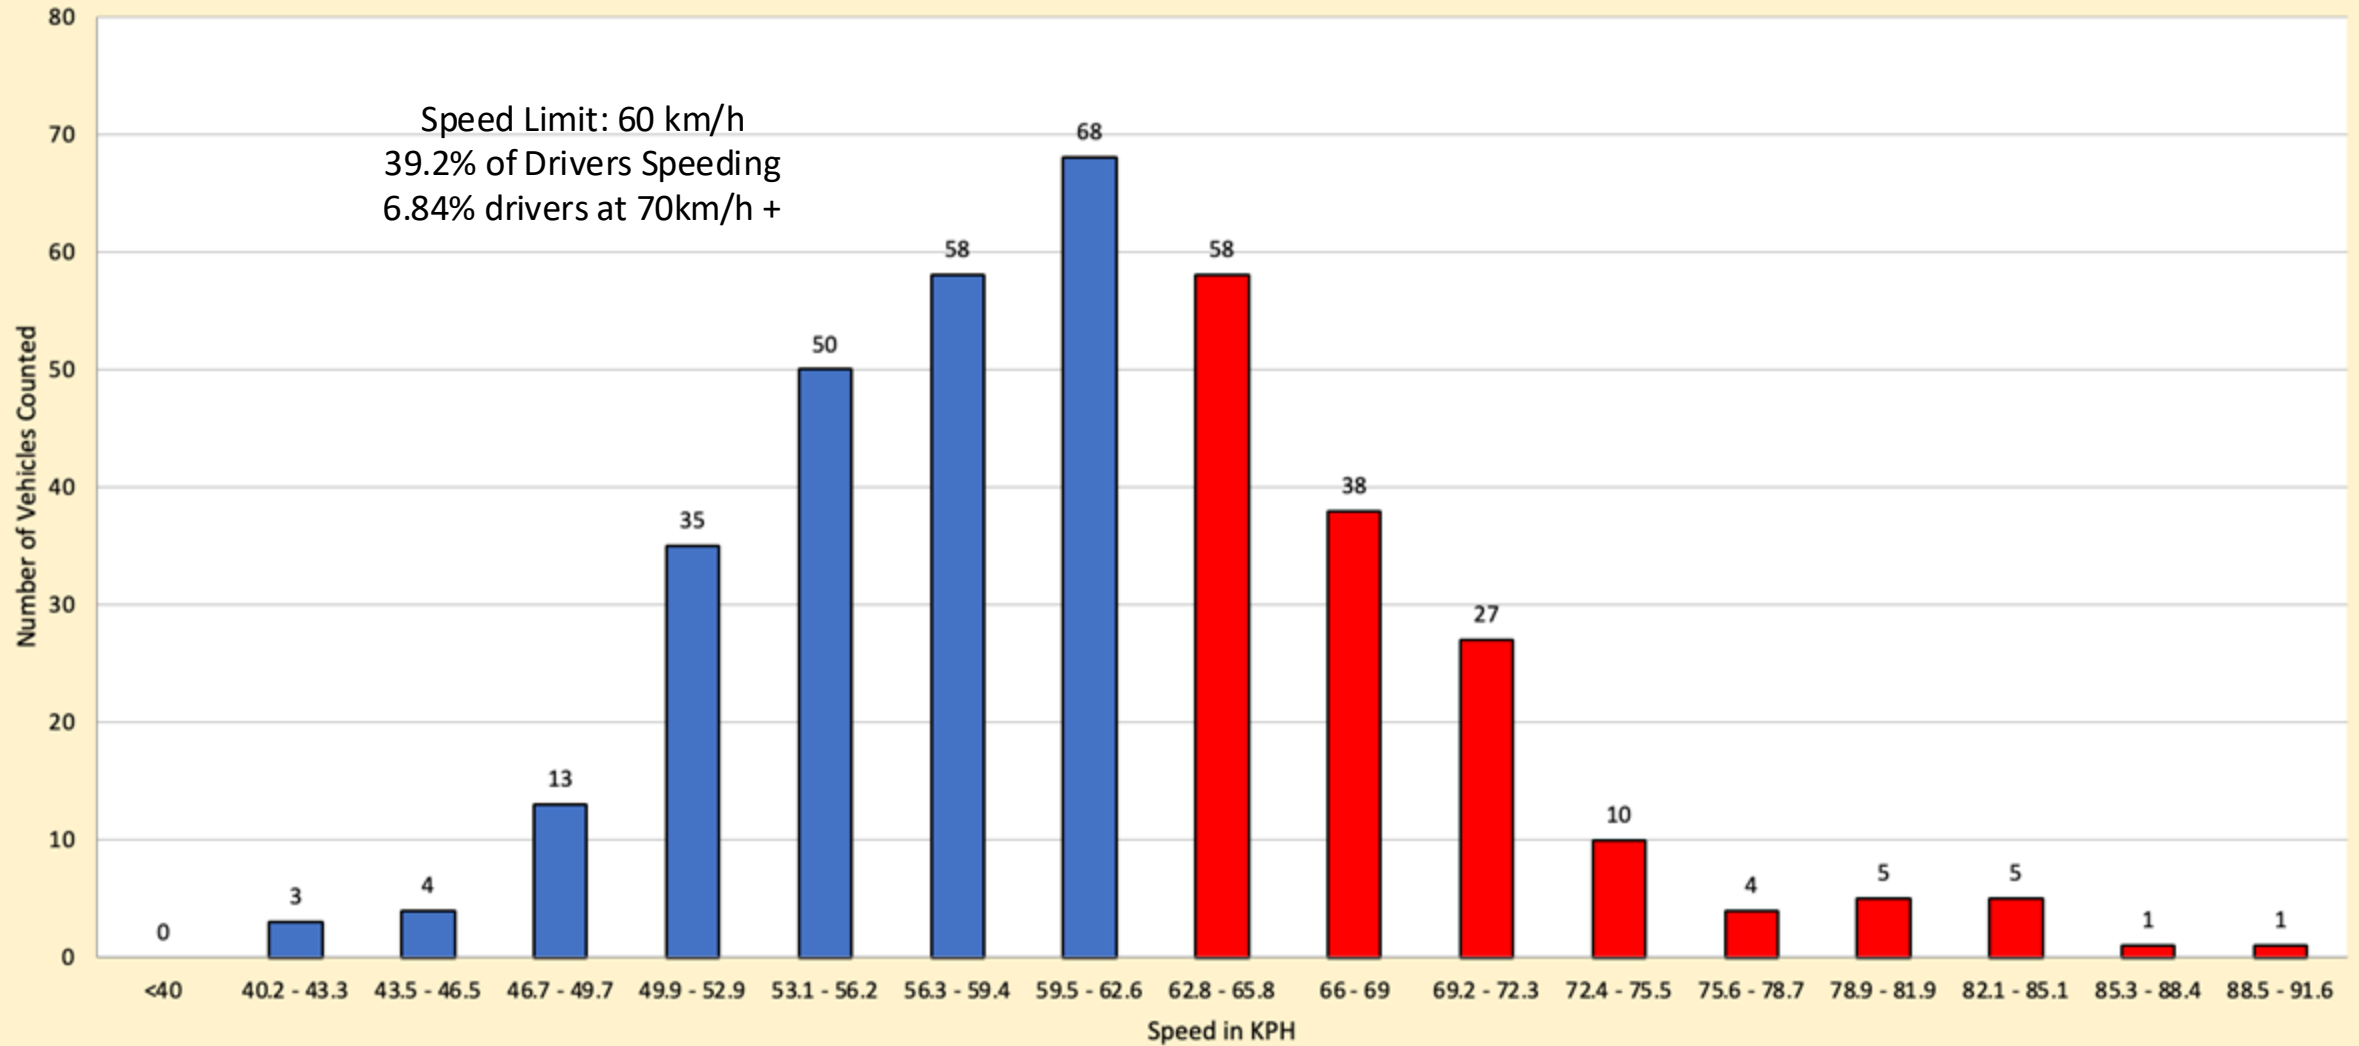
CONROY ROAD
of Vehicles Driving at Each Speed

380 cars tracked
85th percentile speed = 62.8 - 65.8 km/h
