Crash Analysis Studio

Memphis, Tennessee - Walnut Street and Vance Avenue

September 13, 2025

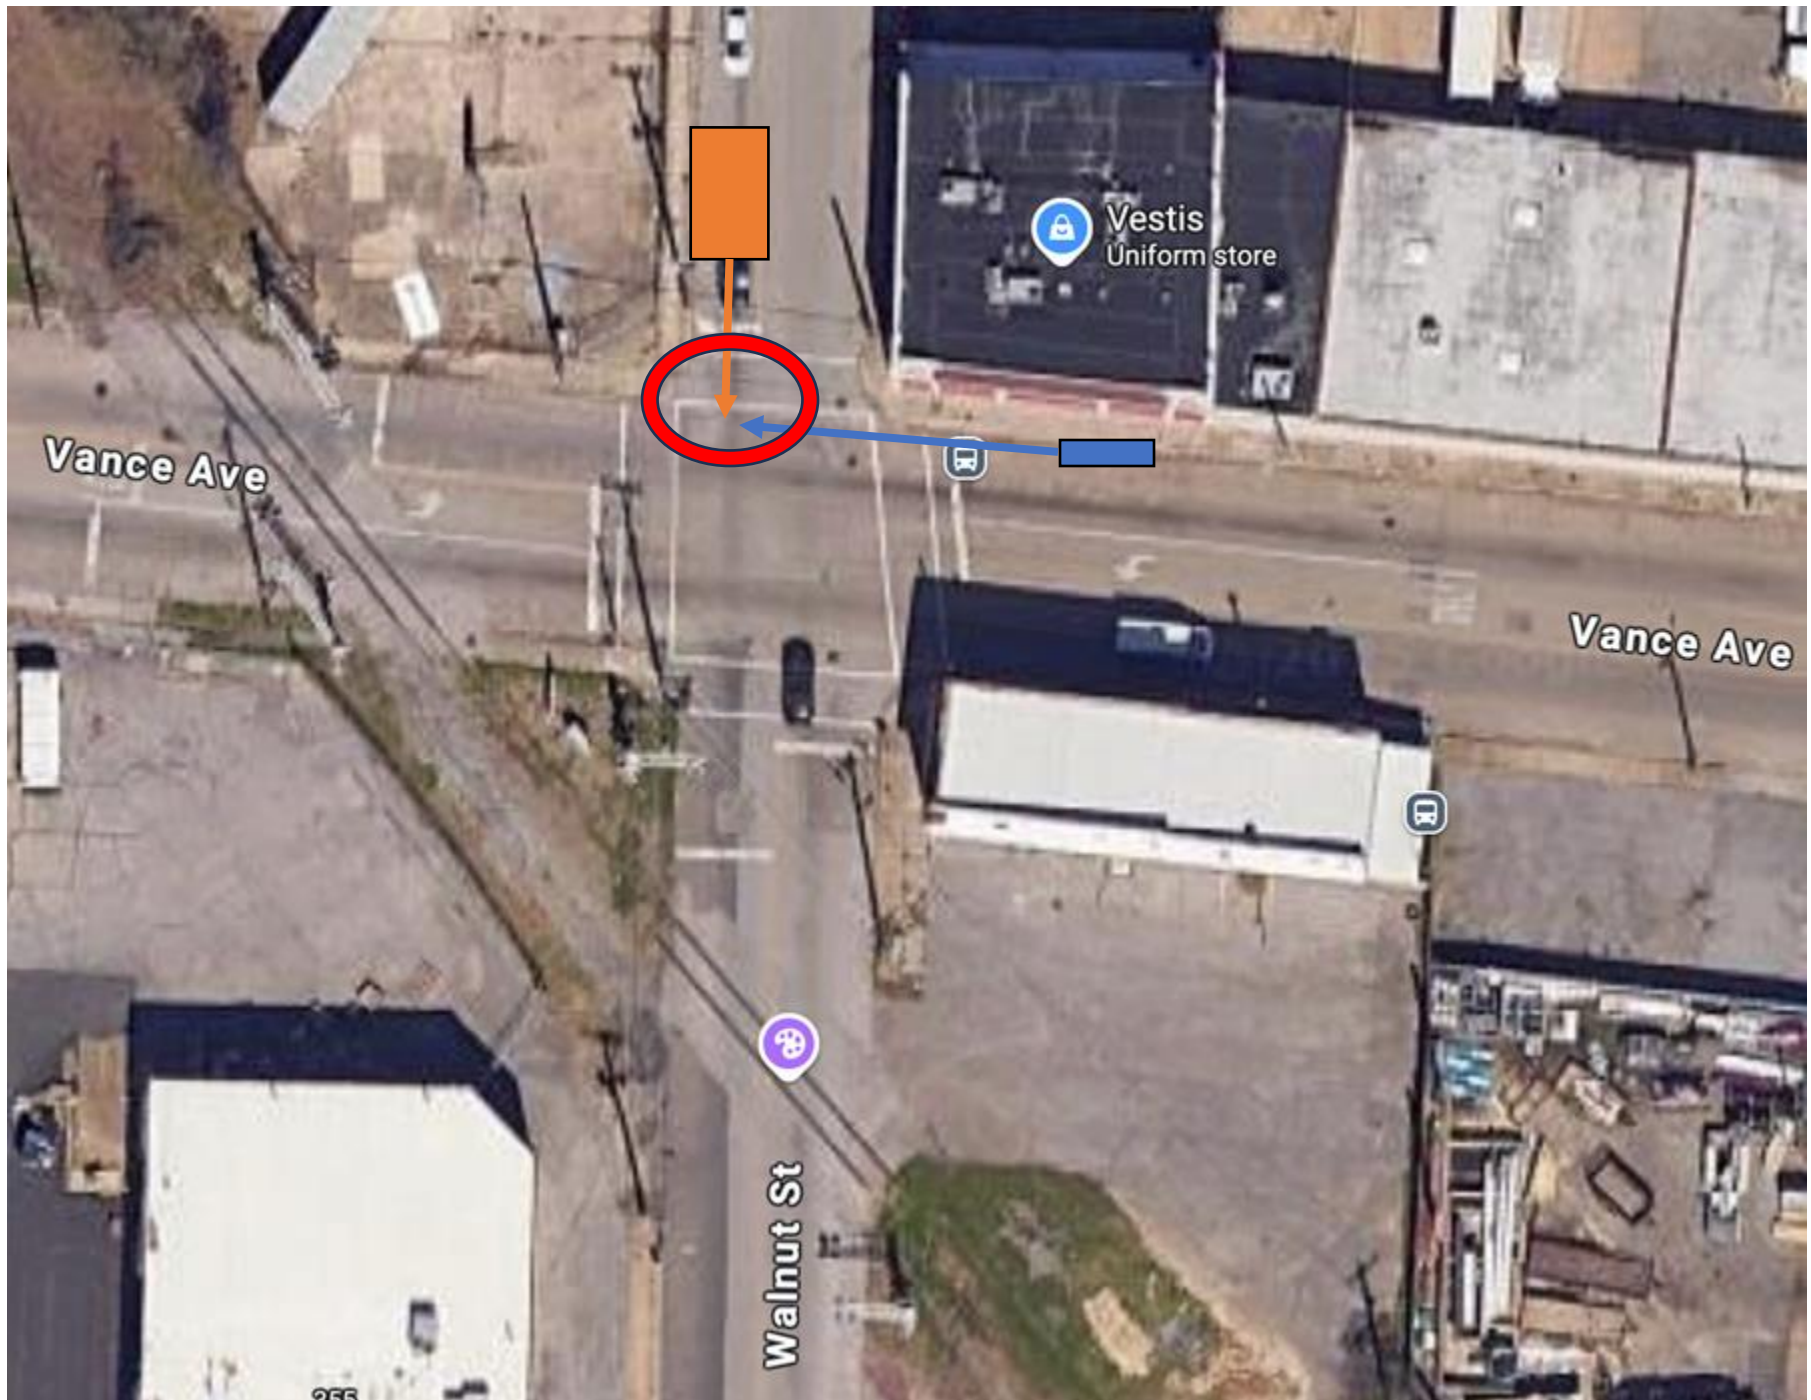
Overall Site Conditions

- You'll see a northbound and southbound lane on Walnut Street,.
- Vance Avenue has lanes for eastbound, westbound, and turning traffic.
- The intersection is an unsignalized 4-way stop with parallel line crosswalks along each leg
- Sharrows or signage for sharing the road between cyclists and drivers do not seem to be present
- Dedicated bike lanes are absent

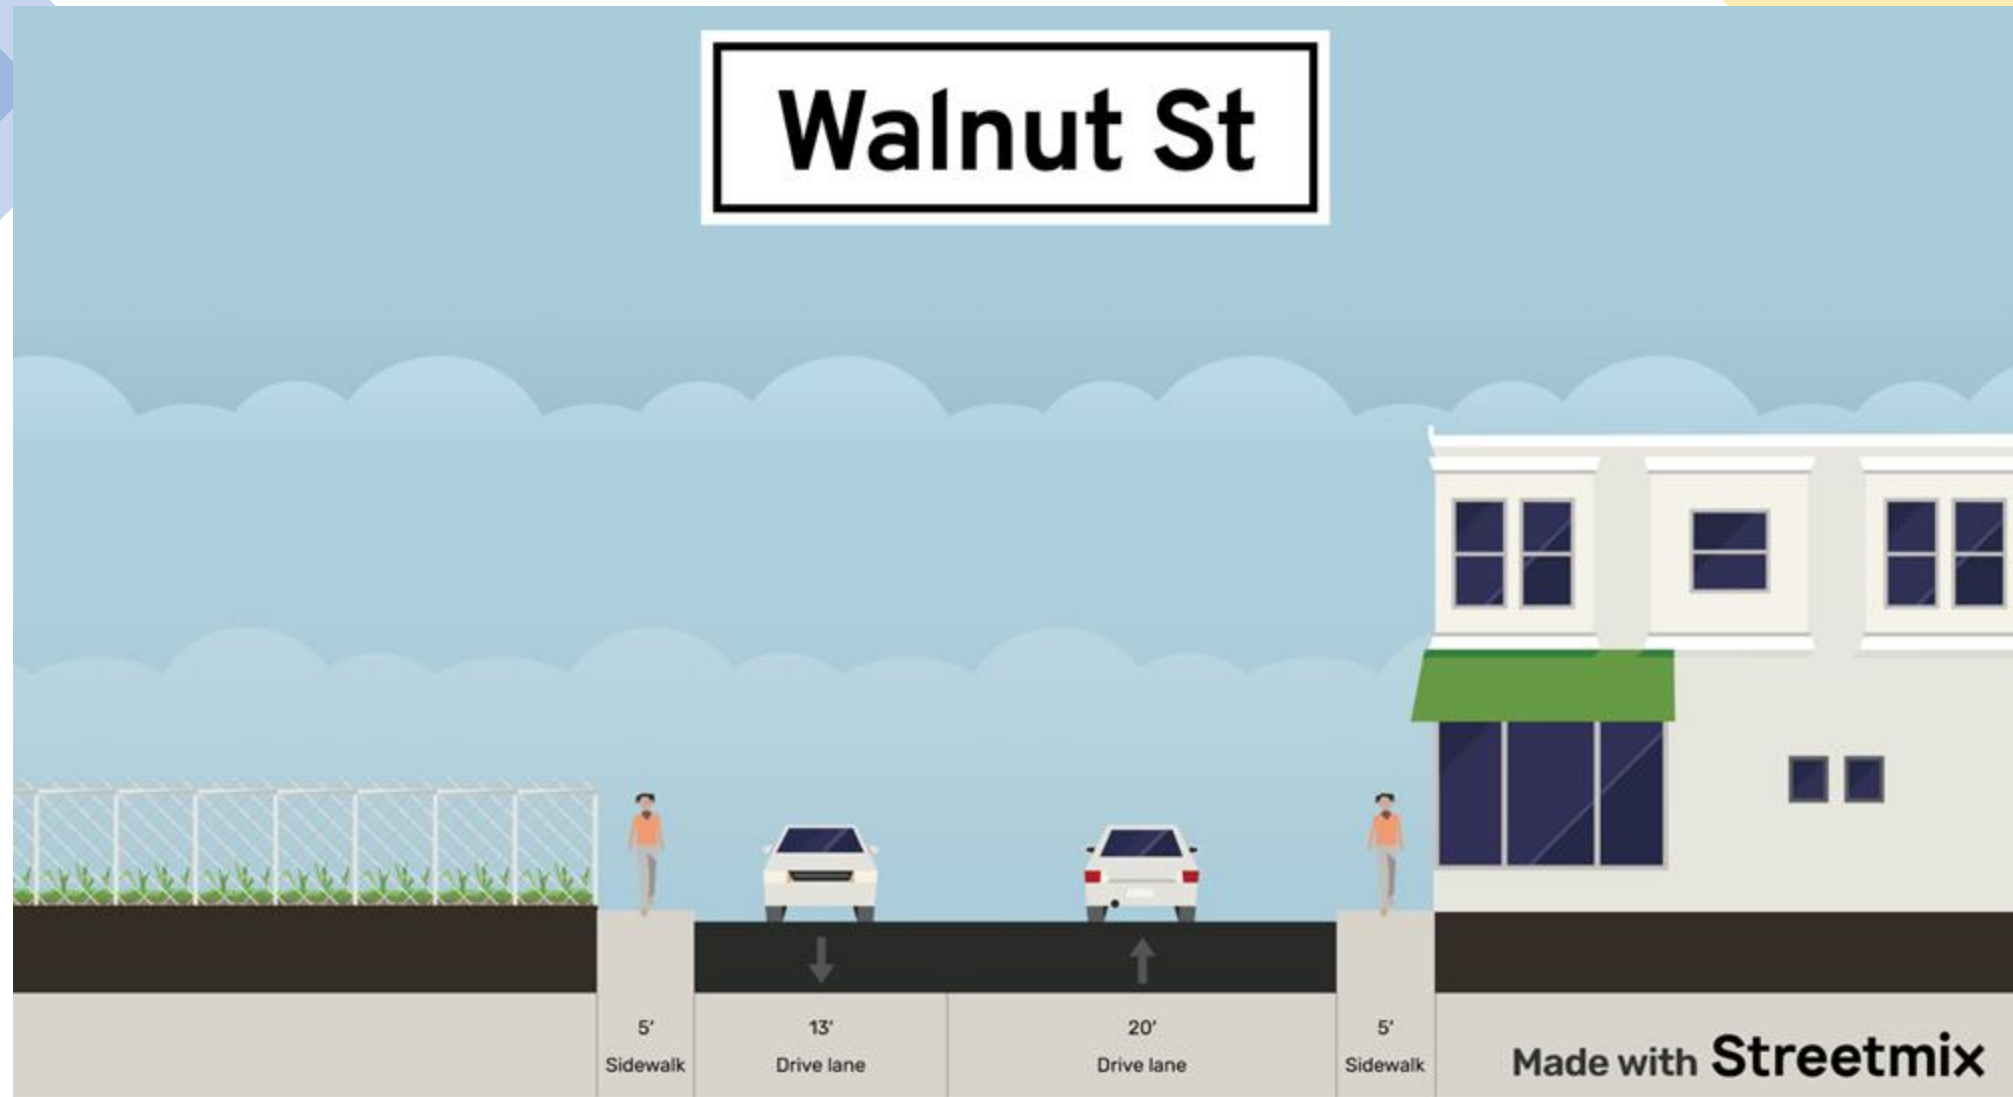
Walnut St

5 Foot sidewalks on either side of North portion of Walnut
One 13 foot-wide drive lane; one 20 foot-wide drive lane
Width across pavement: 33 feet
Width with sidewalks & pavement - 43 feet.

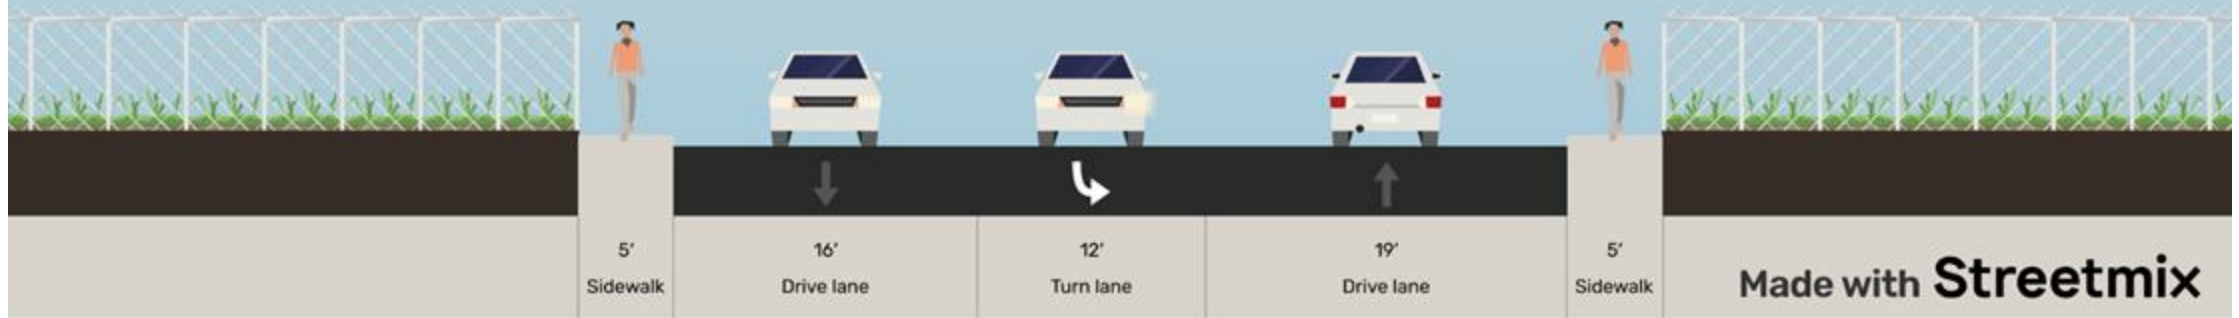
Vance Ave

5 Foot sidewalks on either side of west portion of Vance
One 16 foot-wide drive lane; one 19 foot-wide drive lane
One 12 foot-wide turn lane
Width across pavement: 47 feet
Width with sidewalks & pavement - 57 feet.

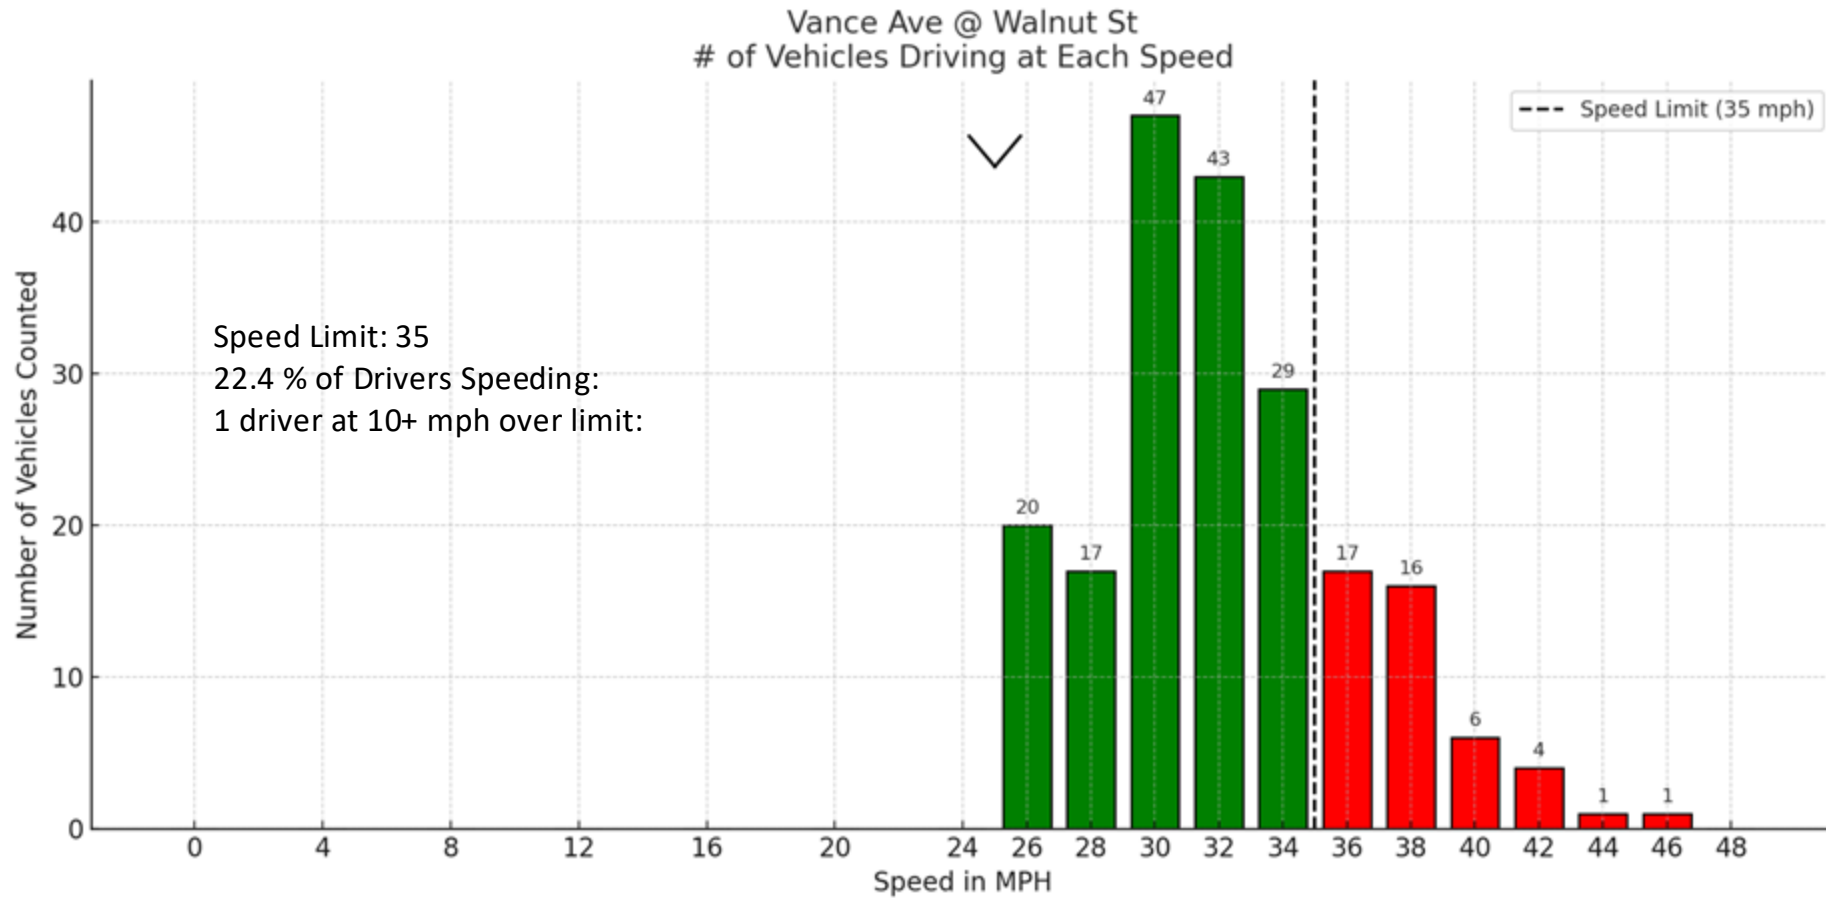
Speed Data

201 cars tracked
85th percentile speed: 36 mph

- Preliminary Speed Study indicates significant number of automobiles traveling at fatal speeds
