Crash Analysis Studio

Session 6: Amarillo, Texas

June 30, 2023

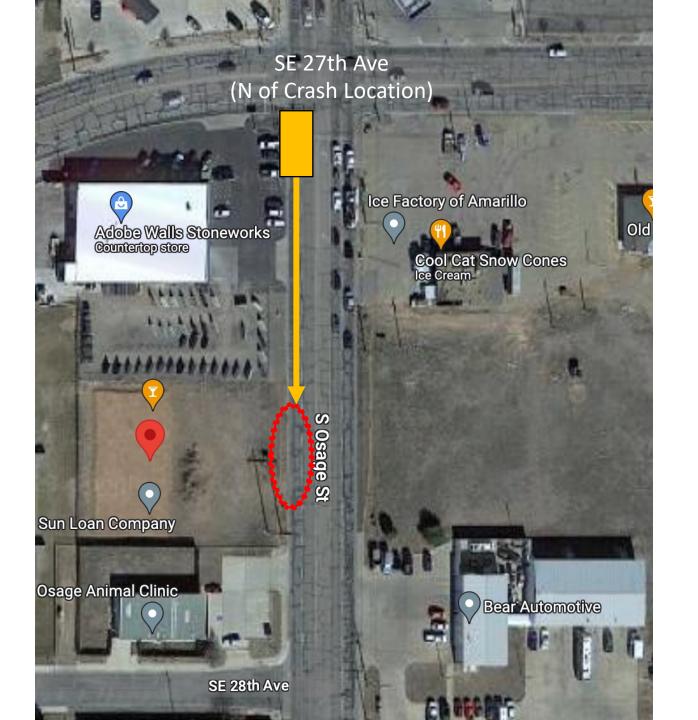
- Eduardo Valdez documented S. Osage Street speed limit is posted at 40mph while the SE 27th Avenue speed limit is posted at 35mph and 28th Street is posted at 30mph
- Motorist was traveling in the outer southbound lane on S. Osage Street
- According to the investigation report, Ducommun was on the street, nearby 2706 S. Osage when the collision occurred
 - Conflicting information from crash report states collision occurred at 2800 block of S. Osage Street & that it happened 75 feet N of SE 27th Avenue (2 different places)
- Crash report, investigation report, and media indicate the motorist was 71 years old and was not issued a citation
