# Crash Analysis Studio

Session 19: Madison, Wisconsin

### Crash Information

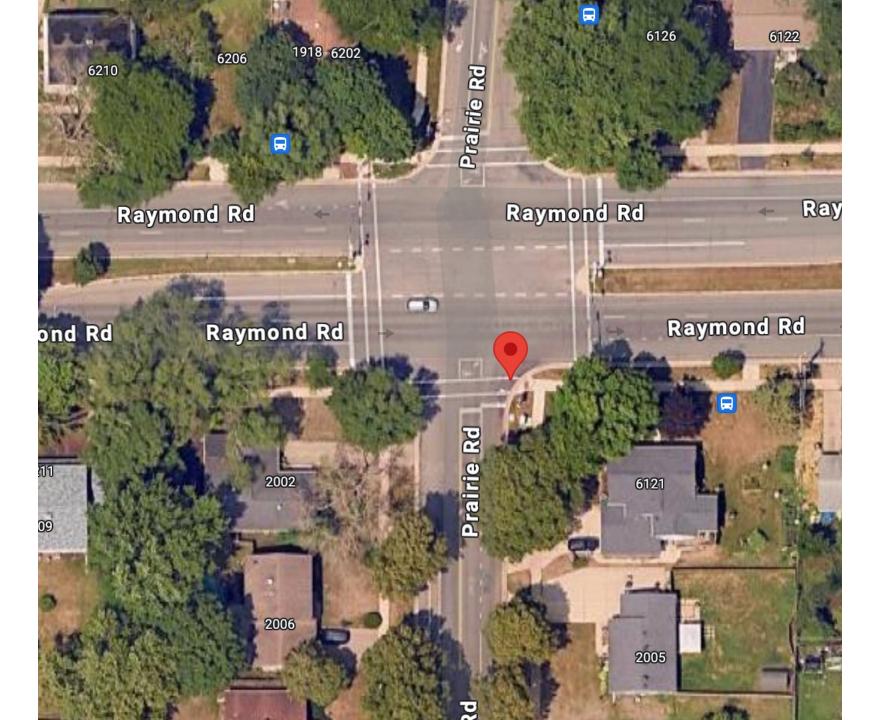
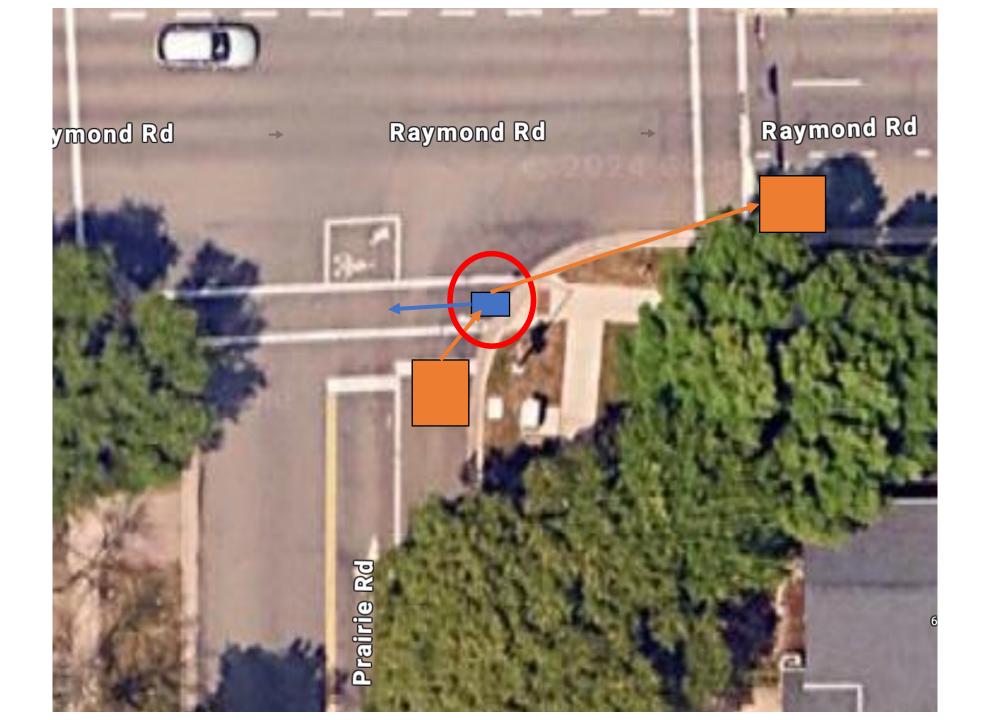
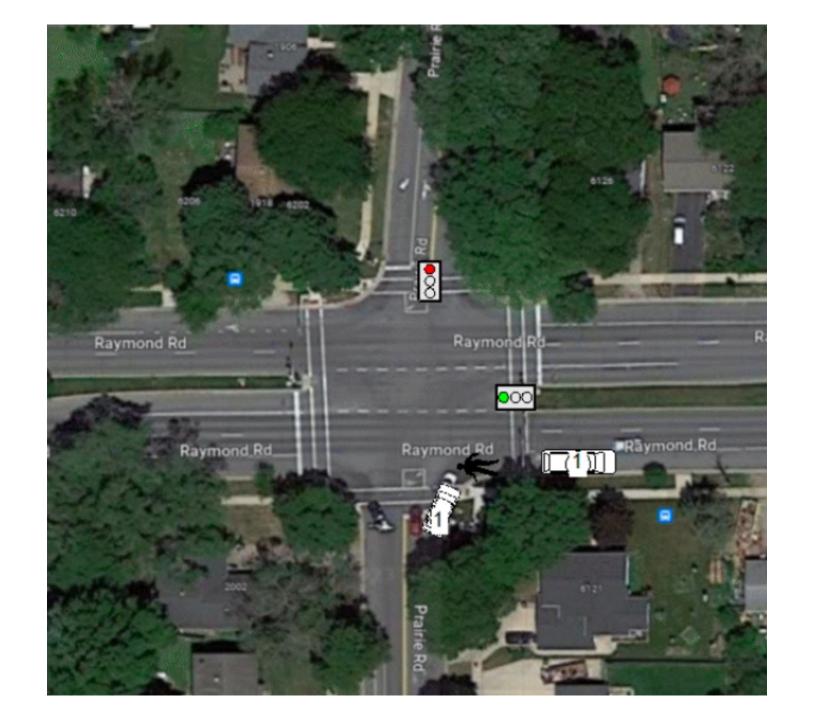
- A person walking west on Raymond Road was struck by a turning driver; the person walking died in the hospital nearly 12 hours after the collision
- The motorist was driving a DHL delivery truck and taking a right turn on red off Prairie Road when he struck the person walking
- The crash occurred at 1:41 pm on August 1, 2023; the non-motorist struck died at 1:12 am on August 2, 2023
- Madison had clear weather and was dry on the day of the crash
- Causal factors in the quarterly report to the transportation commission listed as "inattentive driving" & "failure to yield"

- In the crash report, the motorist was listed as "not distracted" and indicated he did not see the pedestrian until the collision occurred
  - Non-motorist location is listed as "at intersection-unmarked / unknown if marked crosswalk"
- This non-motorist was transported to the University of Wisconsin hospital immediately following the collision and that is where she succumbed to her injuries.
- Law enforcement indicate that neither drug or alcohol usage by the motorist was suspected; crash report lists results of the blood test as "pending"

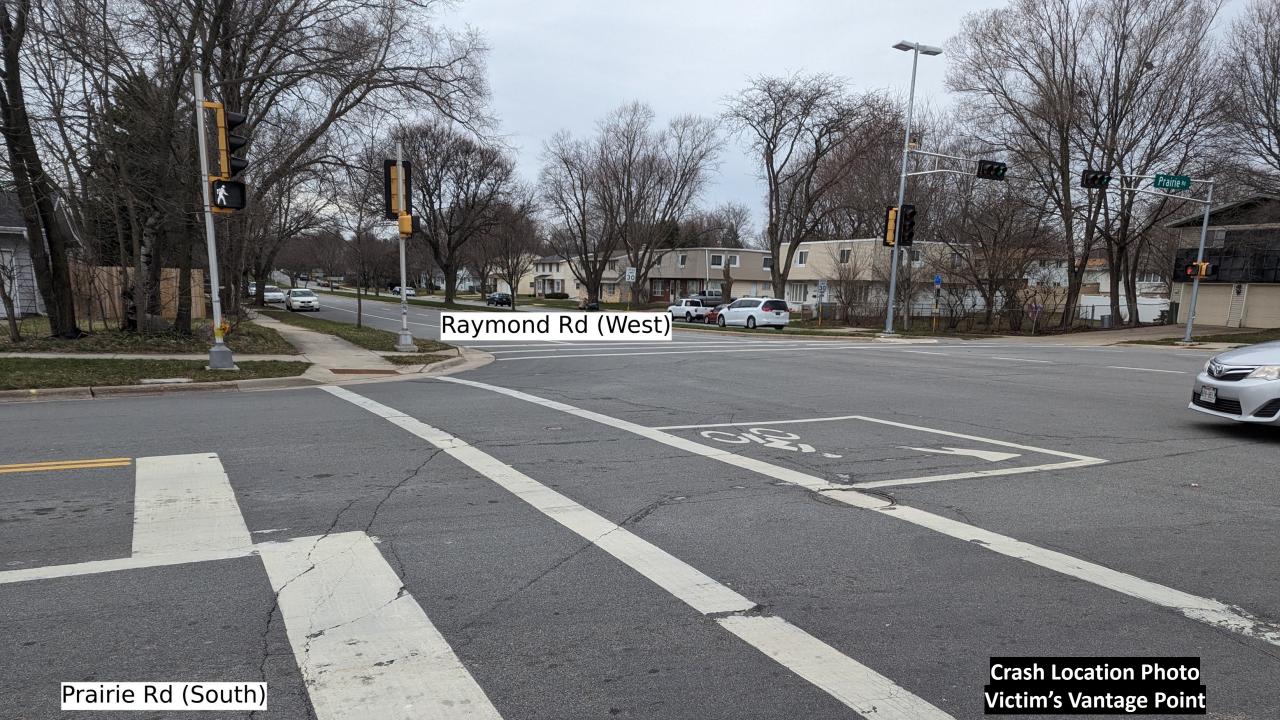
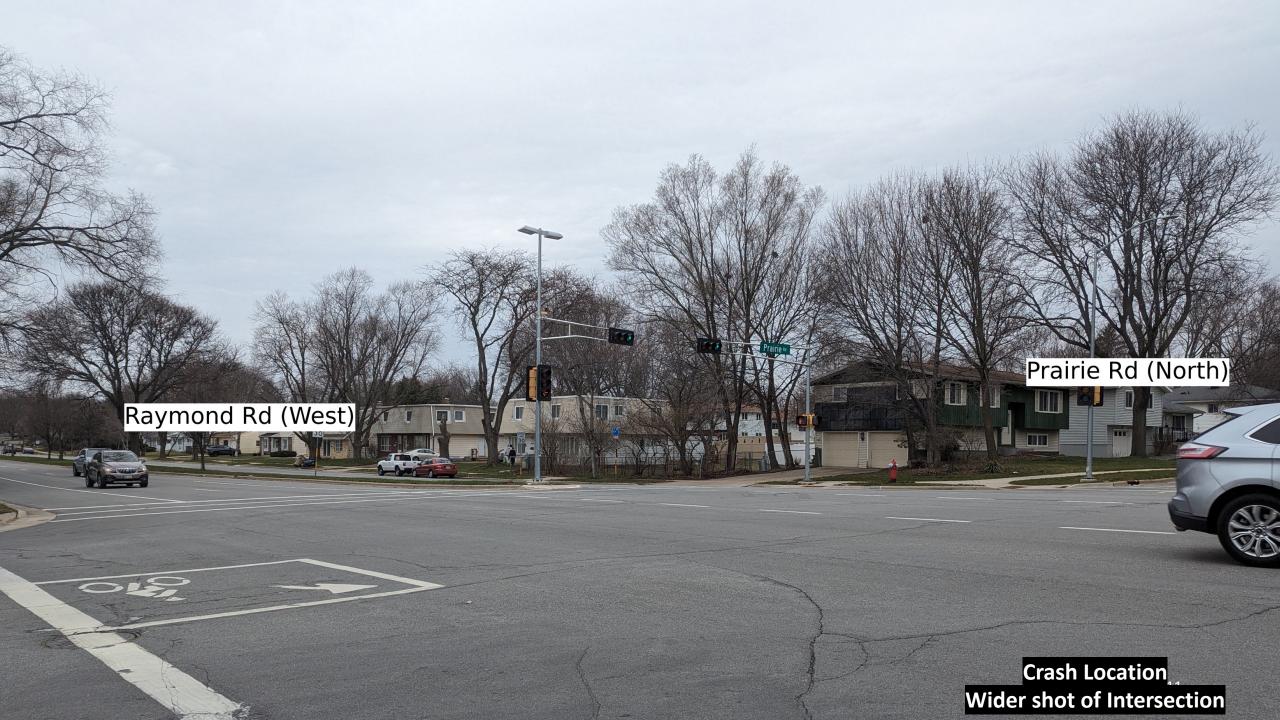
#### **Overall Site Conditions**

- South portion of Prairie Road has one northbound through traffic lane, a northbound shared through and left-turn lane, and one southbound through lane
  - This segment of Prairie also has unprotected bike lanes
- At the intersection, eastbound Raymond Road consists of a parking lane, two through traffic lanes, and a dedicated left turn lane
- All four legs of the intersection are signalized, have marked crossings, and allow access to sidewalks
